**DEPARTMENT OF TRANSPORTATION**

Contract #: 04-0120F4Cty: SF/ALA Rte: 80 PM: 13.2/13.9File #: 69.28**WELDING INSPECTION REPORT****Resident Engineer:** Siegenthaler, Peter**Address:** 333 Burma Road**City:** Oakland, CA 94607**Report No:** WIR-022272**Date Inspected:** 03-Apr-2011**Project Name:** SAS Superstructure**OSM Arrival Time:** 700**Prime Contractor:** American Bridge/Fluor Enterprises, a JV**OSM Departure Time:** 1900**Contractor:** Zhenhua Port Machinery Company, Ltd (ZPMC), Changxing Island **Location:** Shanghai, China**CWI Name:** Zhu Zhong Hai**CWI Present:** Yes No**Inspected CWI report:** Yes No N/A**Rod Oven in Use:** Yes No N/A**Electrode to specification:** Yes No N/A**Weld Procedures Followed:** Yes No N/A**Qualified Welders:** Yes No N/A**Verified Joint Fit-up:** Yes No N/A**Approved Drawings:** Yes No N/A**Approved WPS:** Yes No N/A**Delayed / Cancelled:** Yes No N/A**Bridge No:** 34-0006**Component:** Orthotropic Box Girder (OBG)**Summary of Items Observed:**

Segment 13AW

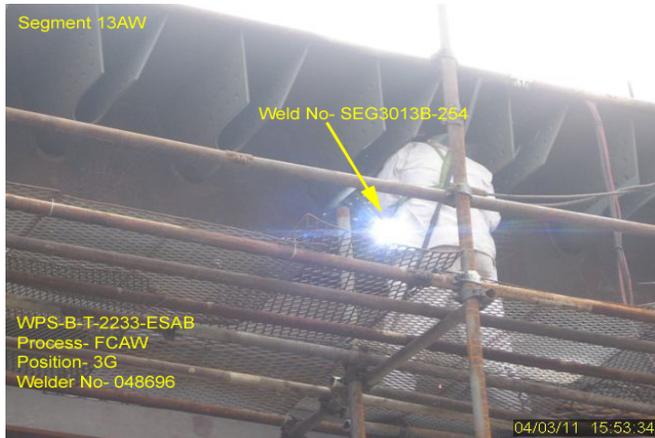
This QA Inspector observed ZPMC qualified welding personnel identified as 048696 perform Flux Cored Arc Welding (FCAW), weld joint identified as SEG3013B-254; located On Orthotropic Box Girder (OBG) Deck Panel Diaphragm to Deck Panel Diaphragm CJP Weld; ZPMC Quality Control (QC) is identified as Mr. Shen Jian Bo . This QA Inspector observed the base material appears to have been preheated by an electrical heating element prior to welding. ZPMC Quality Control (QC) Mr. Shen Jian Bo was onsite monitoring the welding variables. The welding variables recorded by QC appeared to comply with applicable WPS-B-T-2233-ESAB. See attached photo for further details.

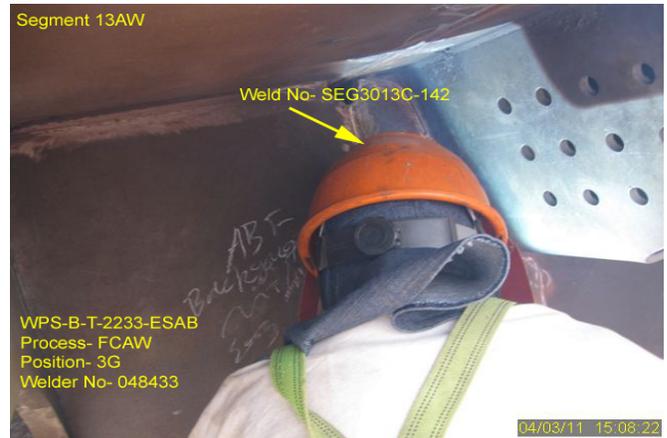
This QA Inspector observed ZPMC qualified welding personnel identified as 048433 perform Flux Cored Arc Welding (FCAW), weld joint identified as SEG3013C-142; located On Orthotropic Box Girder (OBG) Deck Panel Diaphragm to Deck Panel Diaphragm CJP Weld; ZPMC Quality Control (QC) is identified as Mr. Shen Jian Bo . This QA Inspector observed the base material appears to have been preheated by an electrical heating element prior to welding. ZPMC Quality Control (QC) Mr. Shen Jian Bo was onsite monitoring the welding variables. The welding variables recorded by QC appeared to comply with applicable WPS-B-T-2233-ESAB. See attached photo for further details.
