Contract #: 04-0120F4Cty: SF/ALA Rte: 80 PM: 13.2/13.9File #: 1.28**WELDING INSPECTION REPORT****Resident Engineer:** Siegenthaler, Peter**Address:** 333 Burma Road**City:** Oakland, CA 94607**Report No:** WIR-022354**Date Inspected:** 01-Apr-2011**Project Name:** SAS Superstructure**OSM Arrival Time:** 700**Prime Contractor:** American Bridge/Fluor Enterprises, a JV**OSM Departure Time:** 1530**Contractor:** American Bridge/Fluor Enterprises, a JV**Location:** Job Site

Caltrans Office of Structural Material (OSM) Quality Assurance Inspector (QAI) Joselito Lizardo was present at the Self Anchored Suspension (SAS) job site as requested to perform observations on the welding of components for the San Francisco Oakland Bay Bridge (SFOBB) Project.

WELDING INSPECTION REPORT

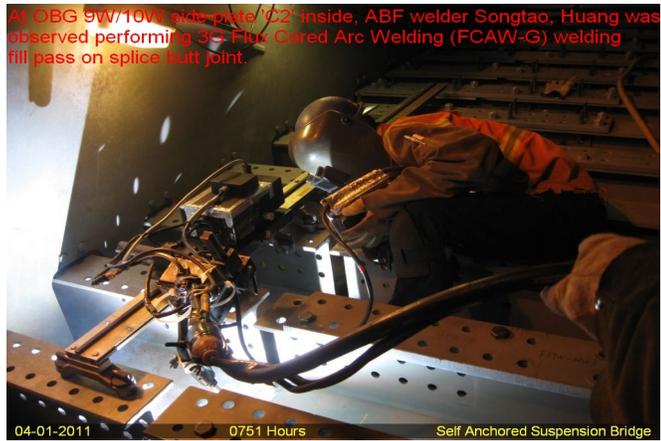
At OBG 9W/10W side plate 'C2' (2640mm to 5277mm) inside, QA randomly observed ABF/JV qualified welder Sungtao, Huang ID # 3794 continuing to perform CJP groove (splice) welding fill pass on the splice butt joint. The welder was observed perform automatic welding in the 3G (vertical) position utilizing a dual shield Flux Cored Arc Welding (FCAW-G) with E71T-1M, 1/16" diameter wire electrode and implementing Caltrans approved Welding Procedure Specification (WPS) ABF-WPS-D15-3042B-1. The joint being welded has a single V-groove butt joint with backing bar. The splice joint was preheated and maintained to greater than 150 degrees Fahrenheit using Miller Proheat 35 Induction Heating System heater blankets located at the opposite side of the plate prior/during welding. During welding, ABF Quality Control (QC) Steve Jensen was noted monitoring the welding parameters of the welder. At the end of the shift, cover pass welding at located mentioned above was completed.

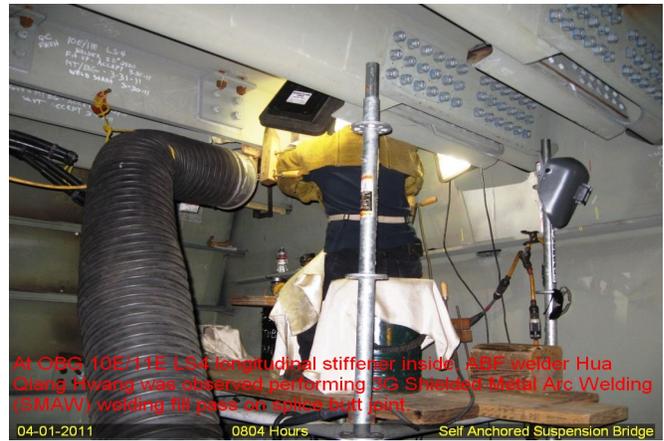
At OBG 10E/11E LS4 longitudinal stiffener inside, QA randomly observed ABF welder Hua Qiang Hwang continuing to perform 3G (vertical) Shielded Metal Arc Welding (SMAW) complete joint penetration (CJP) welding fill pass on the stiffener splice butt joint. The stiffener plates being welded are made of high strength plate material HPS 485W and has a thickness of 38mm. The joint has a double V joint preparation that was welded from one side and after the completion from one side to be back gouged, Non Destructive Testing (NDT) tested using Magnetic Particle Testing (MT) and back welded to the other side. The welder was noted using E9018H4R with 1/8" diameter electrode implementing Caltrans approved welding procedure specification (WPS) ABF-WPS-D1.

5-1012-3. The joint being welded was root welded using a ceramic backing. The splice joint was preheated to greater than 200 degrees Fahrenheit using Miller Proheat 35 Induction Heating System heater blanket located at the opposite side of the plate prior/during welding. The QA Inspector noted the ABF QC Fred Von Hoff was on site monitoring the in process preheats and welding parameters. During the shift, QA noted ABF QC Fred Von Hoff was closely monitoring the issuance of E9018H4R electrodes due to its limited exposure time allowed. At the end of the shift, cover pass welding on both sides of the butt was completed and the welder was instructed by QC to hold the preheat of >200° F for three more hours after welding as required.

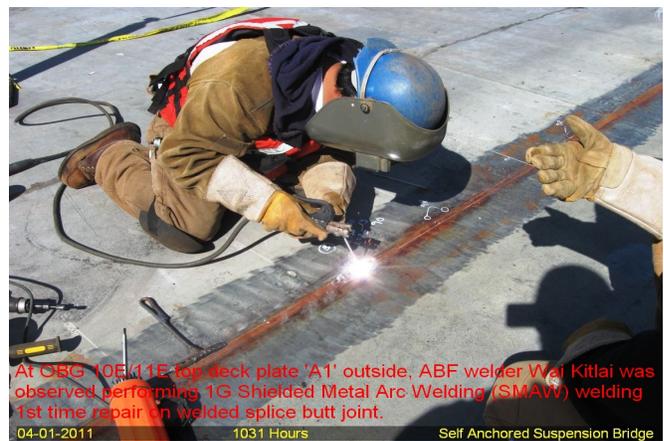
At OBG 10E/11E top deck plate 'A1' outside, QA randomly observed ABF/JV qualified welder Wai Kitlai perform CJP repair welding. The welder was noted welding in 1G (flat) position utilizing SMAW with 1/8" diameter E7018H4R electrode implementing new Caltrans approved Welding Procedure Specification (WPS) ABF-WPS-D15-1003 Repair. The new repair procedure includes putting in place a copper backing alongside the typical steel backing bar when the repair excavation is expected to occur at the edge of the steel backing. The first time welding repairs were excavated to a boat shape profile and were tested with Magnetic Particle Testing (MT) prior welding. During welding, ABF QC Jesse Cayabyab was noted monitoring the welder and his welding parameters. QA noted parameter during welding was 135 amperes which appears in compliance to the WPS. The locations of the repairs were noted below;

Location	Y-dimension	Length	Width	Depth	Remarks
1.	A1	3580mm	100mm	22mm	12mm	Completed (R1)
2.	A1	4630mm	30mm	20mm	13mm	Completed (R1)
3.	A1	1630mm	90mm	22mm	20mm	Completed (R1)
