Contract #: 04-0120F4Cty: SF/ALA Rte: 80 PM: 13.2/13.9File #: 69.28**WELDING INSPECTION REPORT****Resident Engineer:** Siegenthaler, Peter**Address:** 333 Burma Road**City:** Oakland, CA 94607**Report No:** WIR-022384**Date Inspected:** 04-Apr-2011**Project Name:** SAS Superstructure**OSM Arrival Time:** 700**Prime Contractor:** American Bridge/Fluor Enterprises, a JV**OSM Departure Time:** 1900**Contractor:** Zhenhua Port Machinery Company, Ltd (ZPMC), Changxing Island **Location:** Shanghai, China**CWI Name:** Li Yang and Zhu Zhong Hai**CWI Present:** Yes No**Inspected CWI report:** Yes No N/A**Rod Oven in Use:** Yes No N/A**Electrode to specification:** Yes No N/A**Weld Procedures Followed:** Yes No N/A**Qualified Welders:** Yes No N/A**Verified Joint Fit-up:** Yes No N/A**Approved Drawings:** Yes No N/A**Approved WPS:** Yes No N/A**Delayed / Cancelled:** Yes No N/A**Bridge No:** 34-0006**Component:** OBG Trial Assembly**Summary of Items Observed:**

Orthotropic Box Girder (OBG) at Trial Assembly Areas

WELDING INSPECTION REPORT

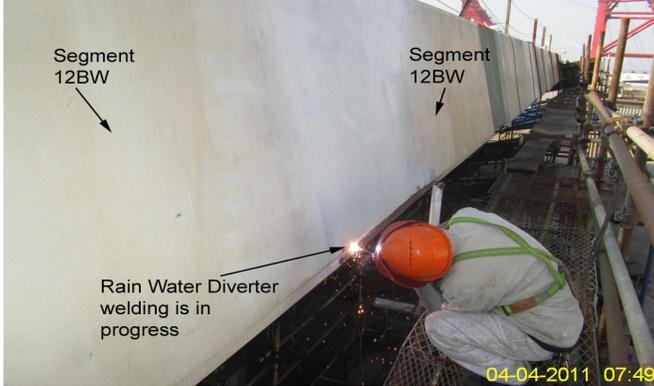
Segment 12BW and Segment 12CW (Rain Water Diverter Plate)

This QA Inspector observed the in-process welding by Shielded Metal Arc Welding (SMAW) process on a Fillet weld. The Weld joint was designated as CA3012-234/235. The welder identification was 046709 and observed welding in the 4F (Overhead) position using approved Welding Procedure Specification WPS-B-P-2114-FCM-1. The piece mark was identified as the weld connecting the Rain Water Diverter Plate at work point W1.

Segment 12BW and Segment 12CW, Rain Water Diverter plate welding is in progress at work point W1 at OBG Trail Assembly.

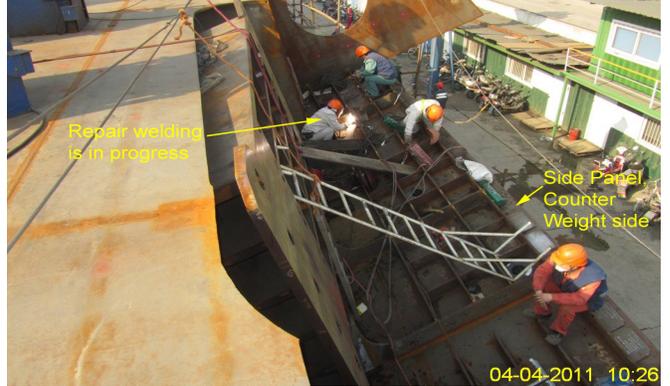
This QA Inspector observed the in-process welding by Shielded Metal Arc Welding (SMAW) process on a Complete Joint Penetration (CJP) weld. The Weld joint was designated as Seg3013M-063. The welder identification was 067572 and observed welding in the 4G (Overhead) position using approved Welding Procedure Specification WPS-345-SMAW-4G(4F)-FCM-Repair-1. The piece mark was identified as the weld connecting the Stiffeners Plates on Side Panel, Counter Weight side between work point W13 towards work point W18.

Segment 13AW, Side Panel, Counter weight side, Stiffener Plates repair welding is in progress at OBG Trial Assembly.

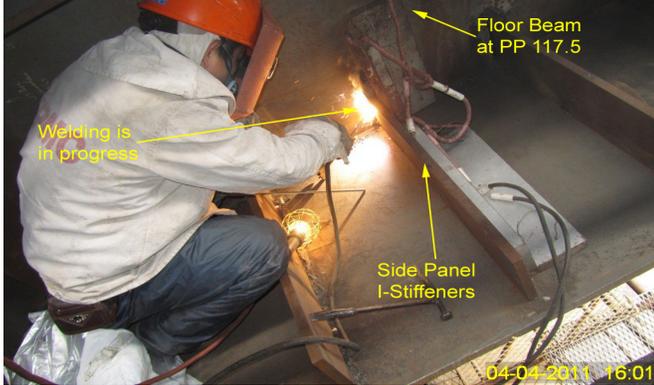
Segment 13AW, Side Panel I-Stiffener welded to the Floor Beam at Cross Beam, Counter Weight side at OBG Trial Assembly.

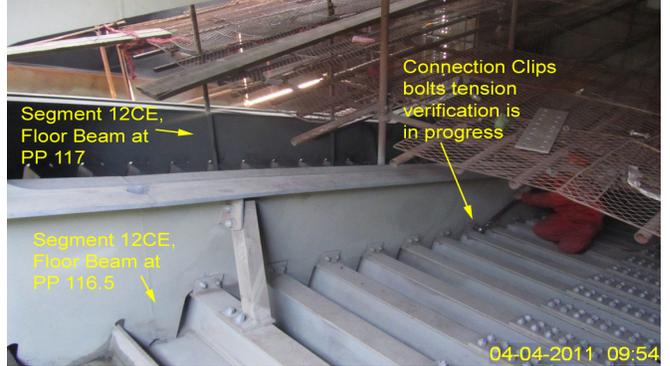
This QA Inspector witnessed the final bolt tension verification on bolts connecting the T-Rib connections clips at Side Panel (Cross Beam and Bike Path side) and at Bottom Panel at the Panel Points (PP) 115, PP 115.2, PP 115.5, PP 116, PP 116.5 and PP 117 for Segment 12CE. The QA Inspector verified the bolt tension on a random basis and the results appeared to be in general compliance. The Inspection was performed against Notification No. 00640 dated April 04, 2011.

Segment 12CE, Side Panel Floor Beam to Side Panel T-Ribs, Connection clip bolt tension verification is in progress at Cross Beam side, OBG Trial Assembly.

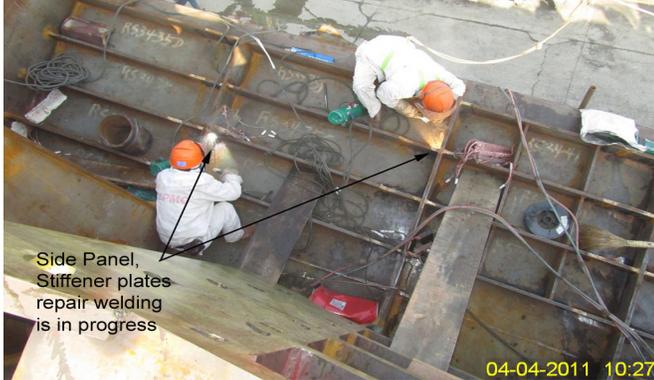
Segment 13AW, Side Panel, Counter Weight side, Stiffener Plates repair welding is in progress at OBG Trial Assmely.

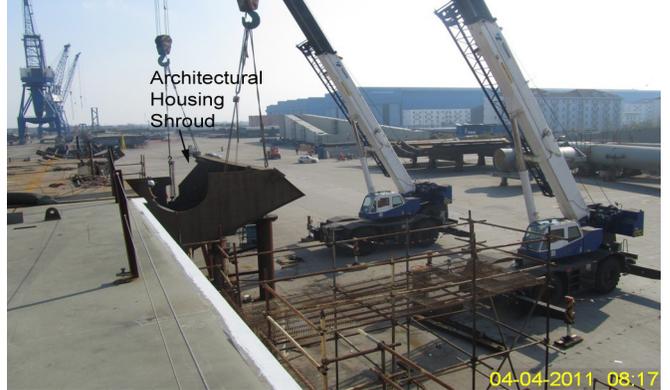
This QA Inspector observed ZPMC personnel's installing the Architectural Housing Shroud at Bike Path side.

Segment 13AE, Architectural Housing Shroud, Installation is in progress at Bike Path side at OBG Trial Assembly.
