**DEPARTMENT OF TRANSPORTATION**

Contract #: 04-0120F4Cty: SF/ALA Rte: 80 PM: 13.2/13.9File #: 69.28**WELDING INSPECTION REPORT****Resident Engineer:** Siegenthaler, Peter**Address:** 333 Burma Road**City:** Oakland, CA 94607**Report No:** WIR-022387**Date Inspected:** 05-Apr-2011**Project Name:** SAS Superstructure**OSM Arrival Time:** 700**Prime Contractor:** American Bridge/Fluor Enterprises, a JV**OSM Departure Time:** 1900**Contractor:** Zhenhua Port Machinery Company, Ltd (ZPMC), Changxing Island **Location:** Shanghai, China**CWI Name:** Li Yang and Zhu Zhong Hai**CWI Present:** Yes No**Inspected CWI report:** Yes No N/A**Rod Oven in Use:** Yes No N/A**Electrode to specification:** Yes No N/A**Weld Procedures Followed:** Yes No N/A**Qualified Welders:** Yes No N/A**Verified Joint Fit-up:** Yes No N/A**Approved Drawings:** Yes No N/A**Approved WPS:** Yes No N/A**Delayed / Cancelled:** Yes No N/A**Bridge No:** 34-0006**Component:** OBG Trial Assembly**Summary of Items Observed:**

Orthotropic Box Girder (OBG) at Trial Assembly Areas

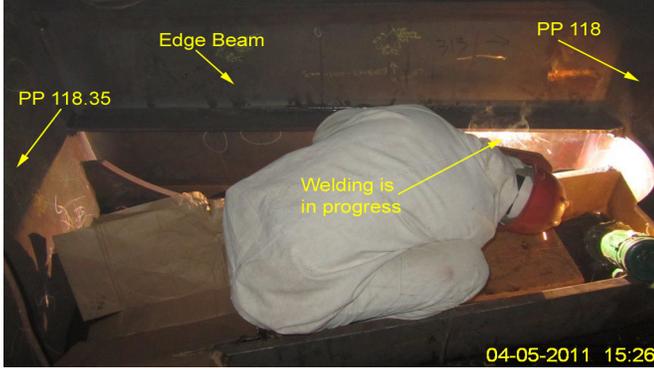
This QA Inspector observed the in-process welding by Shielded Metal Arc Welding (SMAW) process on a Fillet weld. The weld joint was designated as Seg3007Q-315. The welder identification was 068917 and observed welding in the 4F (Overhead) position using approved Welding Procedure Specification WPS-B-P-2114-FCM. The piece mark was identified as the weld connecting the Stiffeners Plates to the Edge Beam Stiffener between PP 118 to PP 118.35 at work point E13.

Segment 13AE, Edge Beam at work point E13, Stiffener welding is in progress at Edge Beam web location between PP 118 to PP 118.35 at OBG Trial Assembly.

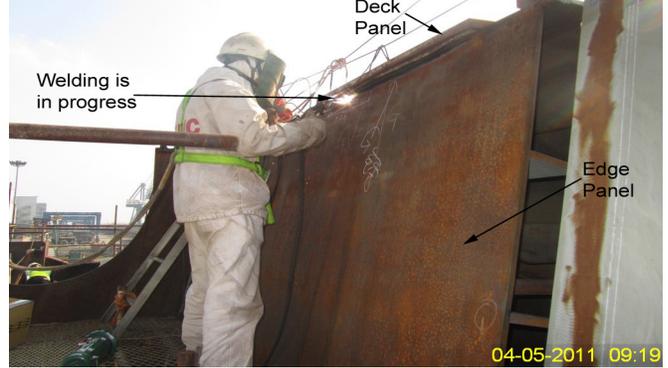
This QA Inspector observed the in-process welding by Shielded Metal Arc Welding (SMAW) process on a Complete Joint Penetration (CJP) weld. The weld joint was designated as Seg3013-001. The welder identification was 066443 and observed welding in the 2G (Horizontal) position using approved Welding Procedure Specification WPS-B-P-2212-Tc-U4b-FCM-1. The piece mark was identified as the weld connecting the Deck Panel to Edge Panel at work point W2, Counter Weight side.

Segment 13AW, Deck Panel to Edge Panel connecting weld, welding is in progress at OBG Trial Assembly at OBG Trial Assembly at work point W2.

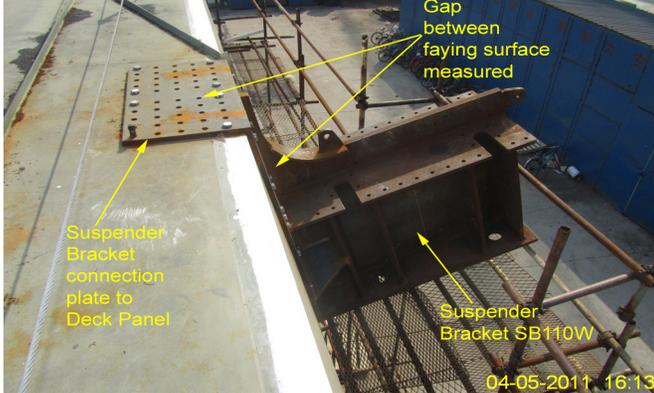
SB110W installed at Segment 12AW at PP 110, Counter Weight side.

The gap measurements was recorded within the allowable tolerance and informed to the Lead Inspector.  
Please reference the pictures attached for more comprehensive details.

Segment 12AW, PP 110, Suspender Bracket Gap measurement performed
