DEPARTMENT OF TRANSPORTATION

Contract #: 04-0120F4Cty: SF/ALA Rte: 80 PM: 13.2/13.9File #: 69.28**WELDING INSPECTION REPORT****Resident Engineer:** Siegenthaler, Peter**Address:** 333 Burma Road**City:** Oakland, CA 94607**Report No:** WIR-022393**Date Inspected:** 04-Apr-2011**Project Name:** SAS Superstructure**OSM Arrival Time:** 700**Prime Contractor:** American Bridge/Fluor Enterprises, a JV**OSM Departure Time:** 1900**Contractor:** Zhenhua Port Machinery Company, Ltd (ZPMC), Changxing Island **Location:** Shanghai, China**CWI Name:** Zhu Zhong Hai**CWI Present:** Yes No**Inspected CWI report:** Yes No N/A**Rod Oven in Use:** Yes No N/A**Electrode to specification:** Yes No N/A**Weld Procedures Followed:** Yes No N/A**Qualified Welders:** Yes No N/A**Verified Joint Fit-up:** Yes No N/A**Approved Drawings:** Yes No N/A**Approved WPS:** Yes No N/A**Delayed / Cancelled:** Yes No N/A**Bridge No:** 34-0006**Component:** Orthotropic Box Girder (OBG)**Summary of Items Observed:**

WELDING INSPECTION REPORT

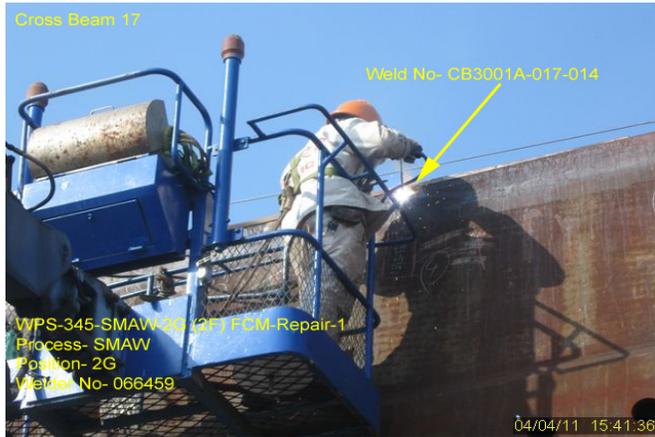
This QA Inspector observed ZPMC qualified welding personnel identified as 066459 perform Shielded Metal Arc Welding (SMAW), weld joint identified as CB3001A-017-014; located On Orthotropic Box Girder (OBG) Edge Plate to Cantilever Bracket CJP Weld; ZPMC Quality Control (QC) is identified as Mr. Li Yang. This QA Inspector observed the base material appears to have been preheated by an electrical heating element prior to welding. The Critical Welding Repair Report (CWRR) was B-CWR2892. ZPMC Quality Control (QC) Mr. Li Yang was onsite monitoring the welding variables. The welding variables recorded by QC appeared to comply with applicable WPS-345-SMAW-2G (2F) FCM-Repair-1. See attached photo for further details.

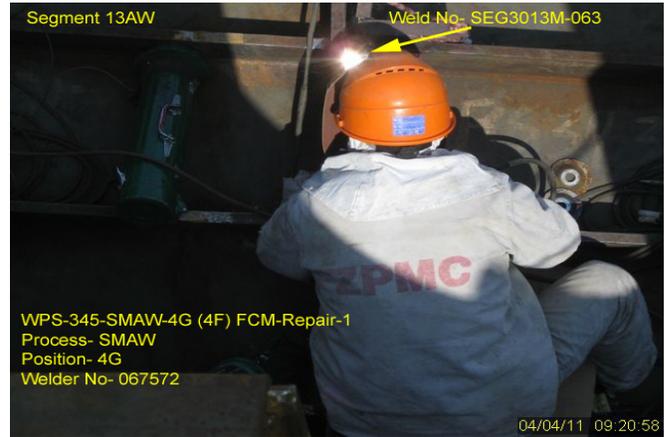
This QA Inspector observed ZPMC qualified welding personnel identified as 067572 perform Shielded Metal Arc Welding (SMAW), weld joint identified as SEG3013M-063; located On Orthotropic Box Girder (OBG) Side Plate to I-Rib Stiffener CJP Weld; ZPMC Quality Control (QC) is identified as Mr. Shen Jian Bo. This QA Inspector observed the base material appears to have been preheated by an electrical heating element prior to welding. The Welding Repair Report (WRR) was B-WR20579. ZPMC Quality Control (QC) Mr. was onsite monitoring the welding variables. The welding variables recorded by QC appeared to comply with applicable WPS-345-SMAW-4G (4F) FCM-Repair-1. See attached photo for further details.
