DEPARTMENT OF TRANSPORTATION

Contract #: 04-0120F4Cty: SF/ALA Rte: 80 PM: 13.2/13.9File #: 1.28**WELDING INSPECTION REPORT****Resident Engineer:** Siegenthaler, Peter**Address:** 333 Burma Road**City:** Oakland, CA 94607**Report No:** WIR-022486**Date Inspected:** 11-Apr-2011**Project Name:** SAS Superstructure**OSM Arrival Time:** 700**Prime Contractor:** American Bridge/Fluor Enterprises, a JV**OSM Departure Time:** 1530**Contractor:** American Bridge/Fluor Enterprises, a JV**Location:** Job Site**CWI Name:** See Report Below**CWI Present:** Yes No**Inspected CWI report:** Yes No N/A**Rod Oven in Use:** Yes No N/A**Electrode to specification:** Yes No N/A**Weld Procedures Followed:** Yes No N/A**Qualified Welders:** Yes No N/A**Verified Joint Fit-up:** Yes No N/A**Approved Drawings:** Yes No N/A**Approved WPS:** Yes No N/A**Delayed / Cancelled:** Yes No N/A**Bridge No:** 34-0006**Component:** Orthotropic Box Girders**Summary of Items Observed:**

WELDING INSPECTION REPORT

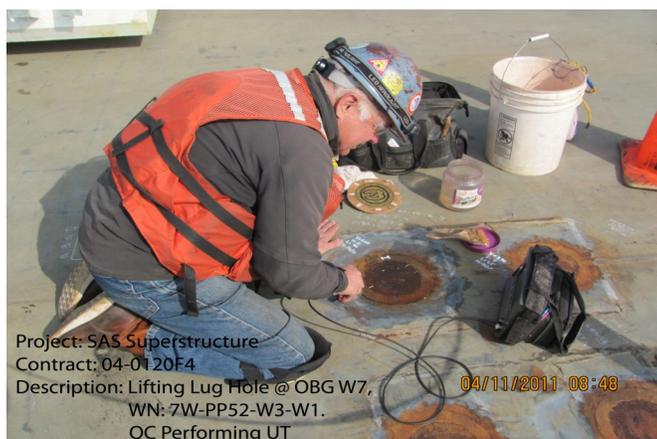
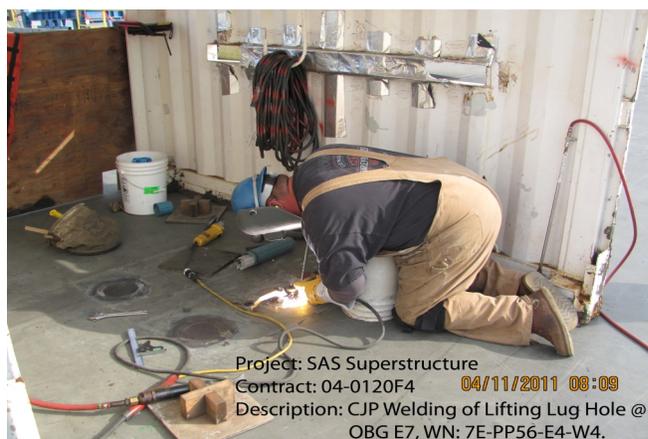
The welding was performed in the vertical (3G) position utilizing the E7018-H4R and E9018-H4R low hydrogen electrodes. The 3.2 mm electrodes were stored in electrically heated, thermostatically controlled oven after removal from the sealed containers. The exposure limits of the electrodes appeared to comply with the minimum storage oven temperature of 120 degrees Celsius as per the contract documents. The WPS were also utilized by the QC inspector, Gary Ehram as a reference to monitor the welding operation, to verify the welding parameters and verify the minimum preheat and the interpass temperatures. The welding parameters and surface temperatures were verified by the QC inspector's utilizing a Fluke 337 clamp meter for the electrical welding parameters and Tempil Heat Indicators for verifying the preheat and interpass temperatures. At the time of the observation no issues were noted by the QAI.

The digital photographs below illustrate some of the work observed during this scheduled shift.
