Contract #: 04-0120F4Cty: SF/ALA Rte: 80 PM: 13.2/13.9File #: 69.28**WELDING INSPECTION REPORT****Resident Engineer:** Siegenthaler, Peter**Address:** 333 Burma Road**City:** Oakland, CA 94607**Report No:** WIR-022522**Date Inspected:** 14-Apr-2011**Project Name:** SAS Superstructure**OSM Arrival Time:** 700**Prime Contractor:** American Bridge/Fluor Enterprises, a JV**OSM Departure Time:** 1900**Contractor:** Zhenhua Port Machinery Company, Ltd (ZPMC), Changxing Island **Location:** Shanghai, China**CWI Name:** Liu Hua Jie**CWI Present:** Yes No**Inspected CWI report:** Yes No N/A**Rod Oven in Use:** Yes No N/A**Electrode to specification:** Yes No N/A**Weld Procedures Followed:** Yes No N/A**Qualified Welders:** Yes No N/A**Verified Joint Fit-up:** Yes No N/A**Approved Drawings:** Yes No N/A**Approved WPS:** Yes No N/A**Delayed / Cancelled:** Yes No N/A**Bridge No:** 34-0006**Component:** Orthotropic Box Girder (OBG)**Summary of Items Observed:**

OBG # TRIAL ASSEMBLY YARD**WELDING:****Segment 13AW**

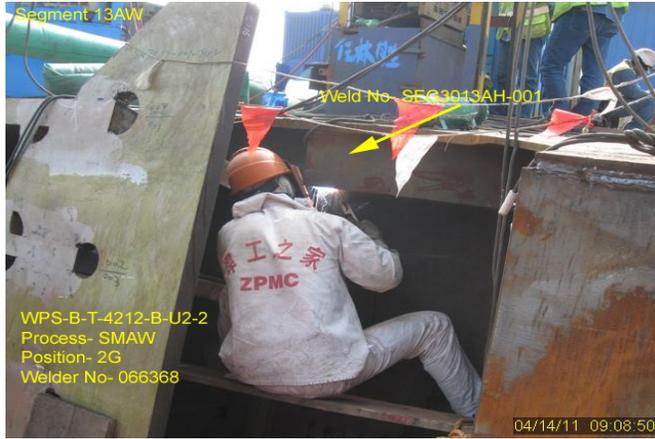
This QA Inspector observed ZPMC qualified welding personnel identified as 066368 perform Shielded Metal Arc Welding (SMAW), weld joint identified as SEG3013AH-001; located On Orthotropic Box Girder (OBG) Deck Plate to I-Rib CJP Weld; ZPMC Quality Control (QC) is identified as Mr. Shen Jian Bo. This QA Inspector observed the base material appears to have been preheated by an electrical heating element prior to welding. ZPMC Quality Control (QC) Mr. Shen Jian Bo was onsite monitoring the welding variables. The welding variables recorded by QC appeared to comply with applicable WPS-B-T-4212-B-U2-2. See attached photo for further details.

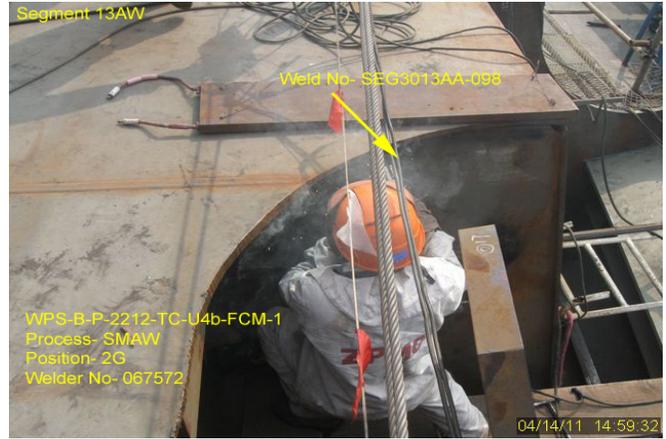
This QA Inspector observed ZPMC qualified welding personnel identified as 067572 perform Shielded Metal Arc Welding (SMAW), weld joint identified as SEG3013AA-098; located On Orthotropic Box Girder (OBG) FB3179A to X4203C CJP Weld; ZPMC Quality Control (QC) is identified as Mr. Shen Jian Bo. This QA Inspector observed the base material appears to have been preheated by an electrical heating element prior to welding. ZPMC Quality Control (QC) Mr. Shen Jian Bo was onsite monitoring the welding variables. The welding variables recorded by QC appeared to comply with applicable WPS-B-P-2212-TC-U4b-FCM-1. See attached photo for further details.
