Contract #: 04-0120F4Cty: SF/ALA Rte: 80 PM: 13.2/13.9File #: 69.28**WELDING INSPECTION REPORT****Resident Engineer:** Siegenthaler, Peter**Address:** 333 Burma Road**City:** Oakland, CA 94607**Report No:** WIR-022570**Date Inspected:** 11-Apr-2011**Project Name:** SAS Superstructure**OSM Arrival Time:** 700**Prime Contractor:** American Bridge/Fluor Enterprises, a JV**OSM Departure Time:** 1900**Contractor:** Zhenhua Port Machinery Company, Ltd (ZPMC), Changxing Island **Location:** Shanghai, China**CWI Name:** Li Yang and Zhu Zhong Hai**CWI Present:** Yes No**Inspected CWI report:** Yes No N/A**Rod Oven in Use:** Yes No N/A**Electrode to specification:** Yes No N/A**Weld Procedures Followed:** Yes No N/A**Qualified Welders:** Yes No N/A**Verified Joint Fit-up:** Yes No N/A**Approved Drawings:** Yes No N/A**Approved WPS:** Yes No N/A**Delayed / Cancelled:** Yes No N/A**Bridge No:** 34-0006**Component:** OBG Trial Assembly**Summary of Items Observed:**

Orthotropic Box Girder (OBG) at Trial Assembly Areas

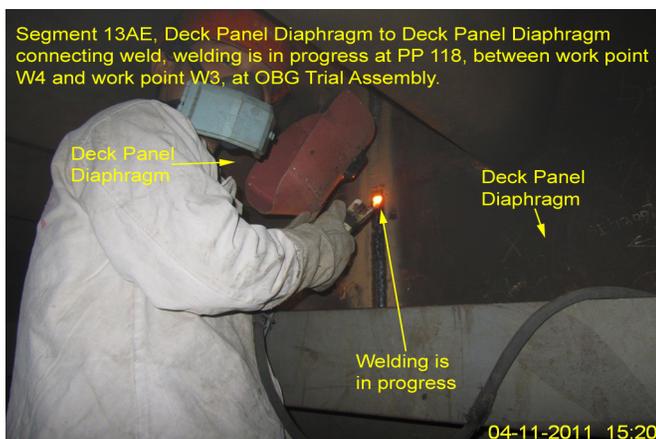
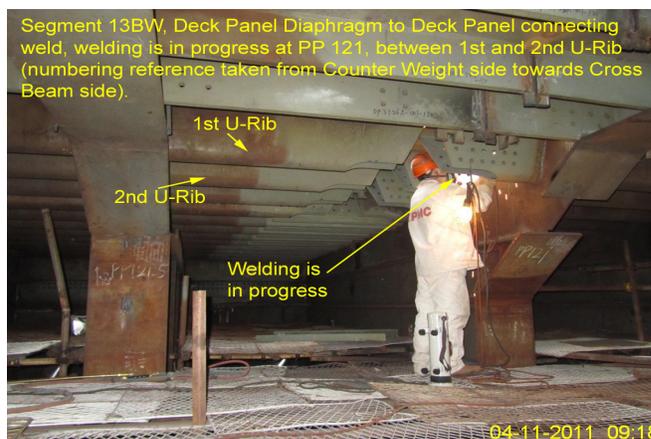
This QA Inspector observed the in-process welding by Shielded Metal Arc Welding (SMAW) process on a Complete Joint Penetration (CJP) weld. The weld joint was designated as Seg3013-004. The welder identification was 069683 and observed welding in the 4G (Overhead) position using approved Welding Procedure Specification WPS-B-P-2214-Tc-U4b-FCM-1. The piece mark was identified as the weld connecting the Deck Panel to Deck Panel.

This QA Inspector observed the repair welding by Shielded Metal Arc Welding (SMAW) process on a Complete Joint Penetration (CJP) weld. The weld joint was designated as Seg3013AD-076. The welder identification was 050242 and observed welding in the 4G (Overhead) position using approved Welding Procedure Specification WPS-345-SMAW-4G(4F)-Repair-FCM-1. The piece mark was identified as the weld connecting the Pier E2 Floor
