Contract #: 04-0120F4Cty: SF/ALA Rte: 80 PM: 13.2/13.9File #: 69.28**WELDING INSPECTION REPORT****Resident Engineer:** Siegenthaler, Peter**Address:** 333 Burma Road**City:** Oakland, CA 94607**Report No:** WIR-022574**Date Inspected:** 10-Apr-2011**Project Name:** SAS Superstructure**OSM Arrival Time:** 700**Prime Contractor:** American Bridge/Fluor Enterprises, a JV**OSM Departure Time:** 1900**Contractor:** Zhenhua Port Machinery Company, Ltd (ZPMC), Changxing Island **Location:** Shanghai, China**CWI Name:** Li Yang and Zhu Zhong Hai**CWI Present:** Yes No**Inspected CWI report:** Yes No N/A**Rod Oven in Use:** Yes No N/A**Electrode to specification:** Yes No N/A**Weld Procedures Followed:** Yes No N/A**Qualified Welders:** Yes No N/A**Verified Joint Fit-up:** Yes No N/A**Approved Drawings:** Yes No N/A**Approved WPS:** Yes No N/A**Delayed / Cancelled:** Yes No N/A**Bridge No:** 34-0006**Component:** OBG Trial Assembly**Summary of Items Observed:**

Orthotropic Box Girder (OBG) at Trial Assembly Areas

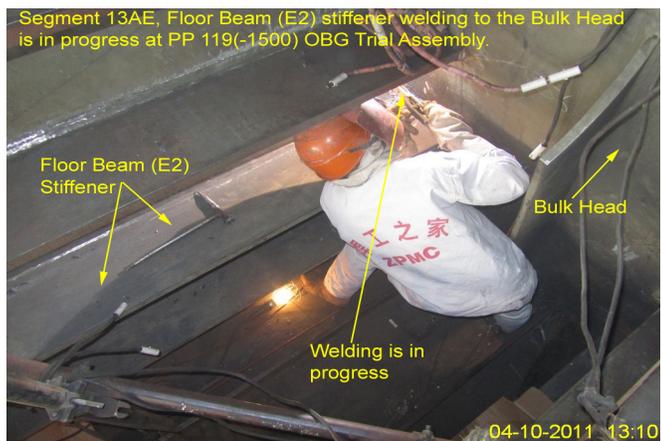
This QA Inspector observed the in-process welding by Shielded Metal Arc Welding (SMAW) process on a Complete Joint Penetration (CJP) weld. The weld joint was designated as Seg3007AH-039. The welder identification was 037743 and observed welding in the 4G (Overhead) position using approved Welding Procedure Specification WPS-B-P-2214-Tc-U4b-FCM-1. The piece mark was identified as the weld connecting the Floor Beam Stiffener to Grillage, Bike Path side.

This QA Inspector observed the repair welding by Shielded Metal Arc Welding (SMAW) process on a Complete Joint Penetration (CJP) weld. The weld joint was designated as Seg3007Y-372. The welder identification was 067183 and observed welding in the 4G (Overhead) position using approved Welding Procedure Specification WPS-345-SMAW-4G(4F)-Repair-FCM-1. The piece mark was identified as the weld connecting the Floor Beam Stiffener to Bulk Head. ZPMC performed repair welding in accordance with Welding Repair Report BWR-20637.
