DEPARTMENT OF TRANSPORTATION

Quality Assurance and Source Inspection

Contract #: 04-0120F4Cty: SF/ALA Rte: 80 PM: 13.2/13.9File #: 69.28**WELDING INSPECTION REPORT****Resident Engineer:** Siegenthaler, Peter**Address:** 333 Burma Road**City:** Oakland, CA 94607**Report No:** WIR-022576**Date Inspected:** 12-Apr-2011**Project Name:** SAS Superstructure**OSM Arrival Time:** 700**Prime Contractor:** American Bridge/Fluor Enterprises, a JV**OSM Departure Time:** 1900**Contractor:** Zhenhua Port Machinery Company, Ltd (ZPMC), Changxing Island **Location:** Shanghai, China**CWI Name:** Zhu Zhong Hai**CWI Present:** Yes No**Inspected CWI report:** Yes No N/A**Rod Oven in Use:** Yes No N/A**Electrode to specification:** Yes No N/A**Weld Procedures Followed:** Yes No N/A**Qualified Welders:** Yes No N/A**Verified Joint Fit-up:** Yes No N/A**Approved Drawings:** Yes No N/A**Approved WPS:** Yes No N/A**Delayed / Cancelled:** Yes No N/A**Bridge No:** 34-0006**Component:** OBG Segments**Summary of Items Observed:**

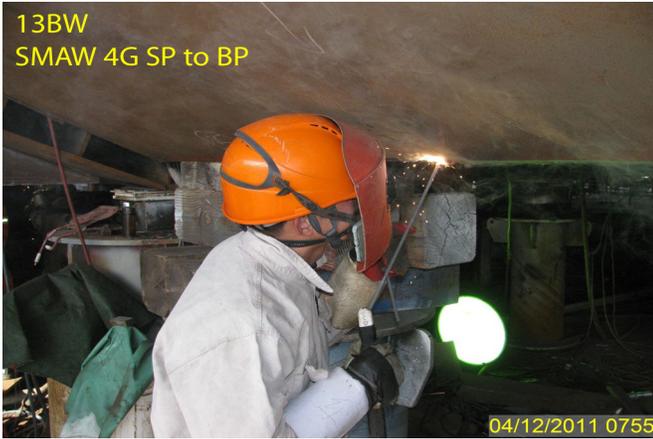
This QA Inspector observed Shielded Metal Arc Welding (SMAW) in progress of a Complete Joint Penetration (CJP) weld joint. The Weld joint is designated as SEG3014A-007, Side Plate to Bottom Plate. The welder is identified as #045213 and was observed welding in the 4G (overhead) position using approved Welding Procedure Specification WPS-B-P-2214-B-U2-FCM-1.

13BW
SMAW 4G SP to BP

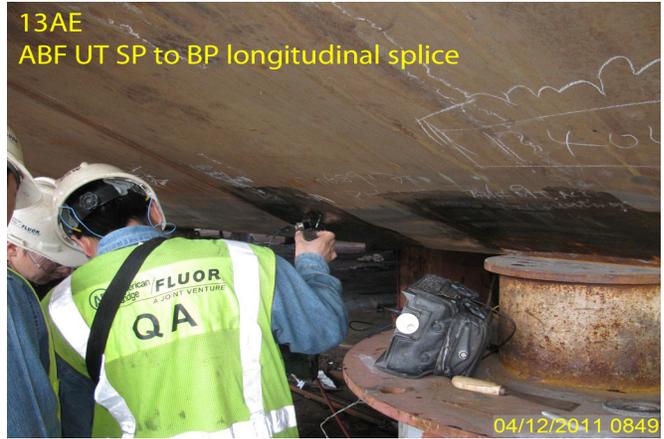
This QA Inspector observed ABF personnel performing Ultrasonic Testing on the Side Plate to Bottom Plate longitudinal splice, bike path side.

13AE
ABF UT SP to BP longitudinal splice
