Contract #: 04-0120F4Cty: SF/ALA Rte: 80 PM: 13.2/13.9File #: 69.28**WELDING INSPECTION REPORT****Resident Engineer:** Siegenthaler, Peter**Address:** 333 Burma Road**City:** Oakland, CA 94607**Report No:** WIR-022624**Date Inspected:** 13-Apr-2011**Project Name:** SAS Superstructure**OSM Arrival Time:** 700**Prime Contractor:** American Bridge/Fluor Enterprises, a JV**OSM Departure Time:** 1900**Contractor:** Zhenhua Port Machinery Company, Ltd (ZPMC), Changxing Island **Location:** Shanghai, China**CWI Name:** Liu Hua Jie**CWI Present:** Yes No**Inspected CWI report:** Yes No N/A**Rod Oven in Use:** Yes No N/A**Electrode to specification:** Yes No N/A**Weld Procedures Followed:** Yes No N/A**Qualified Welders:** Yes No N/A**Verified Joint Fit-up:** Yes No N/A**Approved Drawings:** Yes No N/A**Approved WPS:** Yes No N/A**Delayed / Cancelled:** Yes No N/A**Bridge No:** 34-0006**Component:** OBG**Summary of Items Observed:**

OBG Trial Assembly

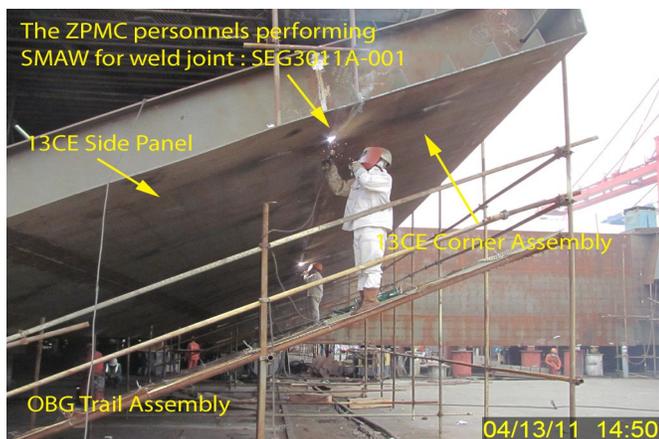
SMAW in the 4G position for the OBG Segment 13CE Side panel to Bottom panel. The weld joint was designated as: SEG3011A-012. The welder is identified as #051359. ZPMC QC is identified as Mr. Wang Xu. The welding variables recorded by QC appear to comply with WPS-B-P-2214-TC-U4B-FCM-1. Please see the attached picture.
