Quality Assurance and Source Inspection

Contract #: 04-0120F4Cty: SF/ALA Rte: 80 PM: 13.2/13.9File #: 69.28**WELDING INSPECTION REPORT****Resident Engineer:** Siegenthaler, Peter**Address:** 333 Burma Road**City:** Oakland, CA 94607**Report No:** WIR-022627**Date Inspected:** 10-Apr-2011**Project Name:** SAS Superstructure**OSM Arrival Time:** 700**Prime Contractor:** American Bridge/Fluor Enterprises, a JV**OSM Departure Time:** 1900**Contractor:** Zhenhua Port Machinery Company, Ltd (ZPMC), Changxing Island **Location:** Shanghai, China**CWI Name:** Lv Li Qing**CWI Present:** Yes No**Inspected CWI report:** Yes No N/A**Rod Oven in Use:** Yes No N/A**Electrode to specification:** Yes No N/A**Weld Procedures Followed:** Yes No N/A**Qualified Welders:** Yes No N/A**Verified Joint Fit-up:** Yes No N/A**Approved Drawings:** Yes No N/A**Approved WPS:** Yes No N/A**Delayed / Cancelled:** Yes No N/A**Bridge No:** 34-0006**Component:** OBG**Summary of Items Observed:**

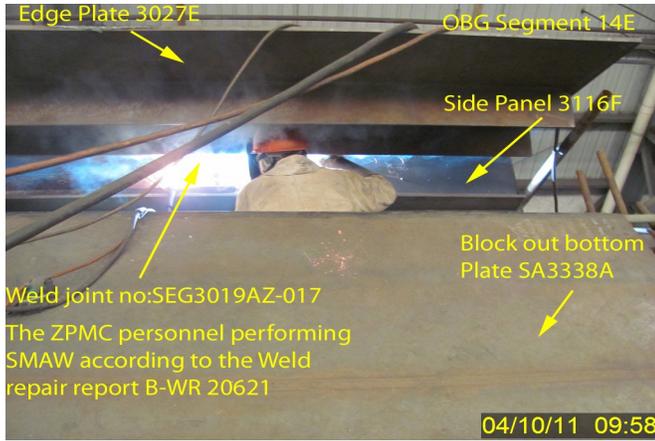
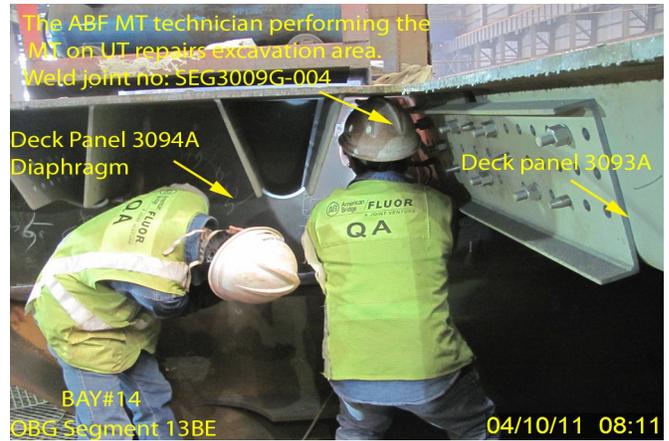
SMAW welding of weld joint No: SEG3019AZ-017 located on OBG Segment 14E Edge Plate to Side Panel.

Welder is identified as #058087. ZPMC QC is identified as Mr. Zhu Yuan Yuan. Welding was performed with the weld repair report BWR-20621. The welding variables recorded by QC appeared to comply with the WPS-345-SMAW-2G(2F)-FCM-Repair-1. Please see the attached picture.
