DEPARTMENT OF TRANSPORTATION

Quality Assurance and Source Inspection

Contract #: 04-0120F4Cty: SF/ALA Rte: 80 PM: 13.2/13.9File #: 69.28**WELDING INSPECTION REPORT****Resident Engineer:** Siegenthaler, Peter**Address:** 333 Burma Road**City:** Oakland, CA 94607**Report No:** WIR-022705**Date Inspected:** 10-Apr-2011**Project Name:** SAS Superstructure**OSM Arrival Time:** 1500**Prime Contractor:** American Bridge/Fluor Enterprises, a JV**OSM Departure Time:** 300**Contractor:** Zhenhua Port Machinery Company, Ltd (ZPMC), Changxing Island **Location:** Shanghai, China**CWI Name:** See Below**CWI Present:** Yes No**Inspected CWI report:** Yes No N/A**Rod Oven in Use:** Yes No N/A**Electrode to specification:** Yes No N/A**Weld Procedures Followed:** Yes No N/A**Qualified Welders:** Yes No N/A**Verified Joint Fit-up:** Yes No N/A**Approved Drawings:** Yes No N/A**Approved WPS:** Yes No N/A**Delayed / Cancelled:** Yes No N/A**Bridge No:** 34-0006**Component:** OBG**Summary of Items Observed:**

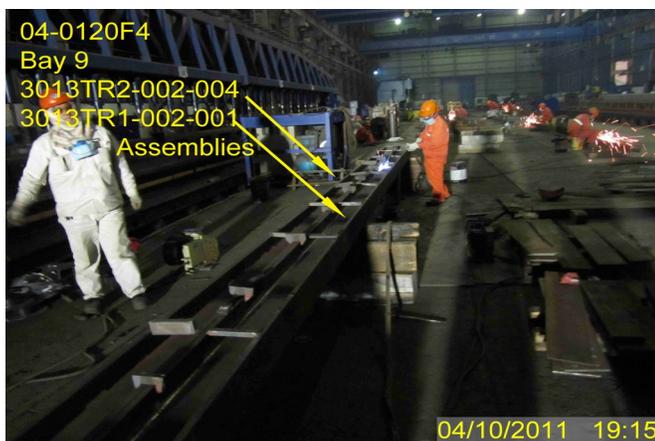
The following digital picture illustrates preheating in progress on traveler rail 3013TR2-002-004 and 3013TR1-002-001 assemblies.
