Contract #: 04-0120F4Cty: SF/ALA Rte: 80 PM: 13.2/13.9File #: 1.28**WELDING INSPECTION REPORT****Resident Engineer:** Siegenthaler, Peter**Address:** 333 Burma Road**City:** Oakland, CA 94607**Report No:** WIR-022764**Date Inspected:** 19-Apr-2011**Project Name:** SAS Superstructure**OSM Arrival Time:** 700**Prime Contractor:** American Bridge/Fluor Enterprises, a JV**OSM Departure Time:** 1730**Contractor:** American Bridge/Fluor Enterprises, a JV**Location:** Job Site

Caltrans Office of Structural Material (OSM) Quality Assurance Inspector (QAI) Joselito Lizardo was present at the Self Anchored Suspension (SAS) job site as requested to perform observations on the welding of components for the San Francisco Oakland Bay Bridge (SFOBB) Project.

## WELDING INSPECTION REPORT

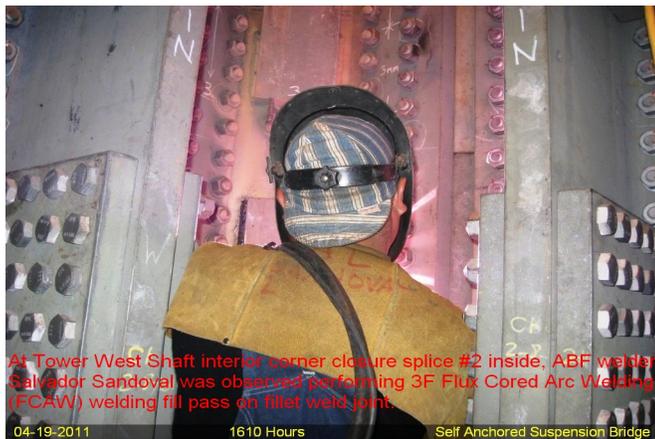
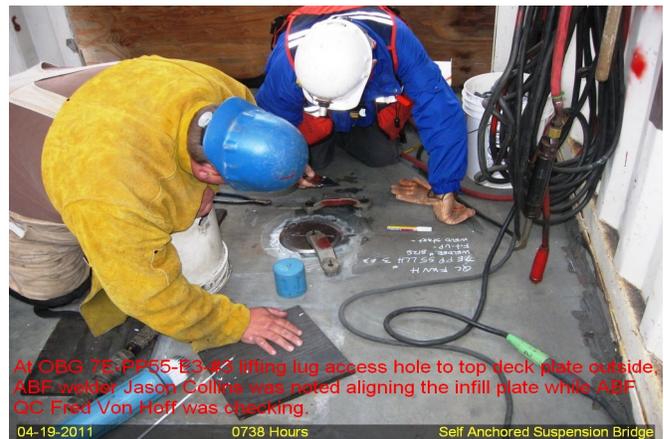
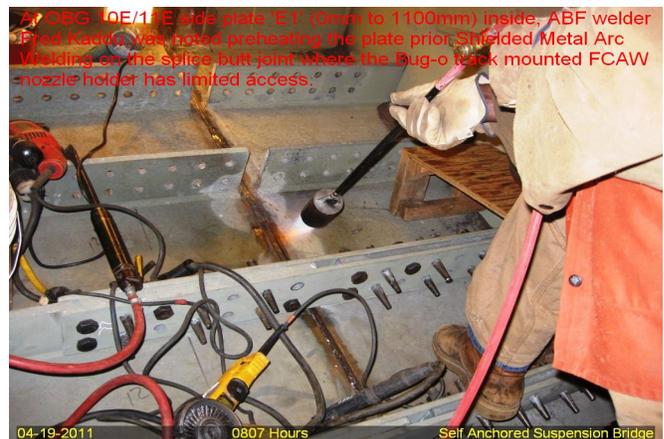
At OBG 10E/11E side plate 'C2' (0mm to 2638mm) inside, QA randomly observed ABF/JV qualified welder Sungtao, Huang ID # 3794 continuing to perform CJP groove (splice) welding fill pass on the splice butt joint. The welder was observed perform automatic welding in the 3G (vertical) position utilizing a dual shield Flux Cored Arc Welding (FCAW-G) with E71T-1M, 1/16" diameter wire electrode and implementing Caltrans approved Welding Procedure Specification (WPS) ABF-WPS-D15-3042B-1. The joint being welded has a single V-groove butt joint with backing bar. The splice joint was preheated and maintained to greater than 150 degrees Fahrenheit using Miller Proheat 35 Induction Heating System heater blankets located at the opposite side of the plate prior/during welding. During welding, ABF Quality Control (QC) William Sherwood was noted monitoring the welding parameters of the welder. At the end of the shift, fill pass welding was still continuing and should remain tomorrow.

At OBG 7E-PP55-E5-#1 & 3 lifting lug access hole to top deck plate outside – ABF welder Jason Collins was observed 1G SMAW welding root pass to cover pass on the infill plate to top deck plate butt joints. The welder was noted using 1/8" and 5/32" diameter E7018H4R electrode implementing Caltrans approved Welding Procedure Specification (WPS) ABF-WPS-D15-1070. Prior welding, ABF QC Fred Von Hoff was observed inspecting the fit up of the butt joints. QA verified the fit up alignment of the two access holes which deemed acceptable to the contract requirements. During welding, ABF QC Fred Von Hoff was noted monitoring the

At OBG 10E/11E side plate 'E1' (0mm to 1100mm) inside, QA randomly observed ABF/JV qualified welder Fred Kaddu continuing to perform fill pass welding on the Complete Joint Penetration (CJP) splice butt joint where the track mounted Bug-o FCAW welder nozzle holder has limited access. The welder was observed manually welding in the 3G (vertical) position utilizing a Shielded Metal Arc Welding (SMAW) with 1/8" diameter E7018H4R electrode and implementing Caltrans approved Welding Procedure Specification (WPS) ABF-WPS-D15-1040B. The joint being welded has a single V-groove butt joint with steel backing bar. During welding, ABF Quality Control (QC) John Pagliero was noted monitoring the welding parameters of the welder. At the end of the shift, fill pass SMAW welding was still continuing and should remain tomorrow.

At West B-C corner, lower splice plate: This QA Inspector randomly observed ABF welding personnel Salvador Sandoval (#2202) performing production welding on the bottom half of the splice plate using the self shielded Flux Cored Arc Welding (FCAW) process. This QA Inspector observed a propane gas torch was being used to preheat areas prior to welding. This QA Inspector observed QC Inspector Steve Jensen using an infra red temperature gauge to verify the preheat temperature of more than 300°F. This QA Inspector performed a verification of the welding parameters and observed 270 amperes and 21.9 volts with a travel speed of 95 mm per minute with equivalent heat input of 3.73 Kj per mm. The welding appeared to comply with Welding Procedure Specification (WPS) ABF-WPS-D15-F2200-3. The welding of the vertical fillet welds was still continuing and should remain tomorrow. Before the end of the shift, at around 1630hours, the welder has stopped fillet welding and ABF personnel were noted covering the weld with heater blanket in preparation for the three hours holding of preheat temperature of more than 300°F as required. ABF personnel were using Miller Proheat 35 Induction Heating System to hold the preheat that was programmed to shut off after three hours.

Arc Welding (FCAW) process. This QA Inspector observed a propane gas torch was being used to preheat areas prior to welding. This QA Inspector observed QC Inspector Steve Jensen using an infra red temperature gauge to verify the preheat temperature of more than 300°F. This QA Inspector performed a verification of the welding parameters and observed 250 amperes and 22.4 volts with a travel speed of 95 mm per minute with equivalent heat input of 3.54 KJ per mm. The welding appeared to comply with Welding Procedure Specification (WPS) ABF-WPS-D15-F2200-3. The welding of the vertical fillet welds was still continuing and should remain tomorrow. Before the end of the shift, at around 1630hours, the welder has stopped fillet welding and ABF personnel were noted covering the weld with heater blanket in preparation for the three hours holding of preheat temperature of more than 300°F as required. ABF personnel were using Miller Proheat 35 Induction Heating System to hold the preheat that was programmed to shut off after three hours.
