DEPARTMENT OF TRANSPORTATION

Quality Assurance and Source Inspection

Contract #: 04-0120F4Cty: SF/ALA Rte: 80 PM: 13.2/13.9File #: 69.28**WELDING INSPECTION REPORT****Resident Engineer:** Siegenthaler, Peter**Address:** 333 Burma Road**City:** Oakland, CA 94607**Report No:** WIR-022817**Date Inspected:** 13-Apr-2011**Project Name:** SAS Superstructure**OSM Arrival Time:** 700**Prime Contractor:** American Bridge/Fluor Enterprises, a JV**OSM Departure Time:** 1900**Contractor:** Zhenhua Port Machinery Company, Ltd (ZPMC), Changxing Island **Location:** Shanghai, China**CWI Name:** Li yan hua**CWI Present:** Yes No**Inspected CWI report:** Yes No N/A**Rod Oven in Use:** Yes No N/A**Electrode to specification:** Yes No N/A**Weld Procedures Followed:** Yes No N/A**Qualified Welders:** Yes No N/A**Verified Joint Fit-up:** Yes No N/A**Approved Drawings:** Yes No N/A**Approved WPS:** Yes No N/A**Delayed / Cancelled:** Yes No N/A**Bridge No:** 34-0006**Component:** OBG Components**Summary of Items Observed:**

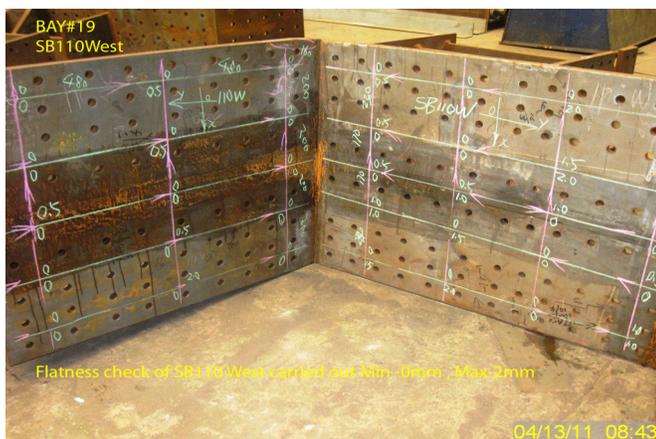
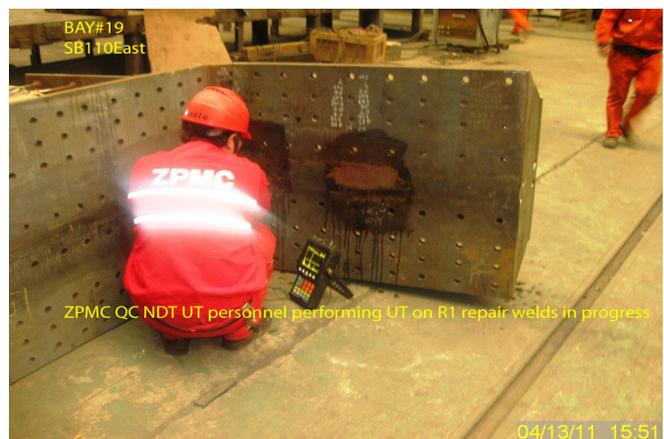
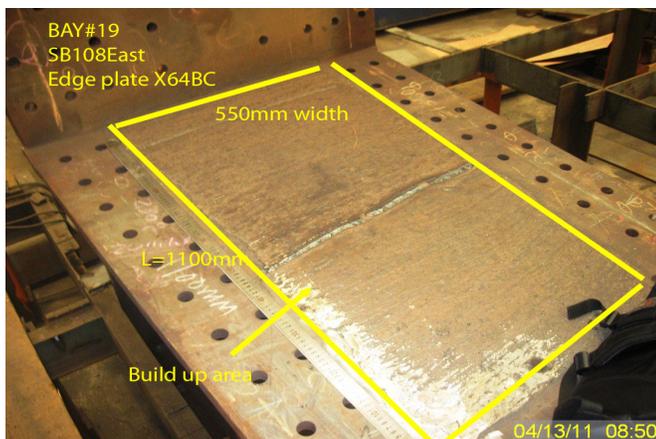
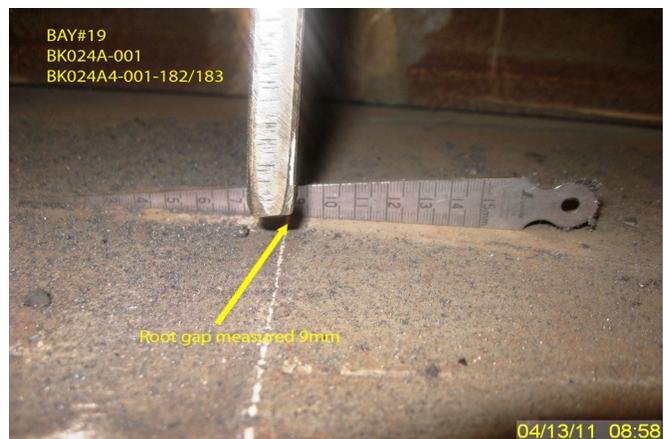
ZPMC QC NDT UT personnel performing UT of suspender bracket SB110 East R1 repair welds is in progress.

During their UT they found R2 reject able indication on following welds

SB027-110-014,022,055.

ZPMC QC NDT MT personnel performing MT of stringer plate to deck plate fillet welds is in progress of bike path is identified as BK023A-001.

During in process visual inspection it is found that fit-up of stringer plates vertical stiffener is identified as BKX96 of stringer plates BKX100C is connecting the top plate of bike path BK0024A-001, the fillet weld root gap is measured more than 5mm. the weld joint is identified as BK024A4-001-180/181 and 182/183. This is marked near by the weld joint and informed to ZPMC QC Mr.Guo xing hui for change of joint configuration approval from engineer.

This QA inspector performed Flatness check of Edge plate of suspender bracket SB110West along with ABF QC Mr.Peng wen jun. measured dimension recorded is appeared to comply with

Flatness measured: Min =0mm and Max=2mm.

ZPMC qualified SMAW welder is identified as 259653 performing tack welding of fit-up for traveler rail support

(TB3001) for Bike path is checked with ZPMC QC Mr.Li ping is appeared to comply with WPS-B-P-2112.

ZPMC grinding personnel performing grinding on weld metal build up of suspender bracket is identified as SB108East is in progress as per B-CWR2877. Before grinding following details are measured and recorded for future reference along with ZPMC QC Mr.Guo xing hui as follows

Length of build up =1100mm

Width of build up =550mm

Thickness of build up= 2 ~6mm.
