DEPARTMENT OF TRANSPORTATION

Quality Assurance and Source Inspection

Contract #: 04-0120F4Cty: SF/Ala Rte: 80 PM: 13.2/13.9File #: 69.28**WELDING INSPECTION REPORT****Resident Engineer:** Siegenthaler, Peter**Address:** 333 Burma Road**City:** Oakland, CA 94607**Report No:** WIR-022984**Date Inspected:** 22-Apr-2011**Project Name:** SAS Superstructure**OSM Arrival Time:** 1900**Prime Contractor:** American Bridge/Fluor Enterprises, a JV**OSM Departure Time:** 700**Contractor:** Zhenhua Port Machinery Company, Ltd (ZPMC), Changxing Island **Location:** Shanghai, China**CWI Name:** See below**CWI Present:** Yes No**Inspected CWI report:** Yes No N/A**Rod Oven in Use:** Yes No N/A**Electrode to specification:** Yes No N/A**Weld Procedures Followed:** Yes No N/A**Qualified Welders:** Yes No N/A**Verified Joint Fit-up:** Yes No N/A**Approved Drawings:** Yes No N/A**Approved WPS:** Yes No N/A**Delayed / Cancelled:** Yes No N/A**Bridge No:** 34-0006**Component:** OBG Components**Summary of Items Observed:**

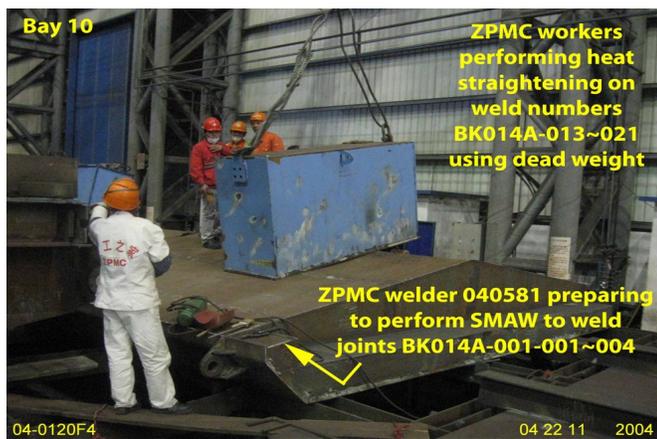
Heat straightening of BK014-002-013~21 located on PCMK OBG bike path. QC was identified as ZPMC QC2. Assisting QC1 at this location and appearing to be monitoring the heat straightening operation and recording data was QCA1, who was not a CWI. Heat treatment variables recorded by QCA1 appeared to comply with ZPMC document HSR1(B)-10313 as presented to this QA Inspector and verbally identified by QCA1. See photo below of the heat straightening operation in progress.
