DEPARTMENT OF TRANSPORTATION

Contract #: 04-0120F4Cty: SF/ALA Rte: 80 PM: 13.2/13.9File #: 69.28**WELDING INSPECTION REPORT****Resident Engineer:** Siegenthaler, Peter**Address:** 333 Burma Road**City:** Oakland, CA 94607**Report No:** WIR-023045**Date Inspected:** 26-Mar-2011**Project Name:** SAS Superstructure**OSM Arrival Time:** 700**Prime Contractor:** American Bridge/Fluor Enterprises, a JV**OSM Departure Time:** 1900**Contractor:** Zhenhua Port Machinery Company, Ltd (ZPMC), Changxing Island **Location:** Shanghai, China**CWI Name:** Xu Le Feng**CWI Present:** Yes No**Inspected CWI report:** Yes No N/A**Rod Oven in Use:** Yes No N/A**Electrode to specification:** Yes No N/A**Weld Procedures Followed:** Yes No N/A**Qualified Welders:** Yes No N/A**Verified Joint Fit-up:** Yes No N/A**Approved Drawings:** Yes No N/A**Approved WPS:** Yes No N/A**Delayed / Cancelled:** Yes No N/A**Bridge No:** 34-0006**Component:** OBG Components**Summary of Items Observed:**

WELDING INSPECTION REPORT

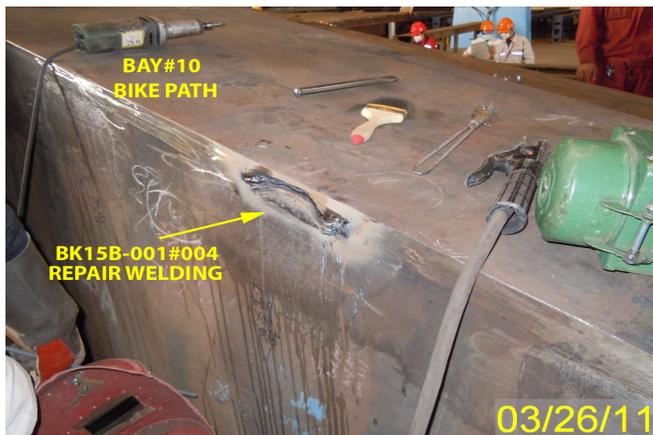
Repair welding of weld joint #004 located on Bike Path BK15B-001 as per the weld repair report #B-WR20496.

Welder is identified as 040581. ZPMC Quality Control (QC) Inspector is identified as Li Jun. The welding variables recorded by QC appeared to comply with the WPS-345-SMAW-2G (2F)-REPAIR. (See attached photo)
