**DEPARTMENT OF TRANSPORTATION**

Quality Assurance and Source Inspection

Contract #: 04-0120F4Cty: SF/ALA Rte: 80 PM: 13.2/13.9File #: 69.28**WELDING INSPECTION REPORT****Resident Engineer:** Siegenthaler, Peter**Address:** 333 Burma Road**City:** Oakland, CA 94607**Report No:** WIR-023090**Date Inspected:** 09-Apr-2011**Project Name:** SAS Superstructure**OSM Arrival Time:** 1500**Prime Contractor:** American Bridge/Fluor Enterprises, a JV**OSM Departure Time:** 300**Contractor:** Zhenhua Port Machinery Company, Ltd (ZPMC), Changxing Island **Location:** Shanghai, China**CWI Name:** Mr. Li Yan Hua**CWI Present:** Yes No**Inspected CWI report:** Yes No N/A**Rod Oven in Use:** Yes No N/A**Electrode to specification:** Yes No N/A**Weld Procedures Followed:** Yes No N/A**Qualified Welders:** Yes No N/A**Verified Joint Fit-up:** Yes No N/A**Approved Drawings:** Yes No N/A**Approved WPS:** Yes No N/A**Delayed / Cancelled:** Yes No N/A**Bridge No:** 34-0006**Component:** OBG**Summary of Items Observed:**

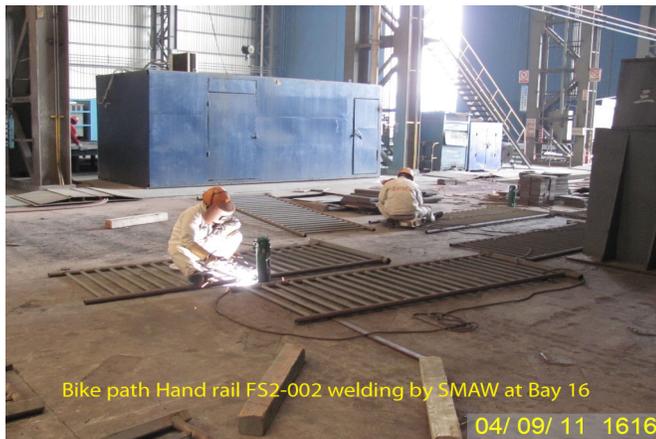
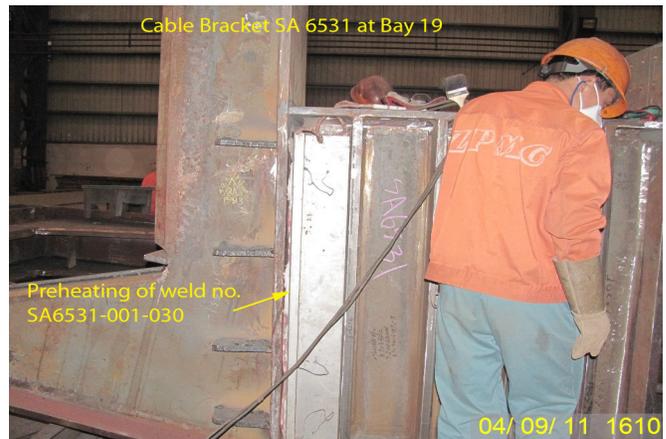
For further information see below pictures:-

Unless otherwise noted, all work observed on this date appeared to be in general compliance with the applicable contract documents.
