DEPARTMENT OF TRANSPORTATION

Contract #: 04-0120F4Cty: SF/ALA Rte: 80 PM: 13.2/13.9File #: 1.28**WELDING INSPECTION REPORT****Resident Engineer:** Siegenthaler, Peter**Address:** 333 Burma Road**City:** Oakland, CA 94607**Report No:** WIR-023099**Date Inspected:** 28-Apr-2011**Project Name:** SAS Superstructure**OSM Arrival Time:** 700**Prime Contractor:** American Bridge/Fluor Enterprises, a JV**OSM Departure Time:** 1730**Contractor:** American Bridge/Fluor Enterprises, a JV**Location:** Job Site**CWI Name:** See Report Below**CWI Present:** Yes No**Inspected CWI report:** Yes No N/A**Rod Oven in Use:** Yes No N/A**Electrode to specification:** Yes No N/A**Weld Procedures Followed:** Yes No N/A**Qualified Welders:** Yes No N/A**Verified Joint Fit-up:** Yes No N/A**Approved Drawings:** Yes No N/A**Approved WPS:** Yes No N/A**Delayed / Cancelled:** Yes No N/A**Bridge No:** 34-0006**Component:** Orthotropic Box Girders**Summary of Items Observed:**

WELDING INSPECTION REPORT

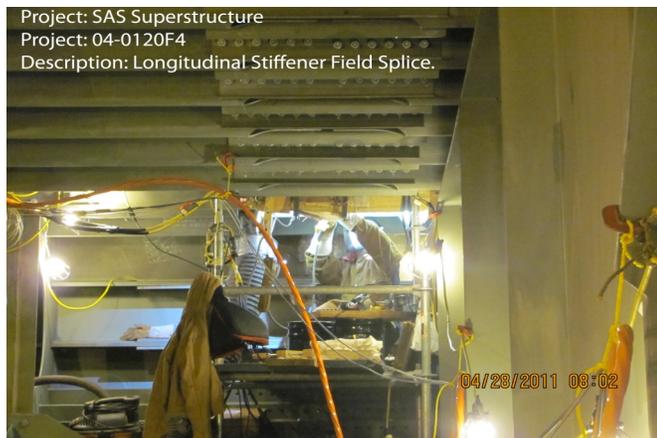
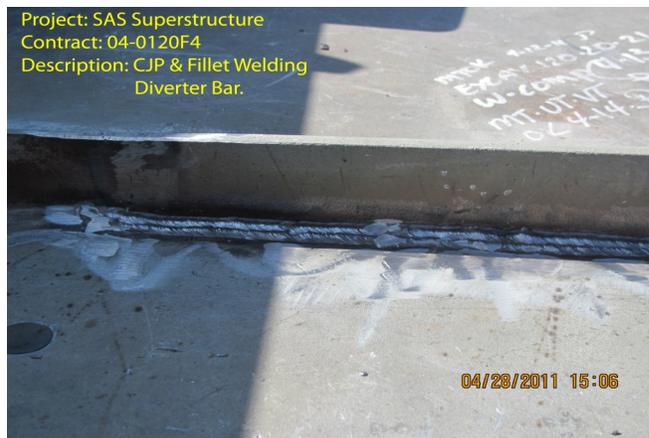
The QAI observed the CJP welding of the lifting lug holes identified as WN:7E-PP55-E3-W1 & W3 and 5W-PP40-W4-W2 & W4. The welding was performed by Jason Collins and Mike Jiminez ID-4671 utilizing the WPS's identified as ABF-WPS-D15-1050A-CU, Rev.0 and 1110A-CU. The field inspection performed by John Pagliero and Fred Von Hoff appeared to comply with the contract specifications. The in process CJP welding appeared to comply with contract specifications.

The QAI observed the CJP and fillet welding of the diverter bar field splice located at grid line W1 at the "A" deck field splice identified as WN: 10W-11W-A1. The welding was performed by Fred Kaddu ID-2188 utilizing the WPS's identified as ABF-WPS-D15-1080, Rev. 1 and ABF-WPS-D15-F1200A, Rev. 2. The inspection was performed by QC personnel John Pagliero. The welding was completed during this shift and the visual inspection performed appeared to comply with contract specifications.

The digital photographs below illustrate some of the related work activities observed during this scheduled shift.
