Contract #: 04-0120F4Cty: SF/ALA Rte: 80 PM: 13.2/13.9File #: 69.28**WELDING INSPECTION REPORT****Resident Engineer:** Siegenthaler, Peter**Address:** 333 Burma Road**City:** Oakland, CA 94607**Report No:** WIR-023168**Date Inspected:** 01-May-2011**Project Name:** SAS Superstructure**OSM Arrival Time:** 700**Prime Contractor:** American Bridge/Fluor Enterprises, a JV**OSM Departure Time:** 1900**Contractor:** Zhenhua Port Machinery Company, Ltd (ZPMC), Changxing Island **Location:** Shanghai, China

Orthotropic Box Girder (OBG) at Trial Assembly Areas

Segment 12AW (FL3 to Bottom Plate)

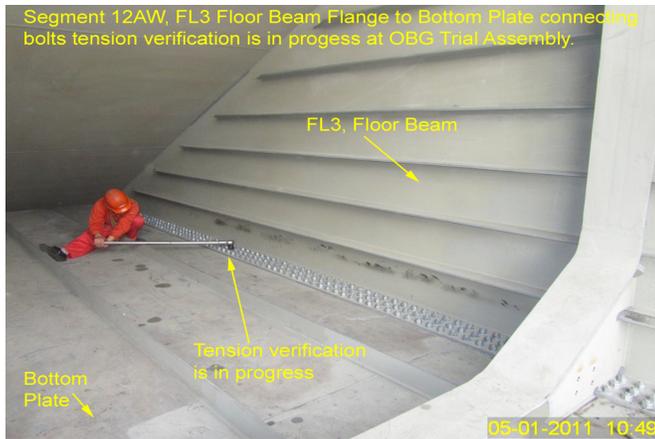
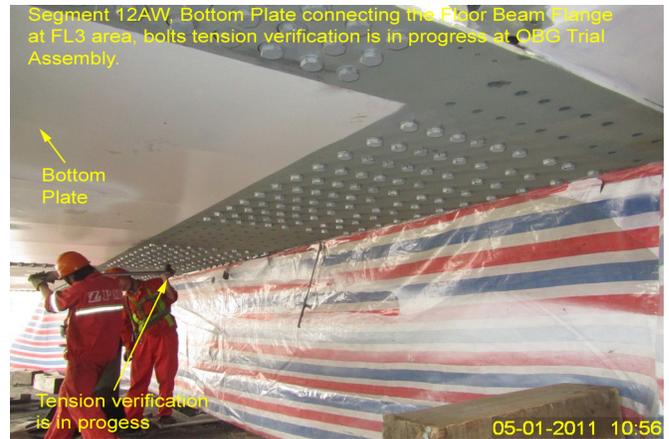
This QA Inspector witnessed the final bolt tension verification on bolts connecting the Bottom Plate to FL3 Flange and Bottom Panel to Bottom Plate at Panel Points (PP) 110, PP 111 and PP 112 for Segment 12AW. The QA Inspector verified the bolt tension on a random basis and the results appeared to be in general compliance. The Inspection was performed against Notification No. 00668 dated April 31, 2011.

The bolt sizes used were M24 x 60 RC Lot # DHGM240001 and the final torque value established was 633 N-m.

Note: At work point W4, PP 110; PP 111 and PP 112 bolts not installed at Sea Fastening interference locations.
