DEPARTMENT OF TRANSPORTATION

Quality Assurance and Source Inspection

Contract #: 04-0120F4Cty: SF/ALA Rte: 80 PM: 13.2/13.9File #: 69.28**WELDING INSPECTION REPORT****Resident Engineer:** Siegenthaler, Peter**Address:** 333 Burma Road**City:** Oakland, CA 94607**Report No:** WIR-023196**Date Inspected:** 27-Apr-2011**Project Name:** SAS Superstructure**OSM Arrival Time:** 700**Prime Contractor:** American Bridge/Fluor Enterprises, a JV**OSM Departure Time:** 1900**Contractor:** Zhenhua Port Machinery Company, Ltd (ZPMC), Changxing Island **Location:** Shanghai, China**CWI Name:** Liu Hua Jie/Geng wei**CWI Present:** Yes No**Inspected CWI report:** Yes No N/A**Rod Oven in Use:** Yes No N/A**Electrode to specification:** Yes No N/A**Weld Procedures Followed:** Yes No N/A**Qualified Welders:** Yes No N/A**Verified Joint Fit-up:** Yes No N/A**Approved Drawings:** Yes No N/A**Approved WPS:** Yes No N/A**Delayed / Cancelled:** Yes No N/A**Bridge No:** 34-0006**Component:** OBG**Summary of Items Observed:**

OBG Trial Assembly

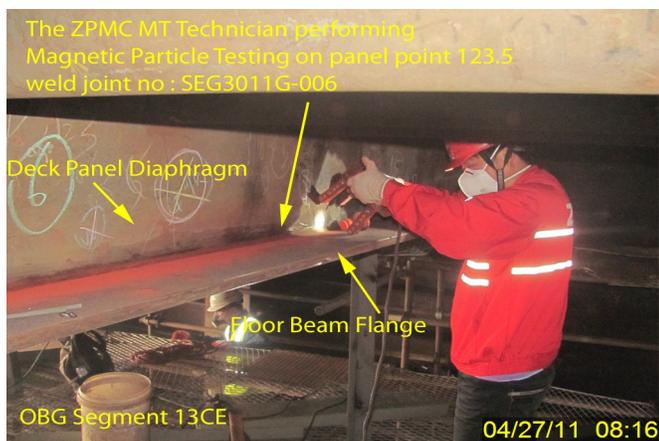
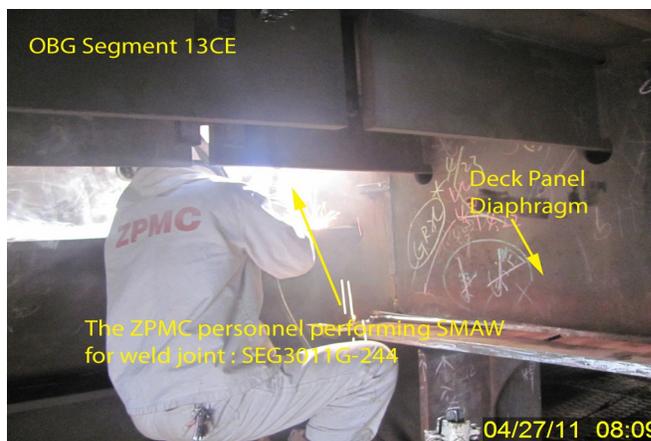
SMAW in the 4G position for the OBG Segment 13CE Deck Panel to Deck Panel Diaphragm. The weld joint was designated as: SEG3011G-244. The welder is identified as #066258. ZPMC QC is identified as Mr. Zhan Hai Feng. The welding variables recorded by QC appear to comply with WPS-B-P-2214-TC-U4B-FCM-1. Please see the attached picture.
