**DEPARTMENT OF TRANSPORTATION**

Contract #: 04-0120F4Cty: SF/ALA Rte: 80 PM: 13.2/13.9File #: 1.28**WELDING INSPECTION REPORT****Resident Engineer:** Siegenthaler, Peter**Address:** 333 Burma Road**City:** Oakland, CA 94607**Report No:** WIR-023226**Date Inspected:** 28-Apr-2011**Project Name:** SAS Superstructure**OSM Arrival Time:** 700**Prime Contractor:** American Bridge/Fluor Enterprises, a JV**OSM Departure Time:** 1730**Contractor:** American Bridge/Fluor Enterprises, a JV**Location:** Job Site**CWI Name:** Steve Jensen**CWI Present:** Yes No**Inspected CWI report:** Yes No N/A**Rod Oven in Use:** Yes No N/A**Electrode to specification:** Yes No N/A**Weld Procedures Followed:** Yes No N/A**Qualified Welders:** Yes No N/A**Verified Joint Fit-up:** Yes No N/A**Approved Drawings:** Yes No N/A**Approved WPS:** Yes No N/A**Delayed / Cancelled:** Yes No N/A**Bridge No:** 34-0006**Component:** SAS Tower**Summary of Items Observed:**

At Tower North Shaft Splice #2 @Elevation 83meters:

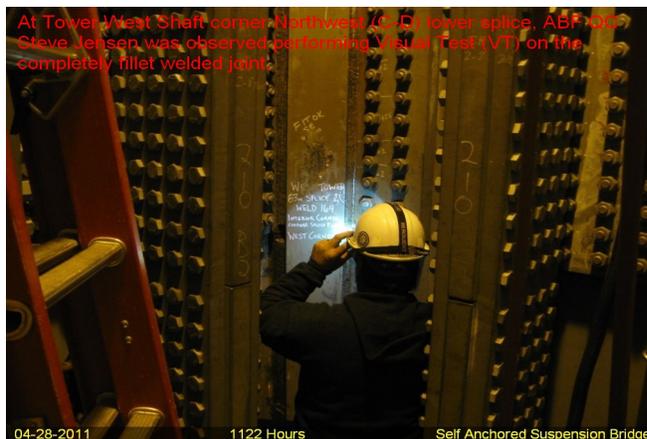
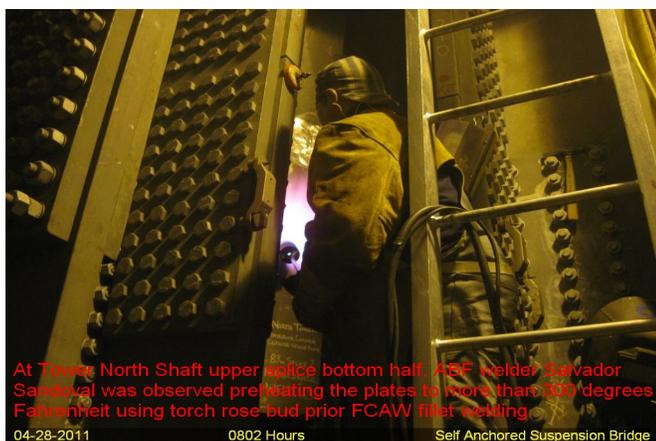
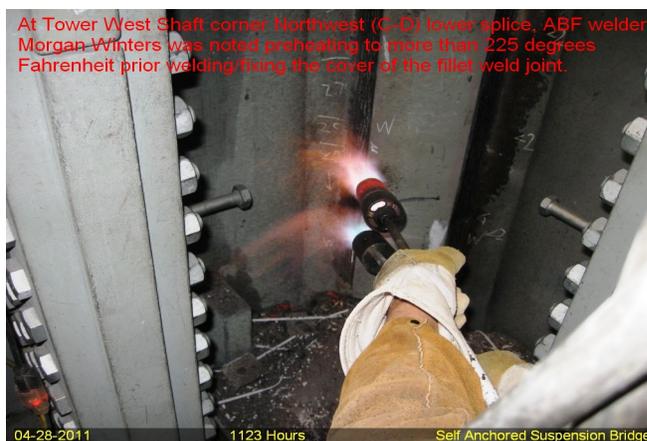
At North corner, upper splice plate, this QA Inspector randomly observed ABF welding personnel Salvador Sandoval (#2202) continuing to perform production welding on the bottom half of the splice plate using the self shielded Flux Cored Arc Welding (FCAW) process. This QA Inspector observed a propylene gas torch was being used to preheat areas prior to welding. This QA Inspector observed QC Inspector Steve Jensen using an infra red temperature gauge to verify the preheat temperature of more than 300°F. This QA Inspector performed a verification of the welding parameters and observed 270 amperes and 21.5 volts with a travel speed of 95 mm per minute with equivalent heat input of 3.6 KJ per mm. The welding appeared to comply with Welding Procedure Specification (WPS) ABF-WPS-D15-F2200-3. The welding of the vertical fillet welds was completed on both sides of the bottom half and the welder has moved to the other splice plate North East lower splice top half. The welder continued fill pass fillet welding on both sides of the plate until 1630hours. Before the end of the shift, at around 1630hours, the welder has stopped fillet welding and ABF personnel were noted covering the weld with heater blanket in preparation for the three hours holding of preheat temperature of more than 300°F as required. ABF personnel were using Miller Proheat 35 Induction Heating System to hold the preheat that was programmed to shut off after three hours.

At Northwest C-D corner, upper splice plate: This QA Inspector randomly observed ABF welding personnel Morgan Winters continuing to perform production welding on the bottom half of the upper splice plate using the Shielded Metal Arc Welding (SMAW) process. This QA Inspector observed a propylene gas torch was being used to preheat areas prior to welding. This QA Inspector observed QC Inspector Steve Jensen using an infra red temperature gauge to verify the preheat temperature of more than 225°F. This QA Inspector performed a verification of the welding parameters and observed 151 amperes on a 5/32" diameter E7018H4R electrode which appeared to comply with Welding Procedure Specification (WPS) ABF-WPS-D15-F1200A. The welding of the overhead fillet weld was completed during the shift. The welder was also observed fixing/welding the cover of the fillet weld with SMAW where undercut, craters and underfill was noted. Before the end of the shift, at around 1630hours, ABF personnel were noted covering the weld with heater blanket in preparation for the three hours holding of preheat temperature of more than 300°F as required. ABF personnel were using Miller Proheat 35 Induction Heating System to hold the preheat that was programmed to shut off after three hours.

At Southeast corner, upper splice plate: This QA Inspector randomly observed ABF welding personnel Rick Clayborn perform tack welding on the lower half of the splice plate to the skin plate. The welder was observed utilizing self shielded Flux Cored Arc Welding (FCAW) with 0.072" diameter E-71T-8 wire electrode implementing Caltrans approved Welding Procedure Specification ABF-WPS-D15-F2200-3. Prior tack welding, the welder was noted preheating the plates to be welded with propylene gas torch to more than 300°F. At the end of the shift, the welder has tack welded four locations of the joint.
