Quality Assurance and Source Inspection

Contract #: 04-0120F4Cty: SF/ALA Rte: 80 PM: 13.2/13.9File #: 1.28**WELDING INSPECTION REPORT****Resident Engineer:** Siegenthaler, Peter**Address:** 333 Burma Road**City:** Oakland, CA 94607**Report No:** WIR-023233**Date Inspected:** 30-Apr-2011**Project Name:** SAS Superstructure**OSM Arrival Time:** 700**Prime Contractor:** American Bridge/Fluor Enterprises, a JV**OSM Departure Time:** 1530**Contractor:** American Bridge/Fluor Enterprises, a JV**Location:** Job Site**CWI Name:** Steve Jensen**CWI Present:** Yes No**Inspected CWI report:** Yes No N/A**Rod Oven in Use:** Yes No N/A**Electrode to specification:** Yes No N/A**Weld Procedures Followed:** Yes No N/A**Qualified Welders:** Yes No N/A**Verified Joint Fit-up:** Yes No N/A**Approved Drawings:** Yes No N/A**Approved WPS:** Yes No N/A**Delayed / Cancelled:** Yes No N/A**Bridge No:** 34-0006**Component:** SAS Tower**Summary of Items Observed:**

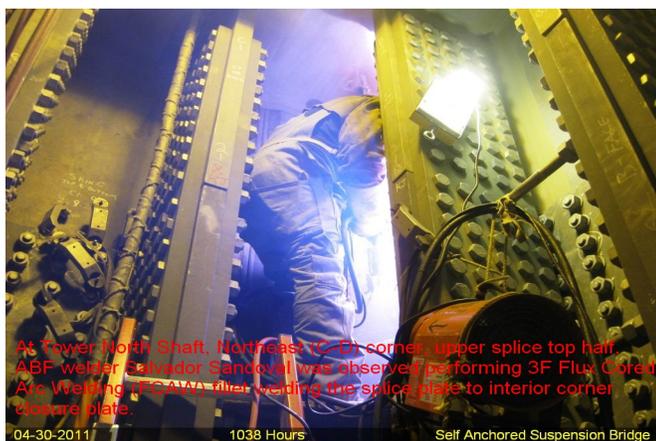
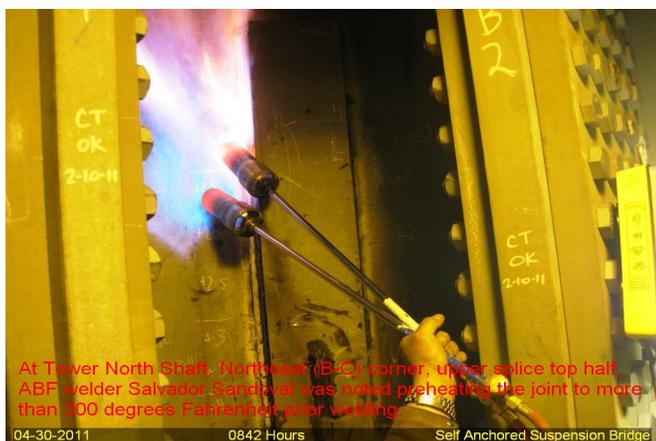
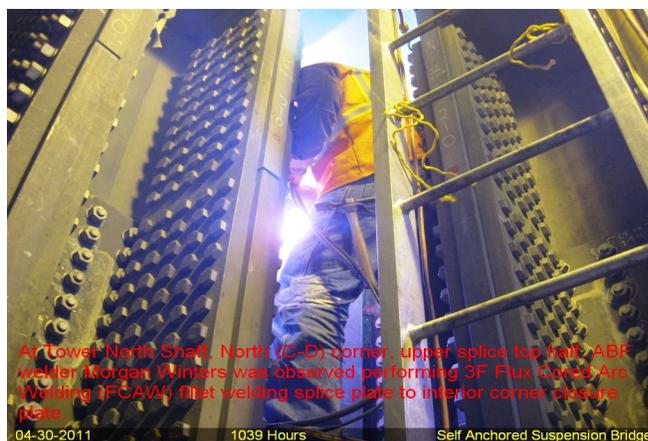
At Northeast (B-C) corner, upper splice plate; this QA Inspector randomly observed ABF welding personnel Salvador Sandoval (#2202) continuing to perform production welding on the top half of the splice plate using the self shielded Flux Cored Arc Welding (FCAW) process. This QA Inspector observed a propylene gas torch was being used to preheat areas prior to welding. This QA Inspector observed QC Inspector Steve Jensen using an infra red temperature gauge to verify the preheat temperature of more than 300°F. This QA Inspector performed a verification of the welding parameters and observed 260 amperes and 21.7volts with a travel speed of 90 mm per minute with equivalent heat input of 3.76 Kj per mm. The welding appeared to comply with Welding Procedure Specification (WPS) ABF-WPS-D15-F2200-3. The welder continued fill pass fillet welding on both sides of the plate until 1630hours. Before the end of the shift, at around 1500hours, the welder has stopped fillet welding and ABF personnel were noted covering the weld with heater blanket in preparation for the three hours holding of preheat temperature of more than 300°F as required. ABF personnel were using Miller Proheat 35 Induction Heating System to hold the preheat that was programmed to shut off after three hours.

At North (C-D) corner, lower splice plate; This QA Inspector randomly observed ABF welding personnel Morgan Winters continuing to perform production welding on the bottom half of the lower splice plate using the self shielded Flux Cored Arc Welding (FCAW) process. This QA Inspector observed a propylene gas torch was being used to preheat areas prior to welding. This QA Inspector observed QC Inspector Steve Jensen using an infra red temperature gauge to verify the preheat temperature of more than 300°F. This QA Inspector performed a verification of the welding parameters and observed 250 amperes and 21.0 volts with a travel speed of 90 mm per minute with equivalent heat input of 3.5 KJ per mm. The welding appeared to comply with Welding Procedure Specification (WPS) ABF-WPS-D15-F2200-3. Welding of the vertical fillet weld was completed during the shift and the welder has moved to upper splice and performed FCAW fillet welding on the top half of the upper splice. At the end of the shift, fillet welding was still continuing and should remain tomorrow. Before the end of the shift, at around 1500hours, ABF personnel were noted covering the weld with heater blanket in preparation for the three hours holding of preheat temperature of more than 300°F as required. ABF personnel were using Miller Proheat 35 Induction Heating System to hold the preheat that was programmed to shut off after three hours.
