Contract #: 04-0120F4Cty: SF/ALA Rte: 80 PM: 13.2/13.9File #: 1.28**WELDING INSPECTION REPORT****Resident Engineer:** Siegenthaler, Peter**Address:** 333 Burma Road**City:** Oakland, CA 94607**Report No:** WIR-023240**Date Inspected:** 03-May-2011**Project Name:** SAS Superstructure**OSM Arrival Time:** 700**Prime Contractor:** American Bridge/Fluor Enterprises, a JV**OSM Departure Time:** 1730**Contractor:** American Bridge/Fluor Enterprises, a JV**Location:** Job Site**CWI Name:** Steve Jensen**CWI Present:** Yes No**Inspected CWI report:** Yes No N/A**Rod Oven in Use:** Yes No N/A**Electrode to specification:** Yes No N/A**Weld Procedures Followed:** Yes No N/A**Qualified Welders:** Yes No N/A**Verified Joint Fit-up:** Yes No N/A**Approved Drawings:** Yes No N/A**Approved WPS:** Yes No N/A**Delayed / Cancelled:** Yes No N/A**Bridge No:** 34-0006**Component:** SAS Tower**Summary of Items Observed:**

At Tower East Shaft Splice #2 @ Elevation 83 meters:

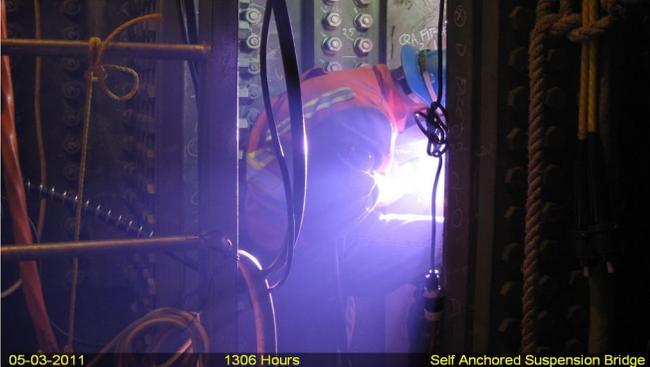
At Tower East Shaft, Southeast (C-D) corner, lower splice bottom half, ABF welder Richard Garcia was observed 3G Flux Cored Arc Welding (FCAW) fillet welding splice plate to interior corner closure plate.

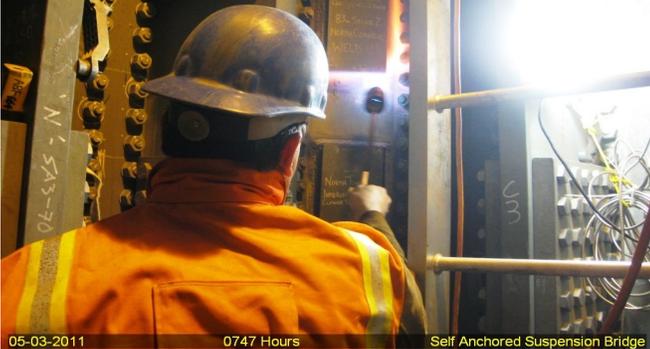
At Tower North Shaft, North (C-D) corner, upper splice bottom half, ABF welder Margarit Winters was noted preheating the plates being welded to more than 225 degrees Fahrenheit using propylene gas torch prior SMAW welding the overhead fillet.

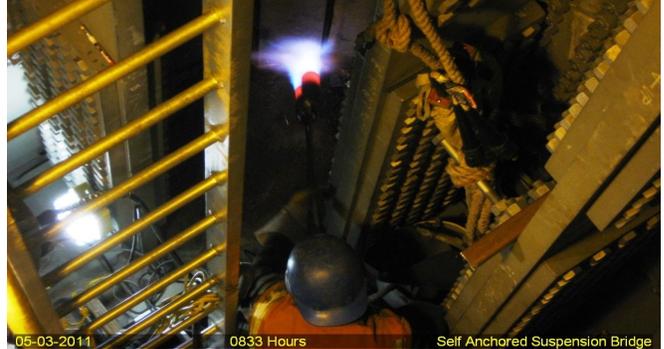
At Tower East Shaft, East (B-C) corner, upper splice top half, ABF welder Salvador Sandoval was noted preheating the plates being welded to more than 300 degrees Fahrenheit using propylene gas torch prior FCAW welding.
