Quality Assurance and Source Inspection

Contract #: 04-0120F4Cty: SF/ALA Rte: 80 PM: 13.2/13.9File #: 69.28**WELDING INSPECTION REPORT****Resident Engineer:** Siegenthaler, Peter**Address:** 333 Burma Road**City:** Oakland, CA 94607**Report No:** WIR-023255**Date Inspected:** 29-Apr-2011**Project Name:** SAS Superstructure**OSM Arrival Time:** 700**Prime Contractor:** American Bridge/Fluor Enterprises, a JV**OSM Departure Time:** 1900**Contractor:** Zhenhua Port Machinery Company, Ltd (ZPMC), Changxing Island **Location:** Shanghai, China**CWI Name:** Liu Hua Jie**CWI Present:** Yes No**Inspected CWI report:** Yes No N/A**Rod Oven in Use:** Yes No N/A**Electrode to specification:** Yes No N/A**Weld Procedures Followed:** Yes No N/A**Qualified Welders:** Yes No N/A**Verified Joint Fit-up:** Yes No N/A**Approved Drawings:** Yes No N/A**Approved WPS:** Yes No N/A**Delayed / Cancelled:** Yes No N/A**Bridge No:** 34-0006**Component:** Orthotropic Box Girder (OBG)**Summary of Items Observed:**

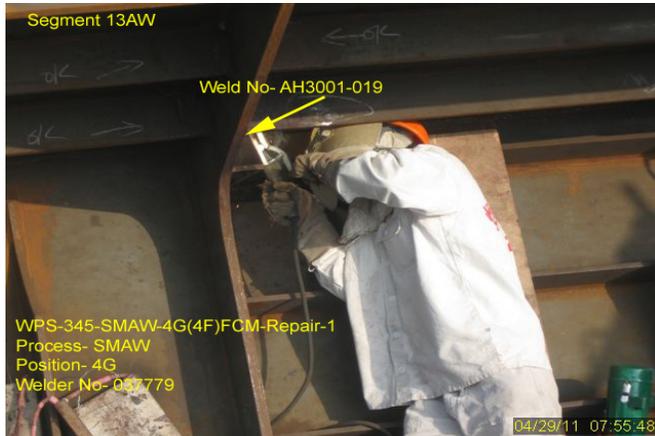
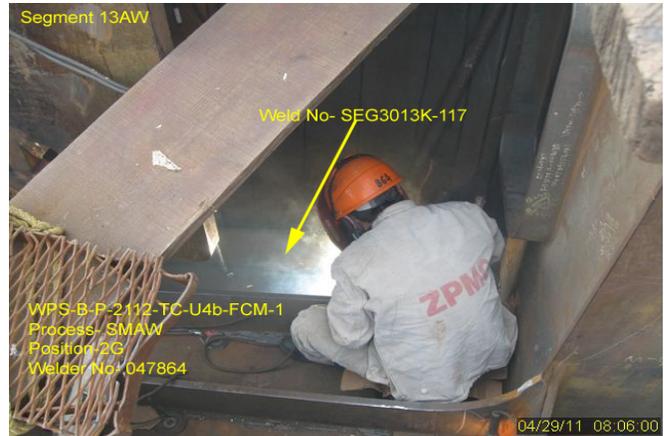
This QA Inspector observed ZPMC qualified welding personnel identified as 037779 perform Shielded Metal Arc Welding (SMAW), weld joint identified as AH3001-019; located On Orthotropic Box Girder (OBG) I-Rib to Stiffener CJP Weld; ZPMC Quality Control (QC) is identified as Mr. Shen Jian Bo. This QA Inspector observed the base material appears to have been preheated by an electrical heating element prior to welding. The Welding Repair Report (WRR) was B-WR20812. ZPMC Quality Control (QC) Mr. Shen Jian Bo was onsite monitoring the welding variables. The welding variables recorded by QC appeared to comply with applicable WPS-345-SMAW-4G(4F) FCM-Repair-1. See attached photo for further details.

This QA Inspector observed ZPMC qualified welding personnel identified as 047864 perform Shielded Metal Arc Welding (SMAW), weld joint identified as SEG3013K-117; located On Orthotropic Box Girder (OBG) Side Plate to I-Rib CJP Weld; ZPMC Quality Control (QC) is identified as Mr. Shen Jian Bo. This QA Inspector observed the base material appears to have been preheated by an electrical heating element prior to welding. ZPMC Quality Control (QC) Mr. Shen Jian Bo was onsite monitoring the welding variables. The welding variables recorded by QC appeared to comply with applicable WPS-B-P-2112-TC-U4b-FCM-1. See attached photo for further details.

to I-Rib CJP Weld; ZPMC Quality Control (QC) is identified as Mr. Shen Jian Bo. This QA Inspector observed the base material appears to have been preheated by an electrical heating element prior to welding. ZPMC Quality Control (QC) Mr. Shen Jian Bo was onsite monitoring the welding variables. The welding variables recorded by QC appeared to comply with applicable WPS-B-P-2112-TC-U4b-FCM-1. See attached photo for further details.
