Contract #: 04-0120F4Cty: SF/ALA Rte: 80 PM: 13.2/13.9File #: 69.28**WELDING INSPECTION REPORT****Resident Engineer:** Siegenthaler, Peter**Address:** 333 Burma Road**City:** Oakland, CA 94607**Report No:** WIR-023265**Date Inspected:** 05-May-2011**Project Name:** SAS Superstructure**OSM Arrival Time:** 700**Prime Contractor:** American Bridge/Fluor Enterprises, a JV**OSM Departure Time:** 1900**Contractor:** Zhenhua Port Machinery Company, Ltd (ZPMC), Changxing Island **Location:** Shanghai, China**CWI Name:** Liu Hua Jie.**CWI Present:** Yes No**Inspected CWI report:** Yes No N/A**Rod Oven in Use:** Yes No N/A**Electrode to specification:** Yes No N/A**Weld Procedures Followed:** Yes No N/A**Qualified Welders:** Yes No N/A**Verified Joint Fit-up:** Yes No N/A**Approved Drawings:** Yes No N/A**Approved WPS:** Yes No N/A**Delayed / Cancelled:** Yes No N/A**Bridge No:** 34-0006**Component:** OBG components.**Summary of Items Observed:**

On this day CALTRANS OSM Quality Assurance Inspector (QA) Mr. Shailesh Wadkar was present during the times noted above for observations relative to the fabrication of the Self Anchored Suspension (SAS) Superstructure being performed by Zhenhua Port

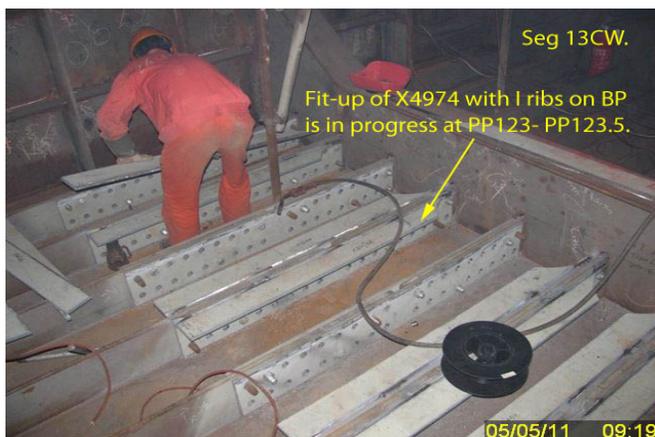
OBG Seg 13CW:

ZPMC personnel performing fit-up of X4074 Flange plate with I-ribs on Bottom Panel [at Panel Point (PP) 123 - PP123.5]. See attached photo for details.
