Quality Assurance and Source Inspection

Contract #: 04-0120F4Cty: SF/ALA Rte: 80 PM: 13.2/13.9File #: 99.28**WELDING INSPECTION REPORT****Resident Engineer:** Siegenthaler, Peter**Address:** 333 Burma Road**City:** Oakland, CA 94607**Report No:** WIR-023318**Date Inspected:** 03-May-2011**Project Name:** SAS Superstructure**OSM Arrival Time:** 700**Prime Contractor:** American Bridge/Fluor Enterprises, a JV**OSM Departure Time:** 1900**Contractor:** Zhenhua Port Machinery Company, Ltd (ZPMC) Chanxing Island**Location:** Shanghai, China**CWI Name:** Mr. ZHU ZHONG HAI**CWI Present:** Yes No**Inspected CWI report:** Yes No N/A**Rod Oven in Use:** Yes No N/A**Electrode to specification:** Yes No N/A**Weld Procedures Followed:** Yes No N/A**Qualified Welders:** Yes No N/A**Verified Joint Fit-up:** Yes No N/A**Approved Drawings:** Yes No N/A**Approved WPS:** Yes No N/A**Delayed / Cancelled:** Yes No N/A**Bridge No:** 34-0006**Component:** OBG Segment**Summary of Items Observed:**

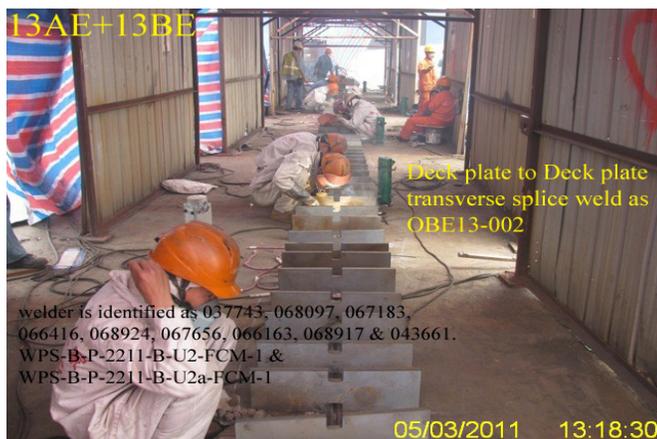
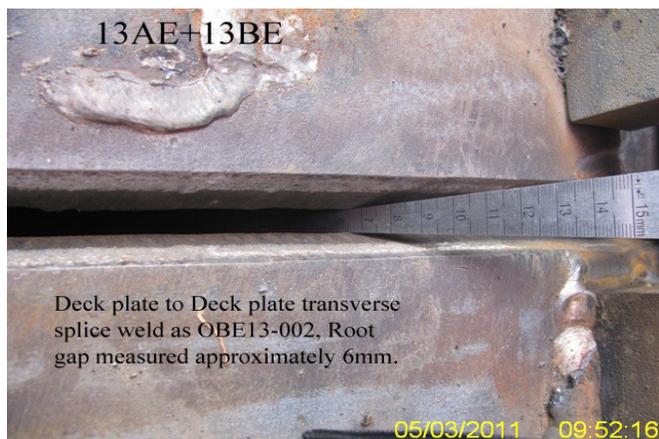
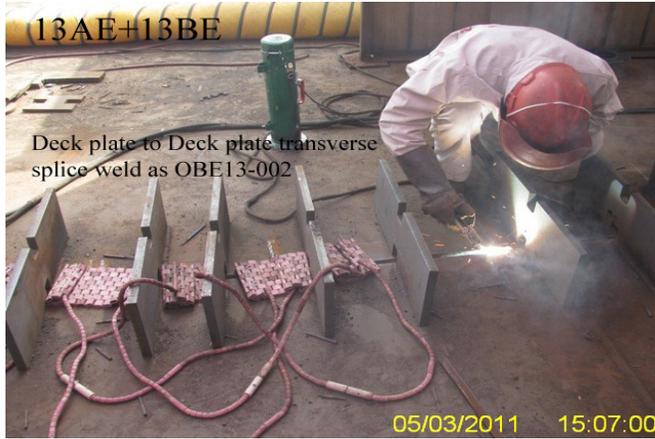
ZPMC welding personnel performing Shielded Metal Arc Welding of Complete Joint Penetration welds joining the deck plate to deck plate transverse splice weld joint located on 13AE+13BE. The weld is designated as OBE13-002. The welder is identified as 037743, 068097, 067183, 066416, 068924, 067656, 066163, 068917 & 043661. ZPMC QC Mr. WANG LI YANG was onsite monitoring the welding variables. The inprocess Shielded Metal Arc Welding appears to be progressing in compliance with WPS-B-P-2211-B-U2-FCM-1 & WPS-B-P-2211-B-U2a-FCM-1. Above 6mm root gap area of the weld the above said second Welding procedure is used for welding. Further weld detail mention in attached picture.
