DEPARTMENT OF TRANSPORTATION

Contract #: 04-0120F4Cty: SF/ALA Rte: 80 PM: 13.2/13.9File #: 99.28**WELDING INSPECTION REPORT****Resident Engineer:** Siegenthaler, Peter**Address:** 333 Burma Road**City:** Oakland, CA 94607**Report No:** WIR-023561**Date Inspected:** 14-May-2011**Project Name:** SAS Superstructure**OSM Arrival Time:** 700**Prime Contractor:** American Bridge/Fluor Enterprises, a JV**OSM Departure Time:** 1900**Contractor:** Zhenhua Port Machinery Company, Ltd (ZPMC), Changxing Island **Location:** Shanghai

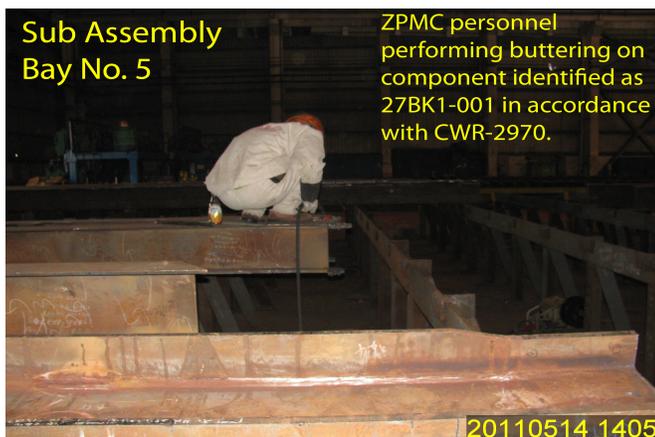
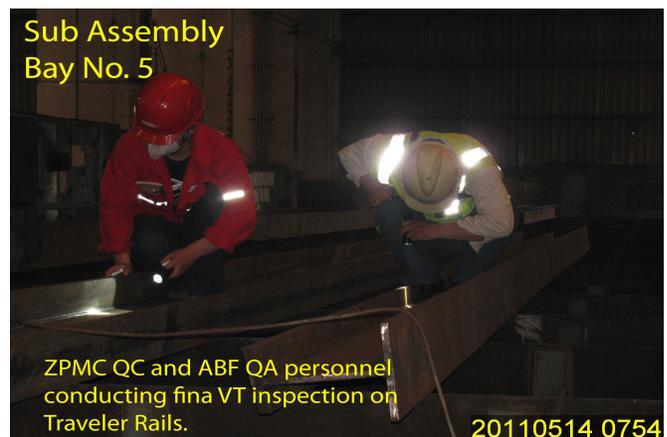
ZPMC personnel heat straightening Orthotropic Box Girder (OBG) traveler rail member identified as 30BK1-001. Distortion appeared to be caused by welding. ZPMC Quality Control (QC) inspector identified as Mr. Tian Lei was present to monitor the heat straightening process. The heat straightening appeared to comply with Heat Straightening Report (HSR) no. HSR(B)-10291.

ZPMC personnel heat straightening Orthotropic Box Girder (OBG) traveler rail member identified as 3016TR3-001 for weld(s) 002, 003, 006~011, 013, & 014. Distortion appeared to be caused by welding. ZPMC Quality Control (QC) inspector identified as Mr. Chen Shigang was present to monitor the heat straightening process. The heat straightening appeared to comply with Heat Straightening Report (HSR) no. HSR(B)-10249.
