Contract #: 04-0120F4Cty: SF/ALA Rte: 80 PM: 13.2/13.9File #: 69.28**WELDING INSPECTION REPORT****Resident Engineer:**Siegenthaler, Peter**Address:** 333 Burma Road**City:** Oakland, CA 94607**Report No:** WIR-023632**Date Inspected:** 11-May-2011**Project Name:** SAS Superstructure**OSM Arrival Time:** 700**Prime Contractor:** American Bridge/Fluor Enterprises, a JV**OSM Departure Time:** 1900**Contractor:** Zhenhua Port Machinery Company, Ltd (ZPMC), Changxing Island **Location:** Shanghai, China**CWI Name:** Mr. An Qing Xiang**CWI Present:** Yes No**Inspected CWI report:** Yes No N/A**Rod Oven in Use:** Yes No N/A**Electrode to specification:** Yes No N/A**Weld Procedures Followed:** Yes No N/A**Qualified Welders:** Yes No N/A**Verified Joint Fit-up:** Yes No N/A**Approved Drawings:** Yes No N/A**Approved WPS:** Yes No N/A**Delayed / Cancelled:** Yes No N/A**Bridge No:** 34-0006**Component:** Orthotropic Box Girder(OBG)**Summary of Items Observed:**

OBG Trial Assembly open yard.

Segment:13AW

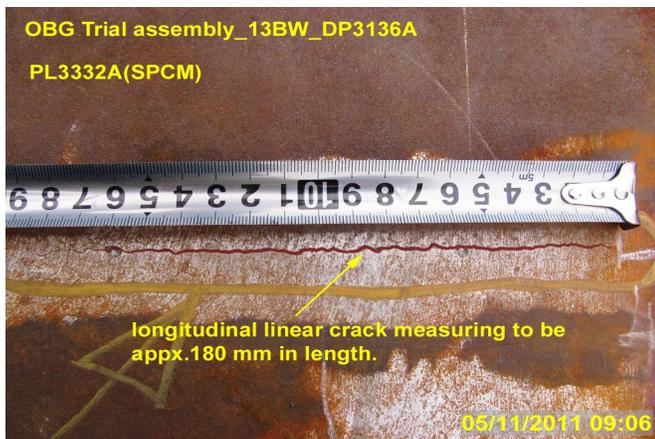
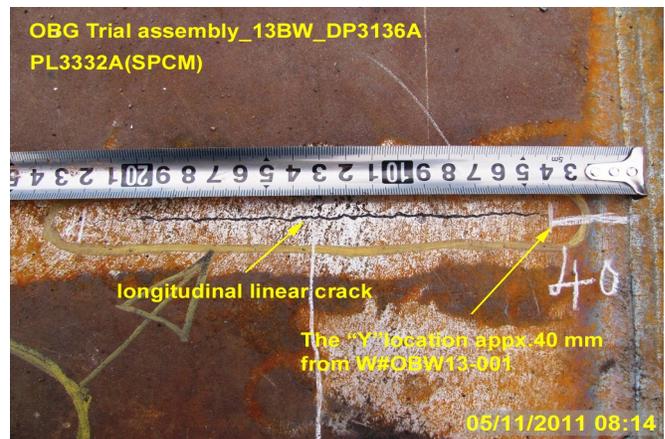
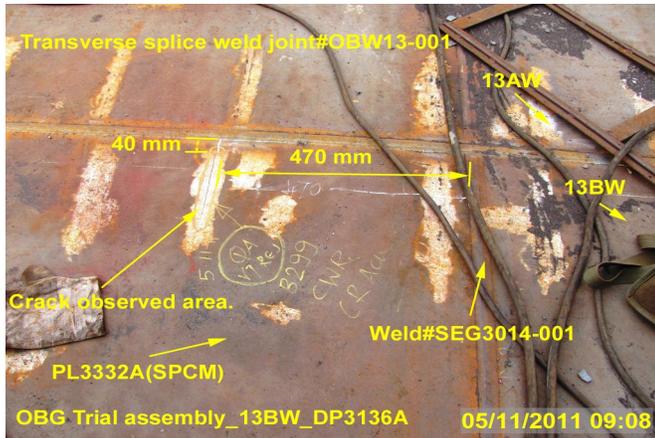
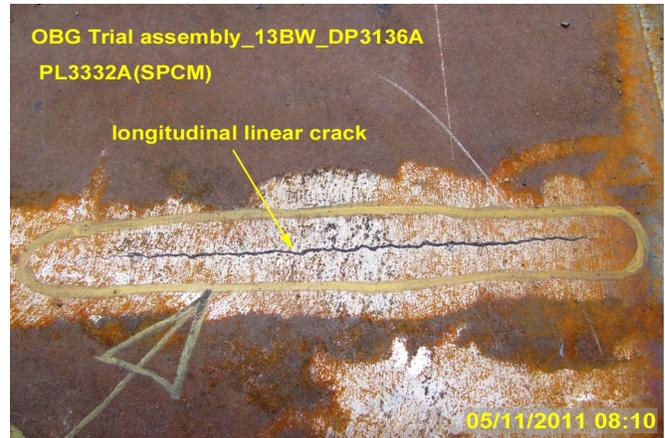
During random in process visual inspection of OBG member identified as deck plate DP3136A, this QA observed 1 longitudinal linear crack on deck plate base metal where the temporary attachment removed area. The length of crack measuring approximately 180 mm in length. The deck plate member is identified as PL3332A. The deck plate is designated as Seismic Performance Critical Material (SPCM) on the approved shop drawing. The nearest welds are identified as SEG3014-001 and OBW13-001. The "Y" locations measured to be approximately 470 mm and 40 mm from the weld toes respectively as shown on the picture below. The thickness of the deck plate is 20 mm. This QA marked the affected area and informed ZPMC Quality Control (QC) CWI identified as Mr. An Qing Xiang of this issue. Mr. An Qing Xiang informed this QA that the crack would be corrected in a manner compliant with the contract documents. This QA Inspector also informed to Lead QA Inspector of the issue. See attached photos for further details.
