Contract #: 04-0120F4Cty: SF/ALA Rte: 80 PM: 13.2/13.9File #: 69.28**WELDING INSPECTION REPORT****Resident Engineer:** Siegenthaler, Peter**Address:** 333 Burma Road**City:** Oakland, CA 94607**Report No:** WIR-023635**Date Inspected:** 14-May-2011**Project Name:** SAS Superstructure**OSM Arrival Time:** 700**Prime Contractor:** American Bridge/Fluor Enterprises, a JV**OSM Departure Time:** 1900**Contractor:** Zhenhua Port Machinery Company, Ltd (ZPMC), Changxing Island **Location:** Shanghai, China**CWI Name:** Mr. An Qing Xiang**CWI Present:** Yes No**Inspected CWI report:** Yes No N/A**Rod Oven in Use:** Yes No N/A**Electrode to specification:** Yes No N/A**Weld Procedures Followed:** Yes No N/A**Qualified Welders:** Yes No N/A**Verified Joint Fit-up:** Yes No N/A**Approved Drawings:** Yes No N/A**Approved WPS:** Yes No N/A**Delayed / Cancelled:** Yes No N/A**Bridge No:** 34-0006**Component:** Orthotropic Box Girder (OBG)**Summary of Items Observed:**

OBG Trial Assembly open yard.

Segment: 13AW

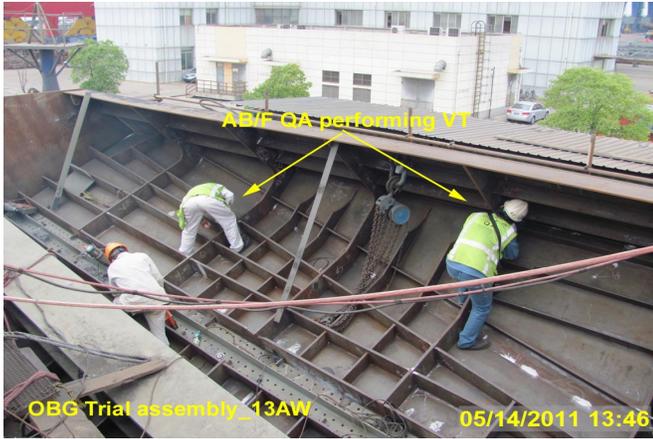
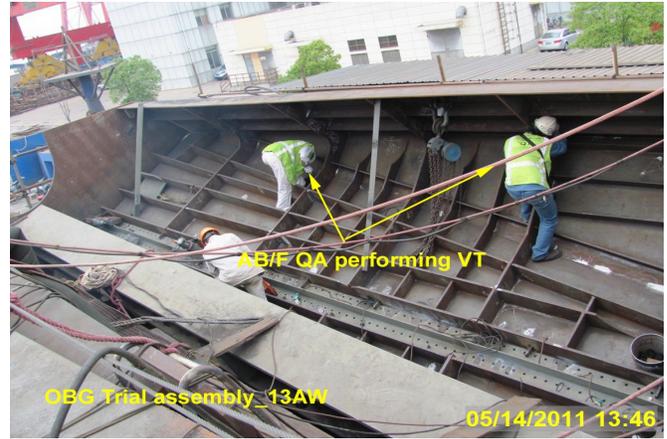
AB/F QA Inspector's performing Visual Testing for the Arch structural Housing weld joints located at Panel Point 118~120 counter weight side. See attached photos for further details.
