Quality Assurance and Source Inspection

Contract #: 04-0120F4Cty: SF/ALA Rte: 80 PM: 13.2/13.9File #: 69.28**WELDING INSPECTION REPORT****Resident Engineer:** Siegenthaler, Peter**Address:** 333 Burma Road**City:** Oakland, CA 94607**Report No:** WIR-023716**Date Inspected:** 14-May-2011**Project Name:** SAS Superstructure**OSM Arrival Time:** 700**Prime Contractor:** American Bridge/Fluor Enterprises, a JV**OSM Departure Time:** 1900**Contractor:** Zhenhua Port Machinery Company, Ltd (ZPMC), Changxing Island **Location:** Shanghai, China**CWI Name:** Zhu Zhong Hai**CWI Present:** Yes No**Inspected CWI report:** Yes No N/A**Rod Oven in Use:** Yes No N/A**Electrode to specification:** Yes No N/A**Weld Procedures Followed:** Yes No N/A**Qualified Welders:** Yes No N/A**Verified Joint Fit-up:** Yes No N/A**Approved Drawings:** Yes No N/A**Approved WPS:** Yes No N/A**Delayed / Cancelled:** Yes No N/A**Bridge No:** 34-0006**Component:** Orthotropic Box Girder (OBG)**Summary of Items Observed:**

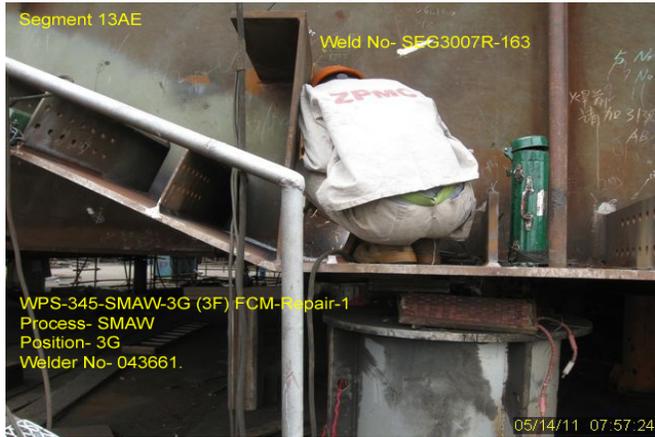
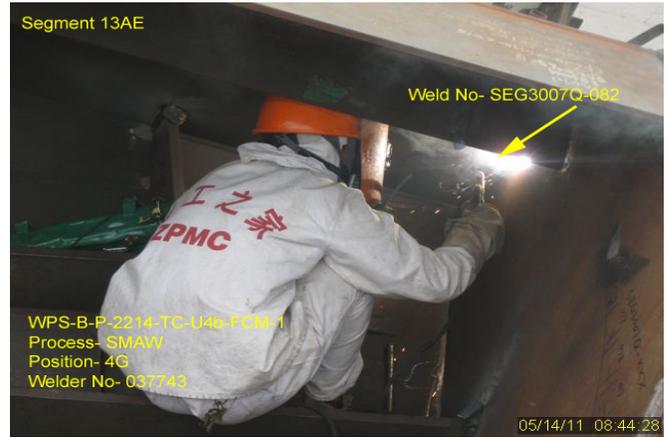
This QA Inspector observed ZPMC qualified welding personnel identified as 043661 perform Shielded Metal Arc Welding (SMAW), weld joint identified as SEG3007Q-082 ; located On Orthotropic Box Girder (OBG) Side Plate to Side Plate CJP Weld; ZPMC Quality Control (QC) is identified as Mr. Zhang Yong Yong. This QA Inspector observed the base material appears to have been preheated by an electrical heating element prior to welding. ZPMC Quality Control (QC) Mr. Zhang Yong Yong was onsite monitoring the welding variables. The welding variables recorded by QC appeared to comply with applicable WPS-B-P-2214-TC-U4b-FCM-1. See attached photo for further details.

Welding (SMAW), weld joint identified as SEG3007R-163; located On Orthotropic Box Girder (OBG) DP3082A to X3897A CJP Weld; ZPMC Quality Control (QC) is identified as Mr. Zhong Yong Yong. This QA Inspector observed the base material appears to have been preheated by an electrical heating element prior to welding. The Welding Repair Report (WRR) was B-WR20954. ZPMC Quality Control (QC) Mr. Zhong Yong Yong was onsite monitoring the welding variables. The welding variables recorded by QC appeared to comply with applicable WPS-345-SMAW-3G (3F) FCM-Repair-1. See attached photo for further details.
