Contract #: 04-0120F4Cty: SF/ALA Rte: 80 PM: 13.2/13.9File #: 1.28**WELDING INSPECTION REPORT****Resident Engineer:** Siegenthaler, Peter**Address:** 333 Burma Road**City:** Oakland, CA 94607**Report No:** WIR-023880**Date Inspected:** 18-May-2011**Project Name:** SAS Superstructure**OSM Arrival Time:** 700**Prime Contractor:** American Bridge/Fluor Enterprises, a JV**OSM Departure Time:** 1730**Contractor:** American Bridge/Fluor Enterprises, a JV**Location:** Job Site**CWI Name:** Steve Jensen**CWI Present:** Yes No**Inspected CWI report:** Yes No N/A**Rod Oven in Use:** Yes No N/A**Electrode to specification:** Yes No N/A**Weld Procedures Followed:** Yes No N/A**Qualified Welders:** Yes No N/A**Verified Joint Fit-up:** Yes No N/A**Approved Drawings:** Yes No N/A**Approved WPS:** Yes No N/A**Delayed / Cancelled:** Yes No N/A**Bridge No:** 34-0006**Component:** SAS Tower**Summary of Items Observed:**

Caltrans Office of Structural Material (OSM) Quality Assurance Inspector (QAI) Joselito Lizardo was present at the Self Anchored Suspension (SAS) job site as requested to perform observations on the welding of components for the San Francisco Oakland Bay Bridge (SFOBB) Project.

At T

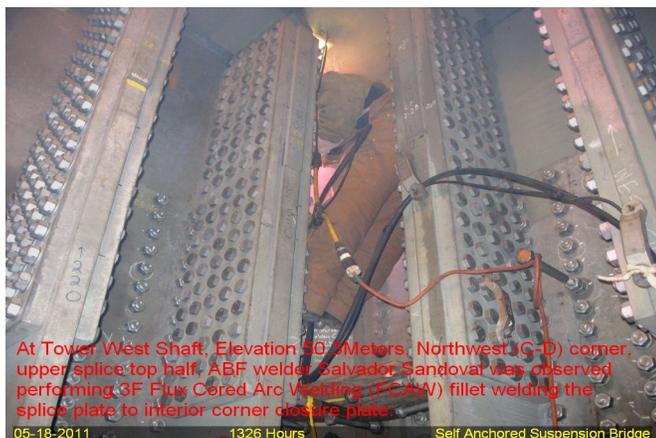
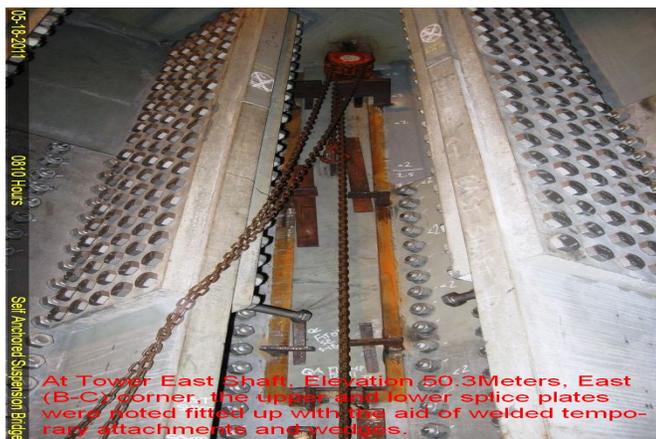
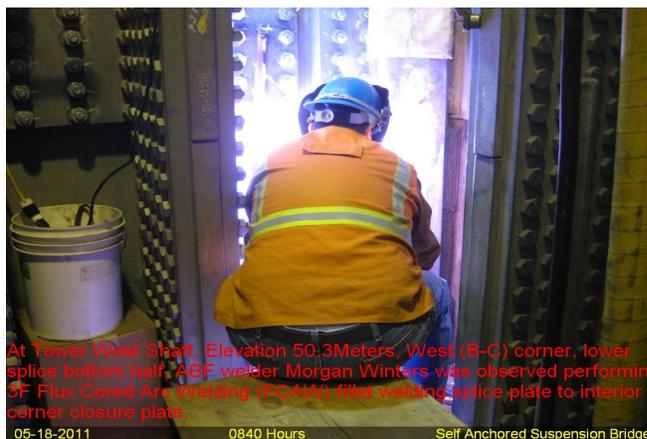
At Northwest (C-D) corner, upper splice plate; this QA Inspector randomly observed ABF welding personnel Salvador Sandoval (#2202) continuing to perform 2F (horizontal) production welding on the top half of the splice plate using the self shielded Flux Cored Arc Welding (FCAW) process. This QA Inspector observed a propylene gas torch was being used to preheat areas prior to welding. This QA Inspector observed QC Inspector Steve Jensen using an infra red temperature gauge to verify the preheat temperature of more than 300°F. This QA Inspector performed a verification of the welding parameters and observed 340 amperes and 24.0 volts. The welding appeared to comply with Welding Procedure Specification (WPS) ABF-WPS-D15-F2200-2. After the completion of the 2F (horizontal) position, the welder has moved to the 3F (vertical) position of the same plate and continued fill pass fillet welding on both sides of the plate until 1700hours. The welder's welding parameters were recorded 270 amperes, 22.1 volts with travel speed of 100 mm per minutes which appear in compliance to the WPS ABF-WPS-D15-F2200-3. Before the end of the shift, the welder has stopped fillet welding and ABF personnel were noted covering the weld with heater blanket in preparation for the three hours holding of preheat temperature of more than 300°F as required. ABF personnel were using Miller Proheat 35 Induction Heating System to hold the preheat that was programmed to shut off after three hours.

At West (B-C) corner, lower splice plate; This QA Inspector randomly observed ABF welding personnel Morgan Winters continuing to perform production welding on the bottom half of the lower splice plate using the self shielded Flux Cored Arc Welding (FCAW) process. This QA Inspector observed ABF personnel using a propylene gas torch on areas prior to welding. This QA Inspector observed QC Inspector Steve Jensen using a Fluke infra red temperature gauge to verify the preheat temperature of more than 300°F. This QA Inspector performed a verification of the welding parameters and observed 230 amperes and 21.3 volts with a travel speed of 95 mm per minute with equivalent heat input of 3.1 Kj per mm. The welding appeared to comply with Welding Procedure Specification (WPS) ABF-WPS-D15-F2200-3. At the end of the shift, fillet welding was still continuing and should remain tomorrow. Before the end of the shift, at around 1700hours, ABF personnel were noted covering the weld with heater blanket in preparation for the three hours holding of preheat temperature of more than 300°F as required. ABF personnel were using Miller Proheat 35 Induction Heating System to hold the preheat that was programmed to shut off after three hours.

At North (C-D) corner, lower splice plate; This QA Inspector randomly observed ABF welding personnel Rick Clayborn perform production welding on the bottom half of the lower splice plate using the self shielded Flux Cored Arc Welding (FCAW) process. This QA Inspector observed ABF personnel using a propylene gas torch on areas prior to welding. This QA Inspector observed QC Inspector Steve Jensen using a Fluke infra red temperature gauge to verify the preheat temperature of more than 300°F. This QA Inspector performed a verification of the welding parameters and observed 265 amperes and 22.0 volts with a travel speed of 95 mm per minute with equivalent heat input of 3.68 Kj per mm. The welding appeared to comply with Welding Procedure Specification (WPS) ABF-WPS-D15-F2200-3. At the end of the shift, fillet welding was still continuing and should remain tomorrow. Before the end of the shift, at around 1700hours, ABF personnel were noted covering the weld with heater blanket in preparation for the three hours holding of preheat temperature of more than 300°F as required. ABF personnel were using Miller Proheat 35 Induction Heating System to hold the preheat that was programmed to shut off after three hours.

At Tower East Shaft East (B-C) corner and Southeast (C-D) corner, ABF welder Richard Garcia was observed performing fit up of the lower and upper splice plates to interior corner closure plate. The welder has tack welded using SMAW various temporary attachments to the interior corner closure plate and used wedges to hold the lower/upper splice plates in place. The welder was also noted preheating the plate to more than 225°F prior welding. ABF QC Steve Jensen was noted at site monitoring the welder and his welding parameter. During the shift, fit up of the splice plates at location mentioned above was completed. This QA has noted ABF QC Steve Jensen perform fit up verification on the installed splice plates. During the verification, the East (B-C) corner upper splice plate top half was noted having 5.0mm gap between the splice plate and the interior corner closure plate. ABF personnel have inserted one shim plate with dimension 3mm thick x 38mm wide x 650mm long. The lower splice plate bottom half was noted having 6.0mm gap. Shim plate having a dimension of 3mm thick x 38mm wide x 610mm long was also inserted. Southeast (C-D) corner lower splice bottom half was noted having 6.0mm gap and shim plate with dimension 3mm thick x 38mm wide x 1100mm long was inserted. All the rest of the joint

fit up was having a reading of 2-3mm gap. According to ABF QC Steve Jensen, he will submit the gathered information to ABF and wait for the Engineer's approval for the use of shim before ABF could start production welding. After the completion of the QA and QC verification of the fit up of the splice plates, the same welder was noted tack welding the plates. The welder was noted utilizing self shielded Flux Cored Arc Welding (FCAW) implementing Caltrans approved ABF-WPS-D15-F2200-3. Tack welding of the plates was ongoing until the end of the shift.
