Contract #: 04-0120F4Cty: SF/ALA Rte: 80 PM: 13.2/13.9File #: 1.28**WELDING INSPECTION REPORT****Resident Engineer:** Siegenthaler, Peter**Address:** 333 Burma Road**City:** Oakland, CA 94607**Report No:** WIR-023881**Date Inspected:** 19-May-2011**Project Name:** SAS Superstructure**OSM Arrival Time:** 700**Prime Contractor:** American Bridge/Fluor Enterprises, a JV**OSM Departure Time:** 1730**Contractor:** American Bridge/Fluor Enterprises, a JV**Location:** Job Site**CWI Name:** Steve Jensen**CWI Present:** Yes No**Inspected CWI report:** Yes No N/A**Rod Oven in Use:** Yes No N/A**Electrode to specification:** Yes No N/A**Weld Procedures Followed:** Yes No N/A**Qualified Welders:** Yes No N/A**Verified Joint Fit-up:** Yes No N/A**Approved Drawings:** Yes No N/A**Approved WPS:** Yes No N/A**Delayed / Cancelled:** Yes No N/A**Bridge No:** 34-0006**Component:** SAS Tower**Summary of Items Observed:**

At Tower West Shaft Splice #1 @Elevation 50.3meters:

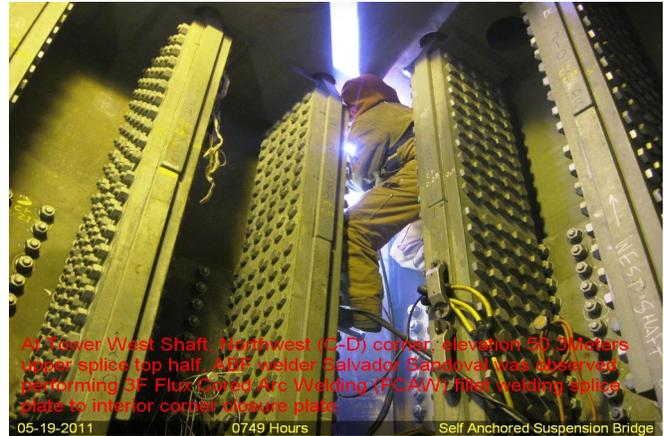
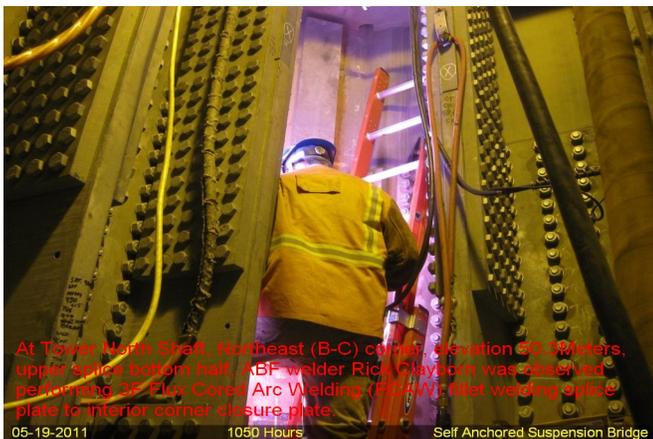
At Northwest (C-D) corner, upper splice plate; this QA Inspector randomly observed ABF welding personnel Salvador Sandoval (#2202) continuing to perform 3F (vertical) production welding on the top half of the splice plate using the self shielded Flux Cored Arc Welding (FCAW) process. This QA Inspector observed a propylene gas torch was being used to preheat areas prior to welding. This QA Inspector observed QC Inspector Steve Jensen using an infra red temperature gauge to verify the preheat temperature of more than 300°F. This QA Inspector performed a verification of the welding parameters and observed 265 amperes and 21.6 volts with travel speed of 100mm per minute with equivalent heat input of 3.43 KJ per mm. The welding appeared to comply with Welding Procedure Specification (WPS) ABF-WPS-D15-F2200-3. Right after the completion of fillet welding, ABF personnel were noted covering the weld with heater blanket in preparation for the three hours holding of preheat temperature of more than 300°F as required. ABF personnel were using Miller Proheat 35 Induction Heating System to hold the preheat that was programmed to shut off after three hours.

Winters continuing to perform production welding on the top half of the upper splice plate using the self shielded Flux Cored Arc Welding (FCAW) process. This QA Inspector observed ABF personnel using a propylene gas torch on areas prior to welding. This QA Inspector observed QC Inspector Steve Jensen using a Fluke infra red temperature gauge to verify the preheat temperature of more than 300°F. This QA Inspector performed a verification of the welding parameters and observed 245 amperes and 20.7 volts with a travel speed of 95 mm per minute with equivalent heat input of 3.2 KJ per mm. The welding appeared to comply with Welding Procedure Specification (WPS) ABF-WPS-D15-F2200-3. At the end of the shift, fillet welding was still continuing and should remain tomorrow. Before the end of the shift, at around 1700hours, ABF personnel were noted covering the weld with heater blanket in preparation for the three hours holding of preheat temperature of more than 300°F as required. ABF personnel were using Miller Proheat 35 Induction Heating System to hold the preheat that was programmed to shut off after three hours.

At North (C-D) corner, lower splice plate; This QA Inspector randomly observed ABF welding personnel Rick Clayborn perform production welding on the top half of the lower splice plate using the self shielded Flux Cored Arc Welding (FCAW) process. This QA Inspector observed ABF personnel using a propylene gas torch on areas prior to welding. This QA Inspector observed QC Inspector Steve Jensen using a Fluke infra red temperature gauge to verify the preheat temperature of more than 300°F. This QA Inspector performed a verification of the welding parameters and observed 270 amperes and 21.6 volts with a travel speed of 95 mm per minute with equivalent heat input of 3.68 KJ per mm. The welding appeared to comply with Welding Procedure Specification (WPS) ABF-WPS-D15-F2200-3. During the shift, fillet welding of the lower splice plate was completed and the welder has moved to the other corner splice of the same tower shaft. The welder was noted 3F production fillet welding at upper splice bottom half, Northeast (B-C) corner utilizing the self shielded Flux Cored Arc Welding (FCAW) process. At the end of the shift, 3F fillet welding on both sides of the upper splice bottom half was completed. ABF personnel were noted covering the weld with heater blanket in preparation for the three hours holding of preheat temperature of more than 300°F as required. ABF personnel were using Miller Proheat 35 Induction Heating System to hold the preheat that was programmed to shut off after three hours.

At Tower East Shaft East (C-D) corner, upper and lower splice plates, ABF welder Richard Garcia was observed tack welding splice plates to the interior corner closure plate. The welder was noted using self shielded Flux Cored Arc Welding (FCAW) with 1.8mm diameter E71T-8 wire electrode implementing Caltrans approved (WPS) ABF-WPS-D15-F2200-3. During the shift, tack welding of the upper and lower splice plates to interior corner closure plate at location mentioned above was completed.

The welder has moved to Tower North Shaft Splice #1 @Elevation 50.3meters, North (C-D) corner, upper splice top half and performed 3F production welding on the top half of the upper splice plate using the self shielded Flux Cored Arc Welding (FCAW) process implementing same procedure as above. At the end of the shift, fillet welding of the splice plate to interior corner closure plate was still continuing and should remain tomorrow. ABF personnel were noted covering the weld with heater blanket in preparation for the three hours holding of preheat temperature of more than 300°F as required. ABF personnel were using Miller Proheat 35 Induction Heating System to hold the preheat that was programmed to shut off after three hours.
