Contract #: 04-0120F4Cty: SF/ALA Rte: 80 PM: 13.2/13.9File #: 1.28**WELDING INSPECTION REPORT****Resident Engineer:** Siegenthaler, Peter**Address:** 333 Burma Road**City:** Oakland, CA 94607**Report No:** WIR-023907**Date Inspected:** 20-May-2011**Project Name:** SAS Superstructure**OSM Arrival Time:** 700**Prime Contractor:** American Bridge/Fluor Enterprises, a JV**OSM Departure Time:** 1530**Contractor:** American Bridge/Fluor Enterprises, a JV**Location:** Job Site**CWI Name:** Pat Swain**CWI Present:** Yes No**Inspected CWI report:** Yes No N/A**Rod Oven in Use:** Yes No N/A**Electrode to specification:** Yes No N/A**Weld Procedures Followed:** Yes No N/A**Qualified Welders:** Yes No N/A**Verified Joint Fit-up:** Yes No N/A**Approved Drawings:** Yes No N/A**Approved WPS:** Yes No N/A**Delayed / Cancelled:** Yes No N/A**Bridge No:** 34-0006**Component:** Tower**Summary of Items Observed:**

## WELDING INSPECTION REPORT

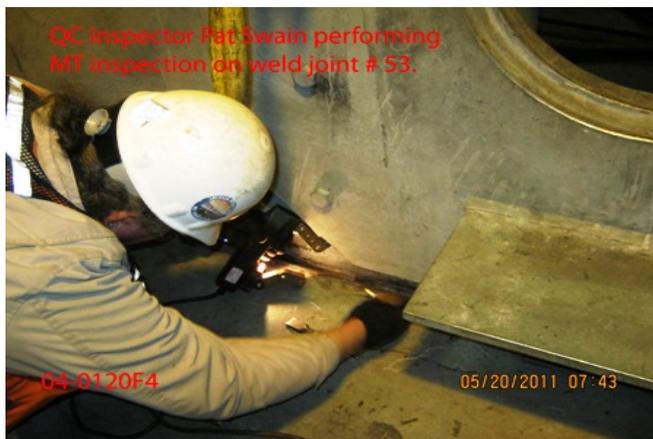
This QA Inspector observed ABF welding personnel Xiao Jian Wan (#9677) start production welding North of the center of weld joint #53 for an approximate length of 675 mm and ABF welding personnel Jin Quan Huang (#9340) and Wai Kitlai (#2953) start production welding north of the center section of weld joint #54 for an approximate length of 1600 mm with one on each end. This QA Inspector observed the welding personnel noted above were using the Flux cored Arc Welding (FCAW) process. This QA Inspector observed as QC Inspector Pat Swain verified the following welding parameters; Xiao Jian Wan (#9677) 290 amperes and 24 volts at a travel speed of 400 mm per minute to produce a heat input of 1.04 Kj per mm, Jin Quan Huang (#9340) 285 amperes and 24.5 volts at a travel speed of 384 mm per minute to produce a heat input of 1.09 Kj per mm and Wai Kitlai (#2953) 278 amperes and 24.1 volts at travel speed of 370 mm per minute to produce a heat input of 1.09 Kj per mm. The welding observed appeared to comply with Welding Procedure Specification (WPS) ABF-WPS-D15-3160-1.

This QA Inspector observed QC Inspector Pat Swain perform Magnetic Particle Testing (MT) on the root pass of weld joint # 53 and #54 and informed this QA Inspector he had accepted both welds. This QA Inspector performed a random visual verification and the welding appeared to comply with the contract requirements.

This QA Inspector observed welding at joints #53 and #54 preceded until approximately 1230 hours when welding was stopped and the induction heat blankets were placed over the welding performed this date. The work observed appeared to comply with the contract requirements.
