DEPARTMENT OF TRANSPORTATION

Quality Assurance and Source Inspection

Contract #: 04-0120F4Cty: SF/ALA Rte: 80 PM: 13.2/13.9File #: 1.28**WELDING INSPECTION REPORT****Resident Engineer:** Siegenthaler, Peter**Address:** 333 Burma Road**City:** Oakland, CA 94607**Report No:** WIR-023942**Date Inspected:** 24-May-2011**Project Name:** SAS Superstructure**OSM Arrival Time:** 700**Prime Contractor:** American Bridge/Fluor Enterprises, a JV**OSM Departure Time:** 1730**Contractor:** American Bridge/Fluor Enterprises, a JV**Location:** Job Site**CWI Name:** Steve Jensen**CWI Present:** Yes No**Inspected CWI report:** Yes No N/A**Rod Oven in Use:** Yes No N/A**Electrode to specification:** Yes No N/A**Weld Procedures Followed:** Yes No N/A**Qualified Welders:** Yes No N/A**Verified Joint Fit-up:** Yes No N/A**Approved Drawings:** Yes No N/A**Approved WPS:** Yes No N/A**Delayed / Cancelled:** Yes No N/A**Bridge No:** 34-0006**Component:** SAS Tower**Summary of Items Observed:**

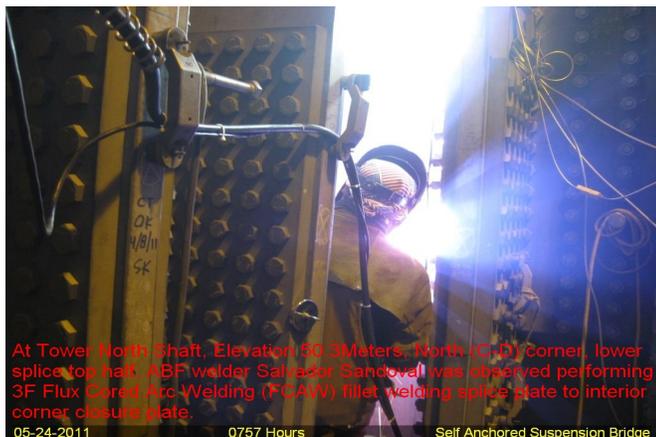
05-24-2011 0757 Hours Self Anchored Suspension Bridge

At Tower North Shaft, Elevation 50.3Meters, North (C-D) corner, lower splice top half ABF welder Salvador Sandoval was observed performing 3F Flux Cored Arc Welding (FCAW) fillet welding splice plate to interior corner closure plate.

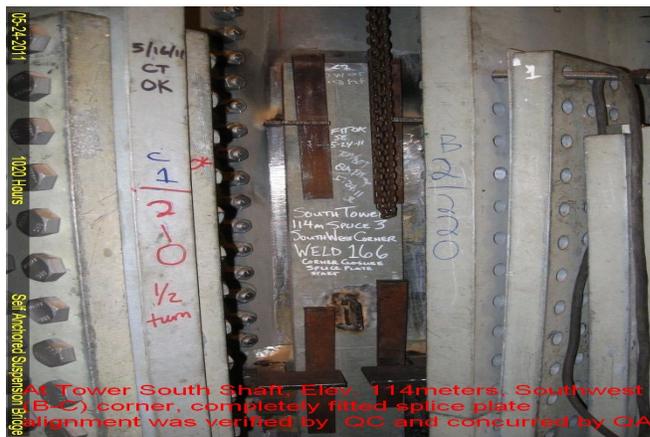
At Tower South Shaft, Elev. 114meters, Southwest (B-C) corner, completely fitted splice plate alignment was verified by QC and concurred by QA.

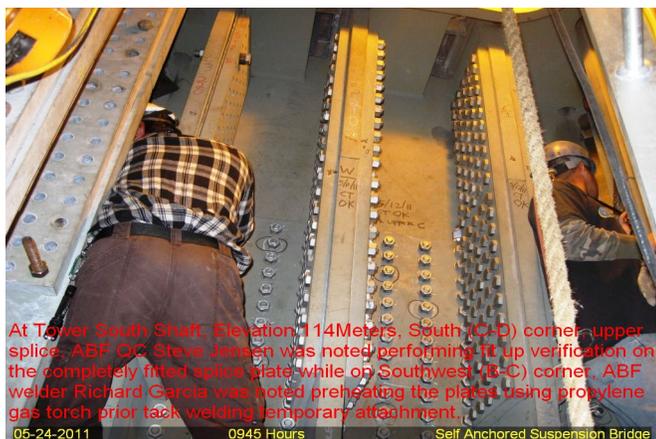
05-24-2011 0945 Hours Self Anchored Suspension Bridge

At Tower South Shaft, Elevation 114Meters, South (C-D) corner upper splice, ABF QC Steve Jensen was noted performing fit up verification on the completely fitted splice plate while on Southwest (B-C) corner, ABF welder Richard Garcia was noted preheating the plates using propane gas torch prior tack welding temporary attachment.
