Contract #: 04-0120F4Cty: SF/ALA Rte: 80 PM: 13.2/13.9File #: 1.28**WELDING INSPECTION REPORT****Resident Engineer:** Siegenthaler, Peter**Address:** 333 Burma Road**City:** Oakland, CA 94607**Report No:** WIR-023964**Date Inspected:** 25-May-2011**Project Name:** SAS Superstructure**OSM Arrival Time:** 700**Prime Contractor:** American Bridge/Fluor Enterprises, a JV**OSM Departure Time:** 1730**Contractor:** American Bridge/Fluor Enterprises, a JV**Location:** Job Site**CWI Name:** Steve Jensen**CWI Present:** Yes No**Inspected CWI report:** Yes No N/A**Rod Oven in Use:** Yes No N/A**Electrode to specification:** Yes No N/A**Weld Procedures Followed:** Yes No N/A**Qualified Welders:** Yes No N/A**Verified Joint Fit-up:** Yes No N/A**Approved Drawings:** Yes No N/A**Approved WPS:** Yes No N/A**Delayed / Cancelled:** Yes No N/A**Bridge No:** 34-0006**Component:** SAS Tower**Summary of Items Observed:**

WELDING INSPECTION REPORT

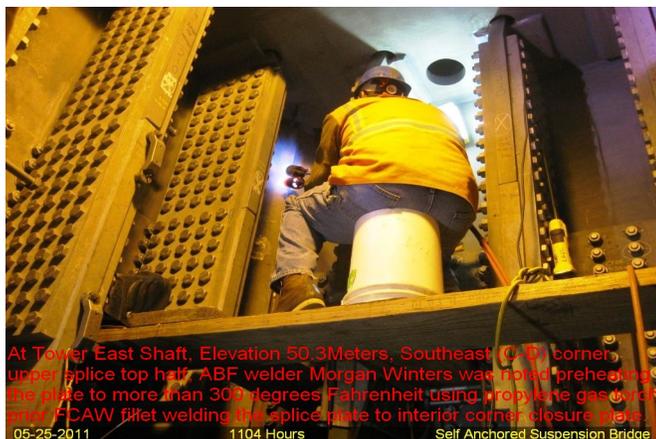
05-25-2011 1104 Hours Self Anchored Suspension Bridge

At Tower East Shaft, Elevation 50.3Meters, Southeast (C-D) corner, upper splice top half, ABF welder Morgan Winters was observed preheating the plate to more than 300 degrees Fahrenheit using propane gas and then FCAW fillet welding the splice plate to interior corner closure plate.

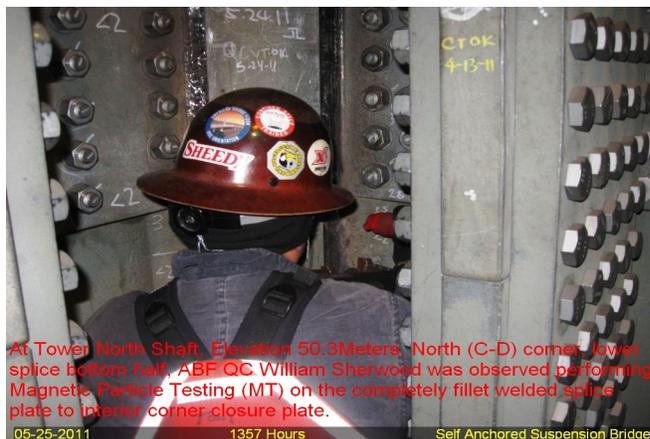
05-25-2011 1357 Hours Self Anchored Suspension Bridge

At Tower North Shaft, Elevation 50.3Meters, North (C-D) corner, lower splice bottom half, ABF QC William Sherwood was observed performing Magnetic Particle Testing (MT) on the completely fillet welded splice plate to interior corner closure plate.

At the request of Quality Control Field Supervisor, Bonifacio Daquinag, QA has randomly verified the QC MT of the fillet welding of two (2) splice plates. The QA verification was performed to verify that the welding and the MT inspection performed by the QC inspector meet the requirements of the contract documents. At the conclusion of the QA verification it appeared that the weld and the QC inspection complied with the contract documents.

1. Tower North Shaft Elev. 50.3meters North (C-D) corner upper splice – QA MT verified
2. Tower North Shaft Elev. 50.3meters North (C-D) corner lower splice – QA MT verified

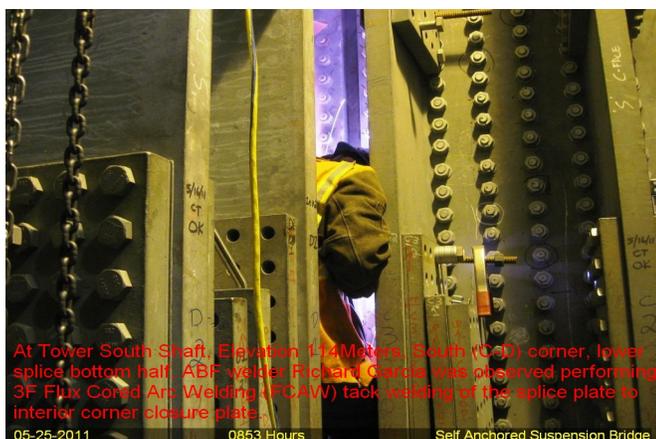
05-25-2011 0853 Hours Self Anchored Suspension Bridge

At Tower South Shaft, Elevation 114Meters, South (C-D) corner, lower splice bottom half, ABF welder Richard Garcia was observed performing 3F Flux Cored Arc Welding (FCAW) tack welding of the splice plate to interior corner closure plate.

At Tower South Shaft South (C-D) corner, upper and lower splice plates, ABF welder Richard Garcia was observed tack welding splice plates to the interior corner closure plate. The welder was noted using self shielded Flux Cored Arc Welding (FCAW) with 1.8mm diameter E71T-8 wire electrode implementing Caltrans approved (WPS) ABF-WPS-D15-F2200-3. This QA Inspector observed ABF personnel using a propylene gas torch on plates to be welded prior to welding. This QA Inspector observed QC Inspector Steve Jensen using a Fluke infra red temperature gauge to verify the preheat temperature of more than 300°F. During the shift, rain has poured moderately at the Baybridge and water seepage has occurred into the splice close to the welding area. The welder has informed ABF foreman Erick Sparks about the situation and the foreman shut down the tack welding of the upper and lower splice plates to interior corner closure plate.

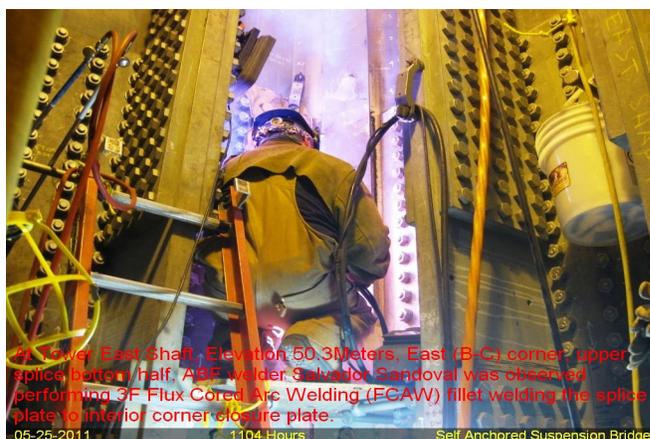
05-25-2011 1104 Hours Self Anchored Suspension Bridge

At Tower East Shaft, Elevation 50.3Meters, East (B-C) corner, upper splice bottom half, ABF welder Salvador Gandoval was observed performing 3F Flux Cored Arc Welding (FCAW) fillet welding the splice plate to interior corner closure plate.
