DEPARTMENT OF TRANSPORTATION

Quality Assurance and Source Inspection

Contract #: 04-0120F4Cty: SF/ALA Rte: 80 PM: 13.2/13.9File #: 69.28**WELDING INSPECTION REPORT****Resident Engineer:**Siegenthaler, Peter**Address:** 333 Burma Road**City:** Oakland, CA 94607**Report No:** WIR-024019**Date Inspected:** 03-May-2011**Project Name:** SAS Superstructure**OSM Arrival Time:** 1500**Prime Contractor:** American Bridge/Fluor Enterprises, a JV**OSM Departure Time:** 300**Contractor:** Zhenhua Port Machinery Company, Ltd (ZPMC), Changxing Island **Location:** Shanghai, China**CWI Name:** Mr. Li Yan Hua**CWI Present:** Yes No**Inspected CWI report:** Yes No N/A**Rod Oven in Use:** Yes No N/A**Electrode to specification:** Yes No N/A**Weld Procedures Followed:** Yes No N/A**Qualified Welders:** Yes No N/A**Verified Joint Fit-up:** Yes No N/A**Approved Drawings:** Yes No N/A**Approved WPS:** Yes No N/A**Delayed / Cancelled:** Yes No N/A**Bridge No:** 34-0006**Component:** OBG**Summary of Items Observed:**

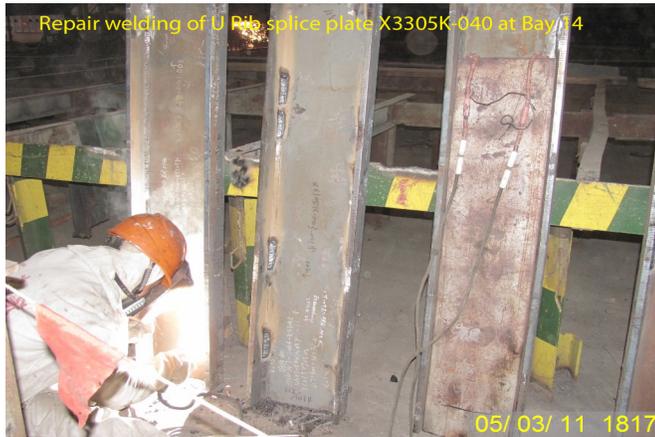
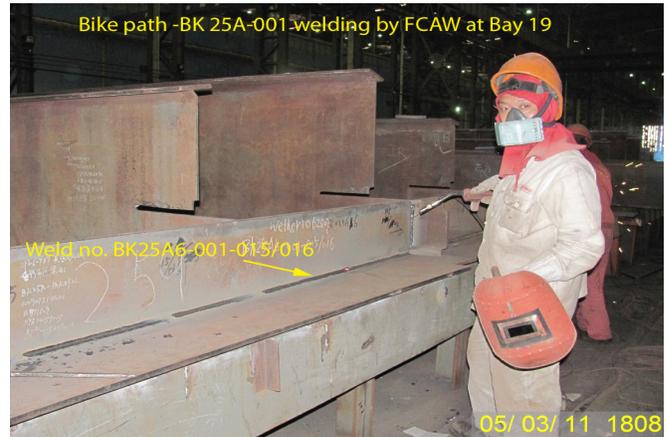
For further information see below pictures:-

Unless otherwise noted, all work observed on this date appeared to be in general compliance with the applicable contract documents.
