**DEPARTMENT OF TRANSPORTATION**

Contract #: 04-0120F4Cty: SF/ALA Rte: 80 PM: 13.2/13.9File #: 1.28**WELDING INSPECTION REPORT****Resident Engineer:** Siegenthaler, Peter**Address:** 333 Burma Road**City:** Oakland, CA 94607**Report No:** WIR-024046**Date Inspected:** 27-May-2011**Project Name:** SAS Superstructure**OSM Arrival Time:** 700**Prime Contractor:** American Bridge/Fluor Enterprises, a JV**OSM Departure Time:** 1530**Contractor:** American Bridge/Fluor Enterprises, a JV**Location:** Job Site**CWI Name:** Steve Jensen**CWI Present:** Yes No**Inspected CWI report:** Yes No N/A**Rod Oven in Use:** Yes No N/A**Electrode to specification:** Yes No N/A**Weld Procedures Followed:** Yes No N/A**Qualified Welders:** Yes No N/A**Verified Joint Fit-up:** Yes No N/A**Approved Drawings:** Yes No N/A**Approved WPS:** Yes No N/A**Delayed / Cancelled:** Yes No N/A**Bridge No:** 34-0006**Component:** SAS Tower**Summary of Items Observed:**

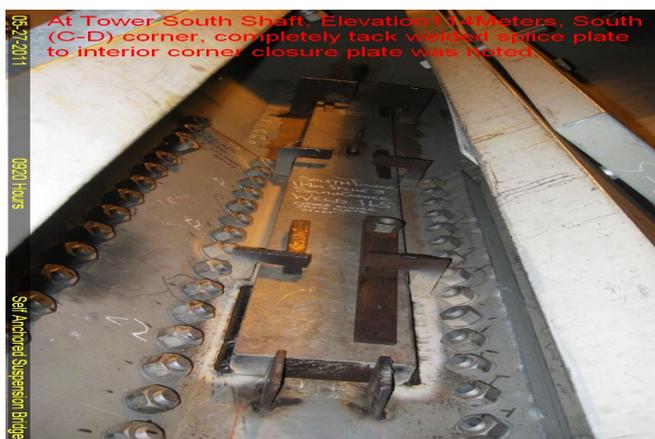
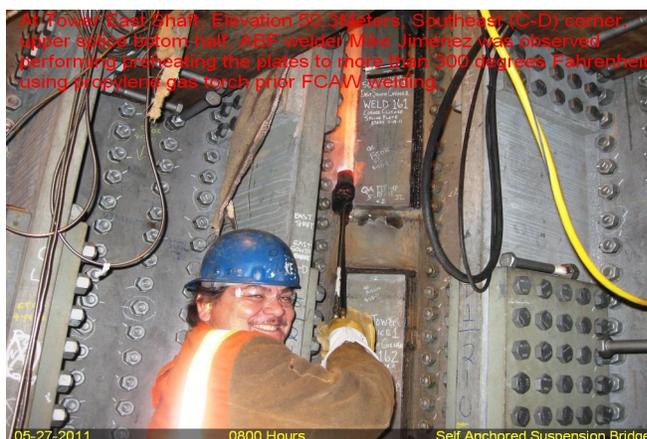
At Tower South Shaft South (C-D) corner, upper splice plates, ABF welder Xiao Jian Wan was observed continuing tack welding splice plates to the interior corner closure plate. The welder was noted using self shielded Flux Cored Arc Welding (FCAW) with 1.8mm diameter E71T-8 wire electrode implementing Caltrans approved (WPS) ABF-WPS-D15-F2200-3. This QA Inspector observed ABF personnel using a propylene gas torch preheating the plates to be welded prior to welding. This QA Inspector observed QC Inspector Steve Jensen using a Fluke infra red temperature gauge to verify the preheat temperature of more than 300°F. At the end of the shift, tack welding of the splice plate to interior corner closure plate was completed.
