Contract #: 04-0120F4Cty: SF/ALA Rte: 80 PM: 13.2/13.9File #: 69.28**WELDING INSPECTION REPORT****Resident Engineer:** Siegenthaler, Peter**Address:** 333 Burma Road**City:** Oakland, CA 94607**Report No:** WIR-024047**Date Inspected:** 27-May-2011**Project Name:** SAS Superstructure**OSM Arrival Time:** 1900**Prime Contractor:** American Bridge/Fluor Enterprises, a JV**OSM Departure Time:** 700**Contractor:** Zhenhua Port Machinery Company, Ltd (ZPMC), Changxing Island **Location:** Shanghai, China

OBG Trial Assembly

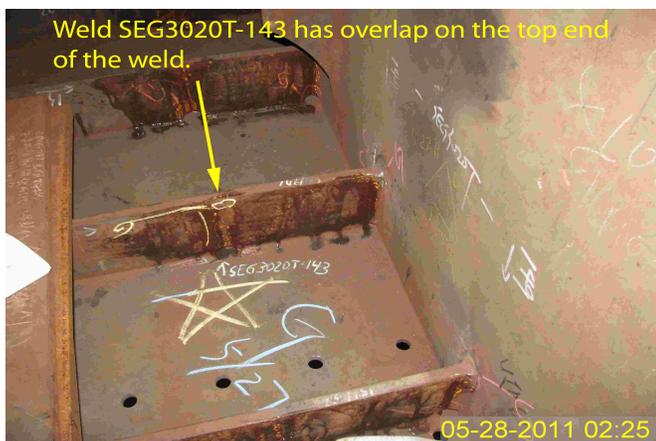
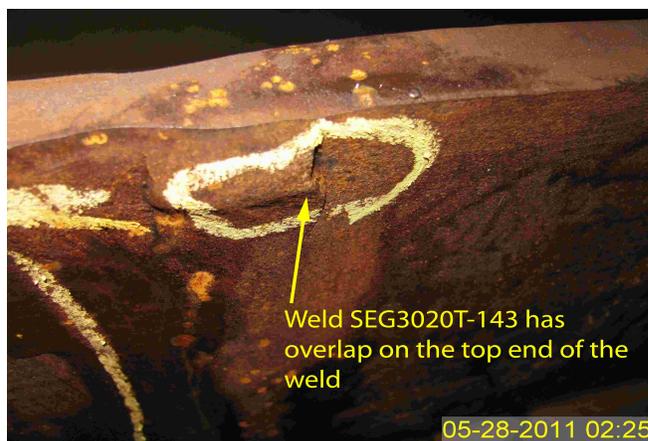
Item #21 welds: SEG3020T-128, 133, 148, 153 See below for information concerning weld SEG3020T-143 which was visually rejected.

This QA Inspector performed random visual and ultrasonic inspections of approximately 15% length of areas previously tested by ZPMC / ABF personnel and items observed by this QA Inspector appear to comply with AWS D1.5 UT requirements. This QA Inspector visually observed weld SEG3020T-143 had was visually rejectable due to having a sharp overlap near the top of the weld. ZPMC QC personnel agreed this weld was visually rejected and no ZPMC personnel were available to grind this weld. Dayshift QA personnel informed this QA Inspector that the weld was ground by day shift personnel and dayshift QA Inspectors visually and ultrasonically accepted this weld. For additional information on these inspections see this QA Inspector's TL6027 Ultrasonic Test Report and the photographs below.
