Quality Assurance and Source Inspection

Contract #: 04-0120F4Cty: SF/ALA Rte: 80 PM: 13.2/13.9File #: 69.28**WELDING INSPECTION REPORT****Resident Engineer:** Siegenthaler, Peter**Address:** 333 Burma Road**City:** Oakland, CA 94607**Report No:** WIR-024090**Date Inspected:** 23-May-2011**Project Name:** SAS Superstructure**OSM Arrival Time:** 700**Prime Contractor:** American Bridge/Fluor Enterprises, a JV**OSM Departure Time:** 1900**Contractor:** Zhenhua Port Machinery Company, Ltd (ZPMC), Changxing Island **Location:** Shanghai, China**CWI Name:** An Qing Xiang**CWI Present:** Yes No**Inspected CWI report:** Yes No N/A**Rod Oven in Use:** Yes No N/A**Electrode to specification:** Yes No N/A**Weld Procedures Followed:** Yes No N/A**Qualified Welders:** Yes No N/A**Verified Joint Fit-up:** Yes No N/A**Approved Drawings:** Yes No N/A**Approved WPS:** Yes No N/A**Delayed / Cancelled:** Yes No N/A**Bridge No:** 34-0006**Component:** OBG**Summary of Items Observed:**

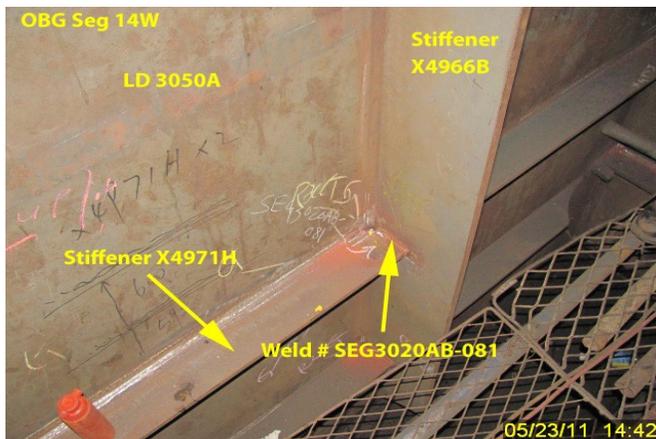
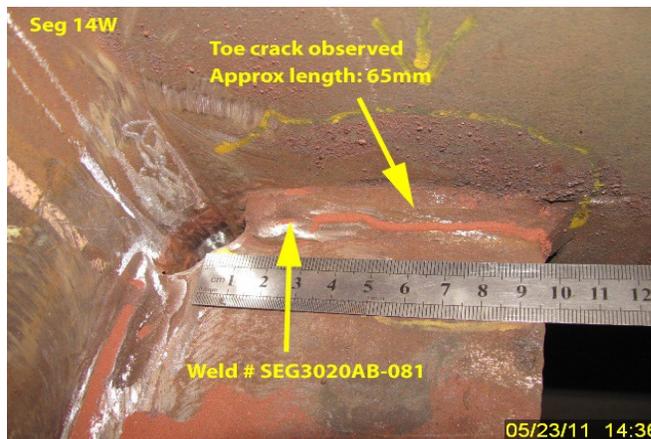
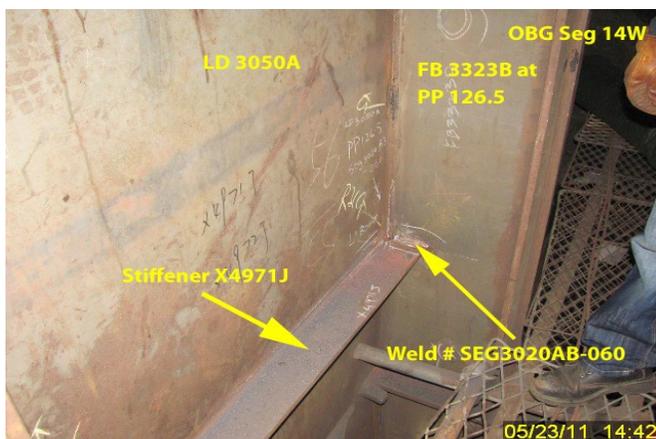
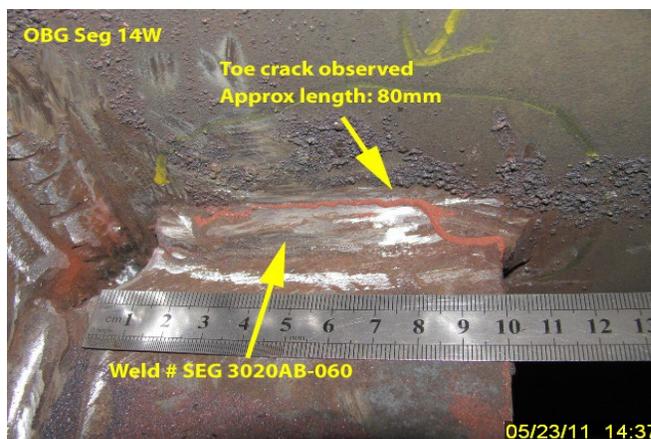
This QA Inspector, along with Mr. Shailesh Wadkar; performed in process Visual Inspection of welds (Segment 14W) at Panel Points (PP) 126 to PP 127. Visual Inspection was performed on the welds between Longitudinal Diaphragm (LD) 3050A to LD 3051A (on the welds inside of the Segment). At two locations stiffener on LD to FB welds, this QA Inspector observed to have toe cracks. Details are as follows:

SEG3020AB-060, 081

This QA Inspector informed to ZPMC CWI, identified as Mr. An Qing Xiang. The weld locations were documented and forwarded to the CT Lead QA Inspector for further disposition. See attached photo for details.
