DEPARTMENT OF TRANSPORTATION

Contract #: 04-0120F4Cty: SF/ALA Rte: 80 PM: 13.2/13.9File #: 69.28**WELDING INSPECTION REPORT****Resident Engineer:** Siegenthaler, Peter**Address:** 333 Burma Road**City:** Oakland, CA 94607**Report No:** WIR-024167**Date Inspected:** 29-May-2011**Project Name:** SAS Superstructure**OSM Arrival Time:** 700**Prime Contractor:** American Bridge/Fluor Enterprises, a JV**OSM Departure Time:** 1900**Contractor:** Zhenhua Port Machinery Company, Ltd (ZPMC), Changxing Island **Location:** Shanghai, China**CWI Name:** Mr. An Qing Xiang**CWI Present:** Yes No**Inspected CWI report:** Yes No N/A**Rod Oven in Use:** Yes No N/A**Electrode to specification:** Yes No N/A**Weld Procedures Followed:** Yes No N/A**Qualified Welders:** Yes No N/A**Verified Joint Fit-up:** Yes No N/A**Approved Drawings:** Yes No N/A**Approved WPS:** Yes No N/A**Delayed / Cancelled:** Yes No N/A**Bridge No:** 34-0006**Component:** Orthotropic Box Girder (OBG)**Summary of Items Observed:**

OBG Trial Assembly open yard.

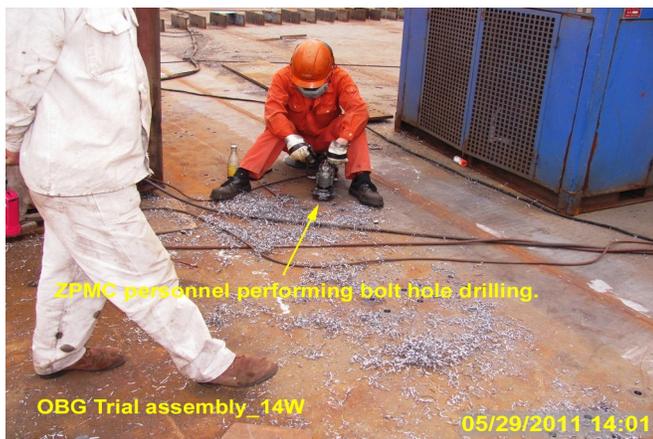
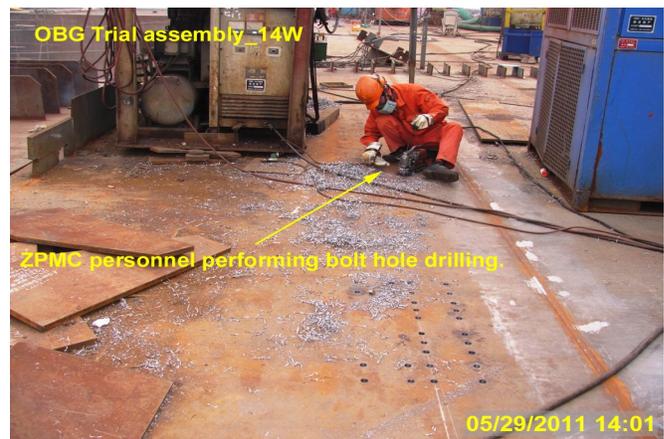
Segment:14W

ZPMC personnel performing bolt hole drilling at deck plate extension location. See attached photos for further details.
