Contract #: 04-0120F4Cty: SF/ALA Rte: 80 PM: 13.2/13.9File #: 69.28**WELDING INSPECTION REPORT****Resident Engineer:** Siegenthaler, Peter**Address:** 333 Burma Road**City:** Oakland, CA 94607**Report No:** WIR-024170**Date Inspected:** 31-May-2011**Project Name:** SAS Superstructure**OSM Arrival Time:** 700**Prime Contractor:** American Bridge/Fluor Enterprises, a JV**OSM Departure Time:** 1900**Contractor:** Zhenhua Port Machinery Company, Ltd (ZPMC), Changxing Island **Location:** Shanghai, China**CWI Name:** Mr. An Qing Xiang**CWI Present:** Yes No**Inspected CWI report:** Yes No N/A**Rod Oven in Use:** Yes No N/A**Electrode to specification:** Yes No N/A**Weld Procedures Followed:** Yes No N/A**Qualified Welders:** Yes No N/A**Verified Joint Fit-up:** Yes No N/A**Approved Drawings:** Yes No N/A**Approved WPS:** Yes No N/A**Delayed / Cancelled:** Yes No N/A**Bridge No:** 34-0006**Component:** Orthotropic Box Girder (OBG)**Summary of Items Observed:**

OBG Trial Assembly open yard.

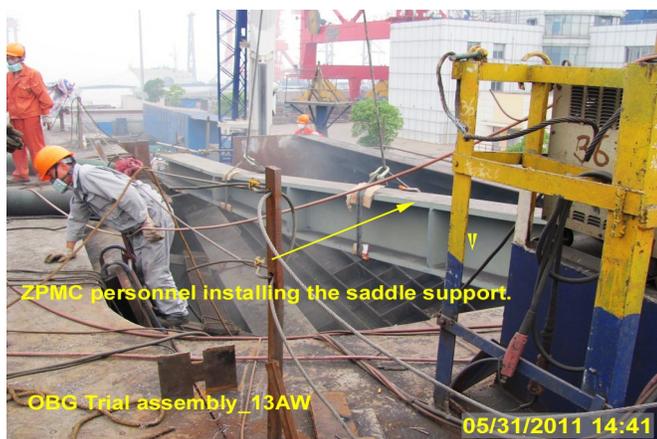
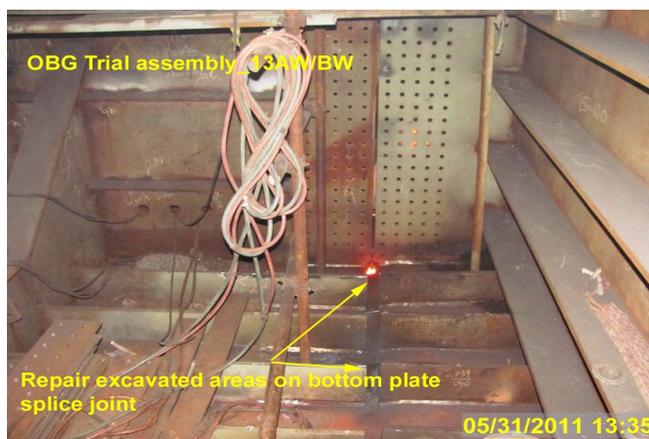
ZPMC personnel installing the saddle support at counter weight side. See attached photos for further details.

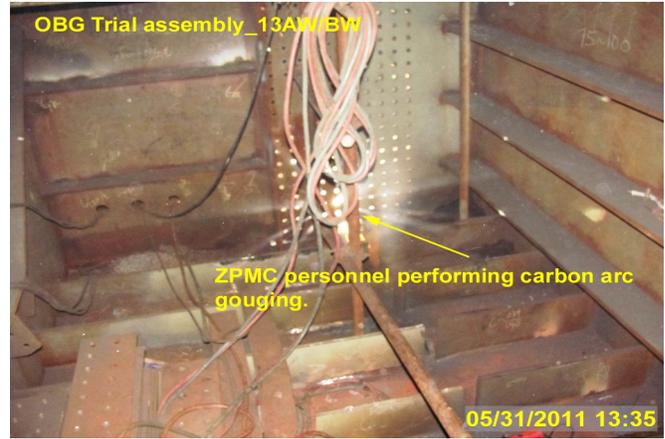
ZPMC personnel performing excavating the weld by using air carbon arc gouging on bottom plate splice weld joint at repair locations. See attached photos for further details.
