Contract #: 04-0120F4Cty: SF/ALA Rte: 80 PM: 13.2/13.9File #: 69.28**WELDING INSPECTION REPORT****Resident Engineer:** Siegenthaler, Peter**Address:** 333 Burma Road**City:** Oakland, CA 94607**Report No:** WIR-024249**Date Inspected:** 21-May-2011**Project Name:** SAS Superstructure**OSM Arrival Time:** 700**Prime Contractor:** American Bridge/Fluor Enterprises, a JV**OSM Departure Time:** 1900**Contractor:** Zhenhua Port Machinery Company, Ltd (ZPMC), Changxing Island **Location:** Shanghai, China**CWI Name:** Lu Hua Jie**CWI Present:** Yes No**Inspected CWI report:** Yes No N/A**Rod Oven in Use:** Yes No N/A**Electrode to specification:** Yes No N/A**Weld Procedures Followed:** Yes No N/A**Qualified Welders:** Yes No N/A**Verified Joint Fit-up:** Yes No N/A**Approved Drawings:** Yes No N/A**Approved WPS:** Yes No N/A**Delayed / Cancelled:** Yes No N/A**Bridge No:** 34-0006**Component:** OBG**Summary of Items Observed:**

**TRIAL ASSEMBLY YARD**

**OBG 14EAST****SHIELDED METAL ARC WELDING PROCESS.**

# WELDING INSPECTION REPORT

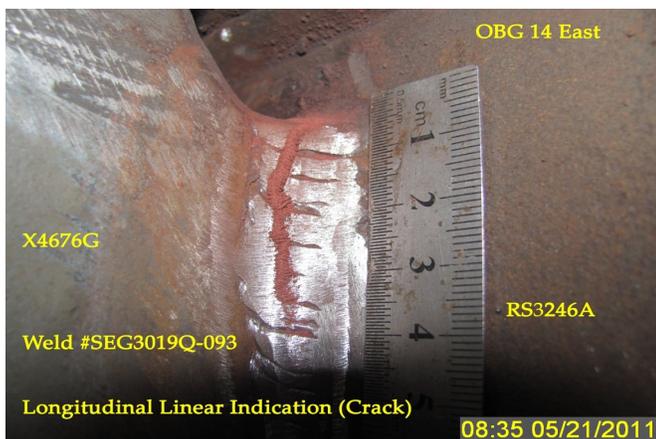
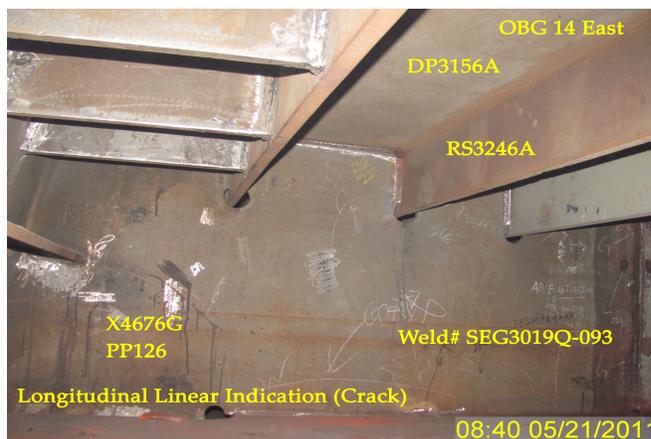
During a random visual inspection of OBG segment 14 East this QA Inspector observed a longitudinal linear indication (crack). The Weld numbers identified as SEG3019Q-093 and having a length approximately 40mm, This weld is a fillet weld type joint. This weld is located between deck panel "I" rib (RS3246A) and X4676A. This QA Inspector informed ZPMC QC Inspector and the Lead QA Inspector(CT)of the location of the longitudinal linear Indication and as per the Lead QA Inspector the disposition will be to put this weld on punch list for further details see the attached photos.
