Contract #: 04-0120F4Cty: SF/ALA Rte: 80 PM: 13.2/13.9File #: 99.28**WELDING INSPECTION REPORT****Resident Engineer:** Siegenthaler, Peter**Address:** 333 Burma Road**City:** Oakland, CA 94607**Report No:** WIR-024287**Date Inspected:** 08-Jun-2011**Project Name:** SAS Superstructure**OSM Arrival Time:** 700**Prime Contractor:** American Bridge/Fluor Enterprises, a JV**OSM Departure Time:** 1900**Contractor:** Zhenhua Port Machinery Company, Ltd (ZPMC), Changxing Island**Location:** Shanghai**CWI Name:****CWI Present:**

Trial Assembly Segments 13AE to 13CE

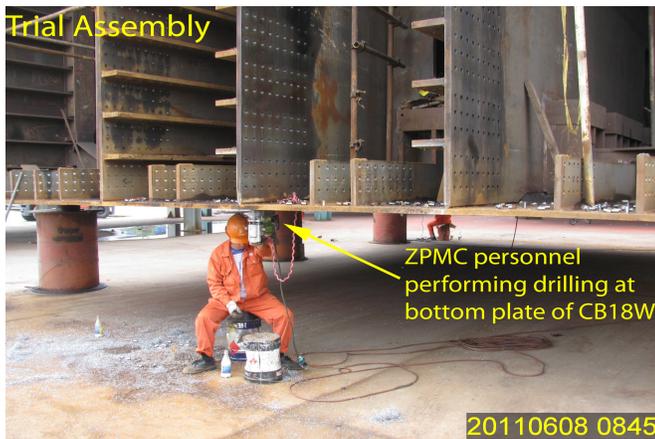
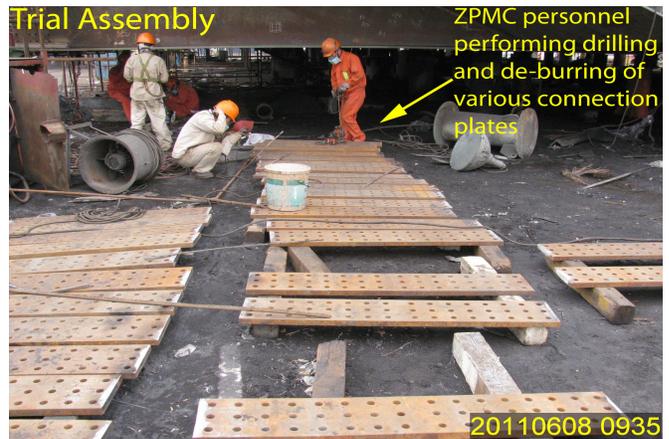
Observed ZPMC personnel performing drilling & de-burring of miscellaneous connection plates (see photo).
Trial Assembly CB18
