DEPARTMENT OF TRANSPORTATION

Quality Assurance and Source Inspection

Contract #: 04-0120F4Cty: SF/ALA Rte: 80 PM: 13.2/13.9File #: 99.28**WELDING INSPECTION REPORT****Resident Engineer:** Siegenthaler, Peter**Address:** 333 Burma Road**City:** Oakland, CA 94607**Report No:** WIR-024297**Date Inspected:** 28-May-2011**Project Name:** SAS Superstructure**OSM Arrival Time:** 700**Prime Contractor:** American Bridge/Fluor Enterprises, a JV**OSM Departure Time:** 1900**Contractor:** Zhenhua Port Machinery Company, Ltd (ZPMC), Changxing Island **Location:** Shanghai**CWI Name:****CWI Present:****Yes No****Inspected CWI report:** Yes No N/A**Rod Oven in Use:****Yes No N/A****Electrode to specification:** Yes No N/A**Weld Procedures Followed:****Yes No N/A****Qualified Welders:** Yes No N/A**Verified Joint Fit-up:****Yes No N/A****Approved Drawings:** Yes No N/A**Approved WPS:****Yes No N/A****Delayed / Cancelled:****Yes No N/A****Bridge No:** 34-0006**Component:** OBG**Summary of Items Observed:**

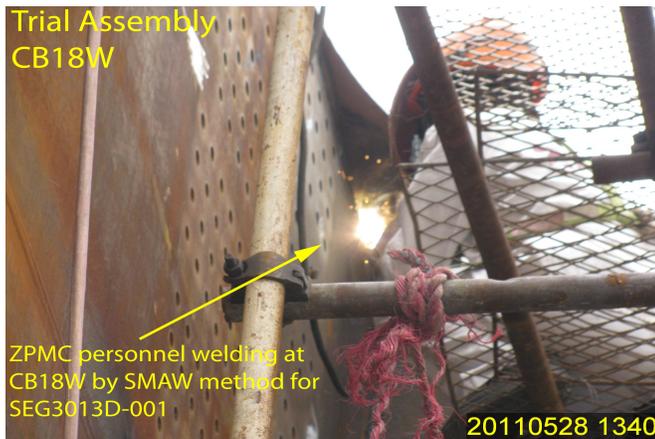
This QA inspector observed the ZPMC personnel performing drilling of floor beams to receive high strength bolting holes at CB19E @ 14AE exterior at bottom plate, also observed match drilling of bolt holes at CB19W @ 14W.

SMAW welding of complete joint penetration welds located on CB18W component identified as CB3013D-018 weld no.(s) 021. Welder is identified as welder no. 215248. The welding variables recorded by ZPMC QC identified as Zhou Zhong Hai appeared to comply with applicable WPS(s) WPS-B-P-2212-TC-U-4b-FCM-1.

This QA inspector observed ZPMC personnel installing alignment pins into bottom plate at CB18E between PP118 & PP120. This inspector conducted visual inspection of hole alignment at FB3108A, FB3122A, FB3109A,

This QA inspector performed MT of approximately 15% of the area previously tested and accepted by ZPMC Quality Control personnel. This QA Inspector generated an MT report for this date. All components were as listed on NWIT notification no. 09283. The member(s) is/are identified as OBG Deck Plates and Segments assembly components identified below with the following identifying weld no.(s):

Unless otherwise noted above all items observed on this day appeared to be in general compliance with the applicable contract documents
