Contract #: 04-0120F4Cty: SF/ALA Rte: 80 PM: 13.2/13.9File #: 1.28**WELDING INSPECTION REPORT****Resident Engineer:** Siegenthaler, Peter**Address:** 333 Burma Road**City:** Oakland, CA 94607**Report No:** WIR-024529**Date Inspected:** 22-Jun-2011**Project Name:** SAS Superstructure**OSM Arrival Time:** 700**Prime Contractor:** American Bridge/Fluor Enterprises, a JV**OSM Departure Time:** 1730**Contractor:** American Bridge/Fluor Enterprises, a JV**Location:** Job Site

CWI Name:	Steve Mc Connell and Pat Swain			CWI Present:	Yes	No	
Inspected CWI report:	Yes	No	N/A	Rod Oven in Use:	Yes	No	N/A
Electrode to specification:	Yes	No	N/A	Weld Procedures Followed:	Yes	No	N/A
Qualified Welders:	Yes	No	N/A	Verified Joint Fit-up:	Yes	No	N/A
Approved Drawings:	Yes	No	N/A	Approved WPS:	Yes	No	N/A
				Delayed / Cancelled:	Yes	No	N/A
Bridge No:	34-0006			Component:	SAS Tower

Caltrans Office of Structural Material (OSM) Quality Assurance Inspector (QAI) Joselito Lizardo was present at the Self Anchored Suspension (SAS) job site as requested to perform observations on the welding of components for the San Francisco Oakland Bay Bridge (SFOBB) Project.

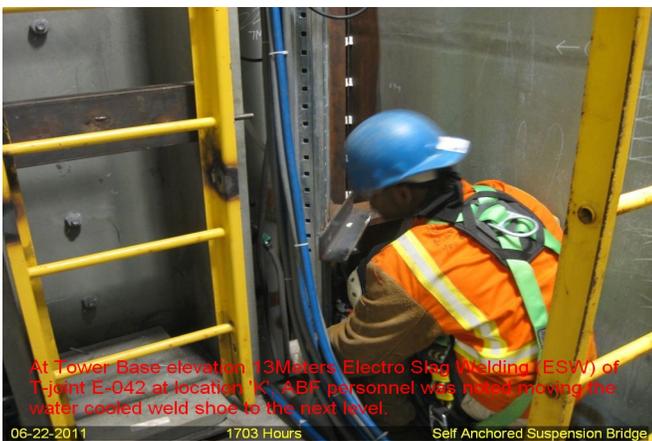
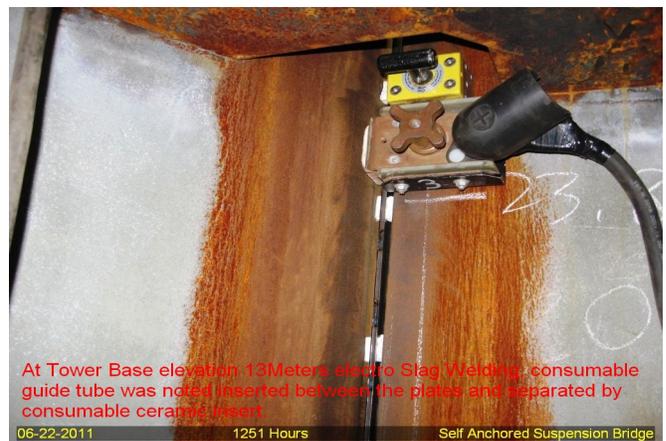
This QA was present at the Tower Base to observe the Electro Slag Welding of the weld number E-042 located at 'K' position per ABF weld map. The weld joint to be welded is a 60mm shear plate to Tower East Shaft skin plate (70mm) 'A', T- joint located at the corner of tower East shaft skin plates 'A' and 'B'. ABF intends to implement Caltrans approved welding procedure ABF-WPS-ESW-150T in performing the ESW.

The fit up alignment was jointly checked by ABF QC Steve Mc Connell and this QA. The root gap was measured from bottom to top and the result noted was 20.2mm minimum and 25mm maximum which deemed in compliance to the WPS.

Initial firing of the ESW has started at 1336 hours and it was successful and that the welding parameters have stabilized. The operation continued until the successful completion of the joint at around 1851 hours.
