Contract #: 04-0120F4Cty: SF/ALA Rte: 80 PM: 13.2/13.9File #: 69.28**WELDING INSPECTION REPORT****Resident Engineer:** Siegenthaler, Peter**Address:** 333 Burma Road**City:** Oakland, CA 94607**Report No:** WIR-024656**Date Inspected:** 08-Jun-2011**Project Name:** SAS Superstructure**OSM Arrival Time:** 700**Prime Contractor:** American Bridge/Fluor Enterprises, a JV**OSM Departure Time:** 1900**Contractor:** Zhenhua Port Machinery Company, Ltd (ZPMC), Changxing Island **Location:** Shanghai, China**CWI Name:** Mr. An Qing Xiang**CWI Present:** Yes No**Inspected CWI report:** Yes No N/A**Rod Oven in Use:** Yes No N/A**Electrode to specification:** Yes No N/A**Weld Procedures Followed:** Yes No N/A**Qualified Welders:** Yes No N/A**Verified Joint Fit-up:** Yes No N/A**Approved Drawings:** Yes No N/A**Approved WPS:** Yes No N/A**Delayed / Cancelled:** Yes No N/A**Bridge No:** 34-0006**Component:** Orthotropic Box Girder (OBG)**Summary of Items Observed:**

OBG Trial Assembly open yard.

Segment: 13BE

WELDING INSPECTION REPORT

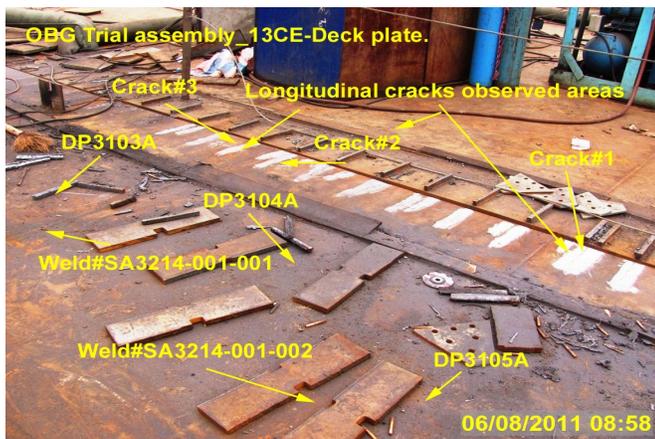
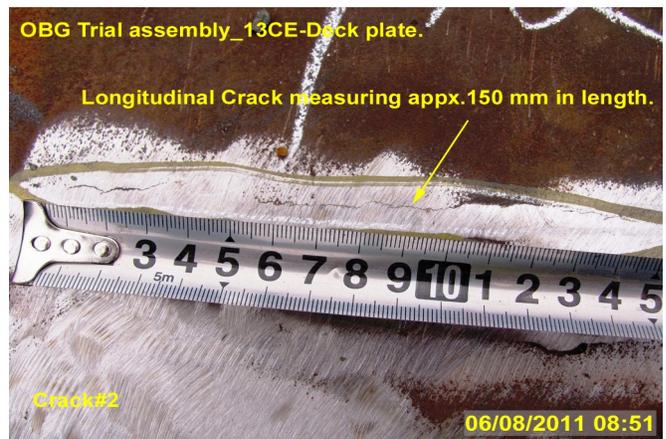
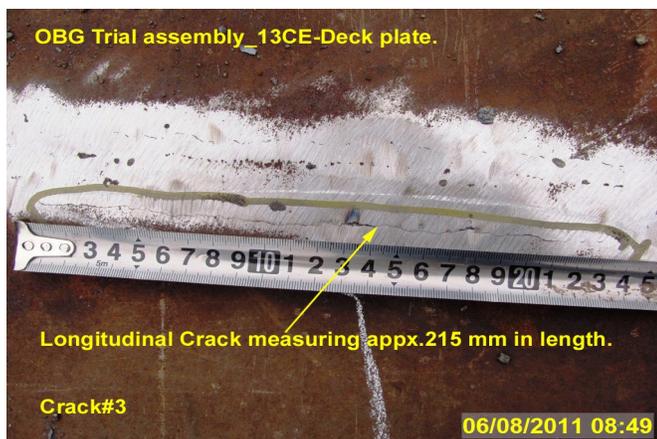
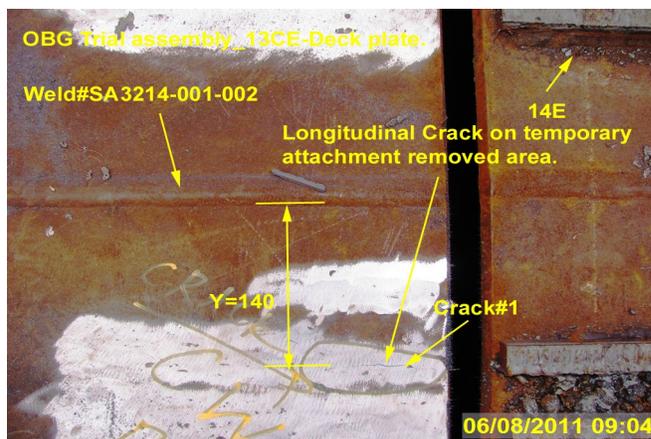
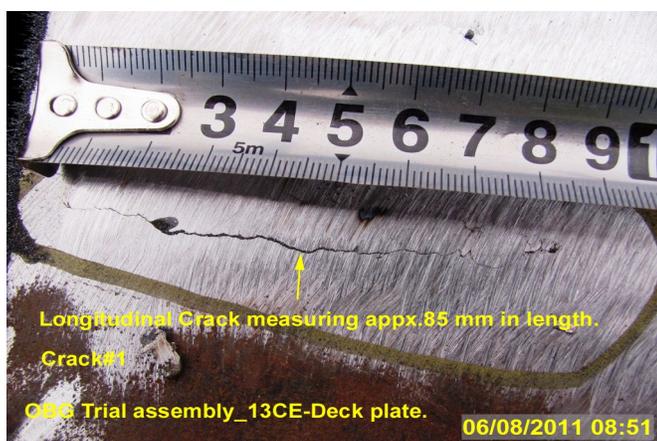
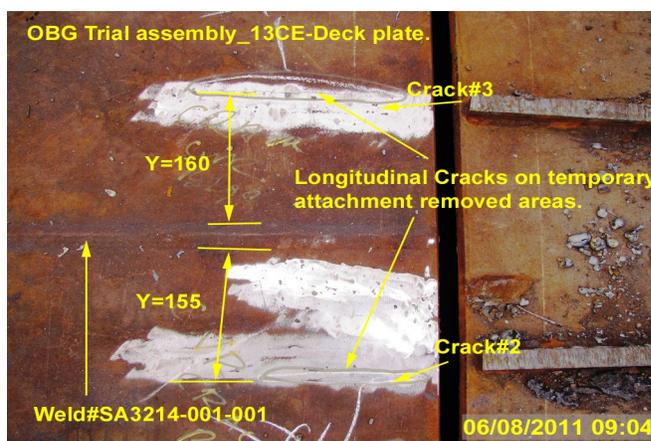
During random in process visual inspection of OBG member identified as deck plate, this QA observed 3 longitudinal linear cracks on deck plate base metal where the temporary attachment removed area. The length of cracks measuring approximately 180 mm ~ mm in length. The deck plate member is identified as PL3332A. The deck plate is designated as Seismic Performance Critical Material (SPCM) on the approved shop drawing. The nearest welds are identified as SEG3014-001 and OBW13-001. The "Y" locations measured to be approximately 470 mm and 40 mm from the weld toes respectively as shown on the picture below. The thickness of the deck plate is 20 mm. This QA marked the affected area and informed ZPMC Quality Control (QC) CWI identified as Mr. Liu hua jie of this issue. Mr. Liu hua jie informed this QA that the cracks would be corrected in a manner compliant with the contract documents. This QA Inspector also informed to Lead QA Inspector of the issue. See attached photos for further details.
