**DEPARTMENT OF TRANSPORTATION**

Contract #: 04-0120F4Cty: SF/ALA Rte: 80 PM: 13.2/13.9File #: 99.28**WELDING INSPECTION REPORT****Resident Engineer:** Siegenthaler, Peter**Address:** 333 Burma Road**City:** Oakland, CA 94607**Report No:** WIR-024700**Date Inspected:** 14-Jun-2011**Project Name:** SAS Superstructure**OSM Arrival Time:** 700**Prime Contractor:** American Bridge/Fluor Enterprises, a JV**OSM Departure Time:** 1900**Contractor:** Zhenhua Port Machinery Company, Ltd (ZPMC) Chanxing Island **Location:** Shanghai, China**CWI Name:** Mr. SHI LIE**CWI Present:** Yes No**Inspected CWI report:** Yes No N/A**Rod Oven in Use:** Yes No N/A**Electrode to specification:** Yes No N/A**Weld Procedures Followed:** Yes No N/A**Qualified Welders:** Yes No N/A**Verified Joint Fit-up:** Yes No N/A**Approved Drawings:** Yes No N/A**Approved WPS:** Yes No N/A**Delayed / Cancelled:** Yes No N/A**Bridge No:** 34-0006**Component:** OBG Segment**Summary of Items Observed:**

# WELDING INSPECTION REPORT

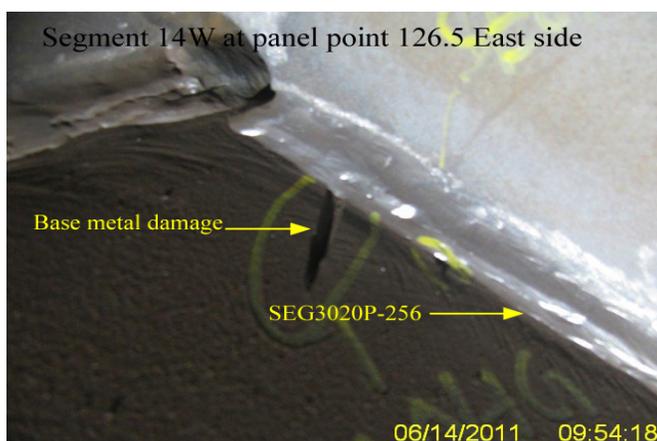
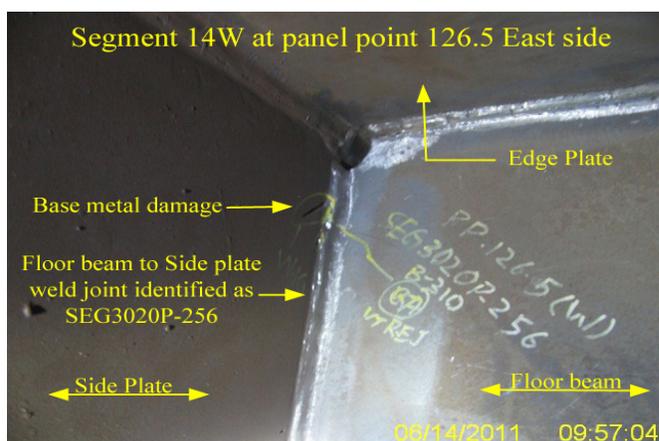
During the random visual inspection of welds located on Segment 14W at panel point 126.5 east side, this Quality Assurance Inspector (QA) observed that ZMPC MT technician personnel performed MT on Floor beam to side plate weld joint identified as SEG3020P-256, during visual inspection of the weld this Quality Assurance Inspector (QA) found base metal damage near the weld. The ZPMC QC is identified as Mr. AN QING XING. QA inform to ZPMC that prior to the repair welding, to prepare report as per the contract and ensure with VT and MT all defect have been removed. See the attached picture.
