DEPARTMENT OF TRANSPORTATION

Contract #: 04-0120F4Cty: SF/ALA Rte: 80 PM: 13.2/13.9File #: 1.28**WELDING INSPECTION REPORT****Resident Engineer:** Siegenthaler, Peter**Address:** 333 Burma Road**City:** Oakland, CA 94607**Report No:** WIR-025086**Date Inspected:** 11-Jul-2011**Project Name:** SAS Superstructure**OSM Arrival Time:** 700**Prime Contractor:** American Bridge/Fluor Enterprises, a JV**OSM Departure Time:** 1530**Contractor:** American Bridge/Fluor Enterprises, a JV**Location:** Job Site**CWI Name:** Pat Swain and Fred Vonn Hoff**CWI Present:** Yes No**Inspected CWI report:** Yes No N/A**Rod Oven in Use:** Yes No N/A**Electrode to specification:** Yes No N/A**Weld Procedures Followed:** Yes No N/A**Qualified Welders:** Yes No N/A**Verified Joint Fit-up:** Yes No N/A**Approved Drawings:** Yes No N/A**Approved WPS:** Yes No N/A**Delayed / Cancelled:** Yes No N/A**Bridge No:** 34-0006**Component:** SAS Tower**Summary of Items Observed:**

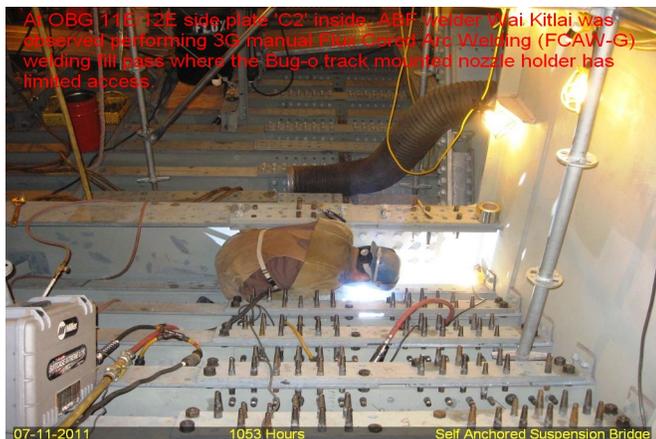
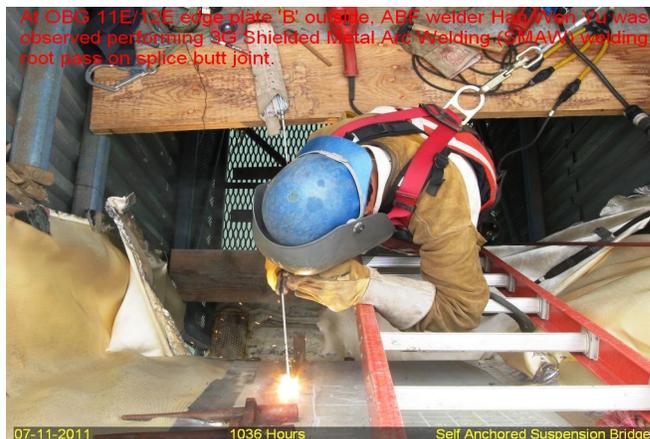
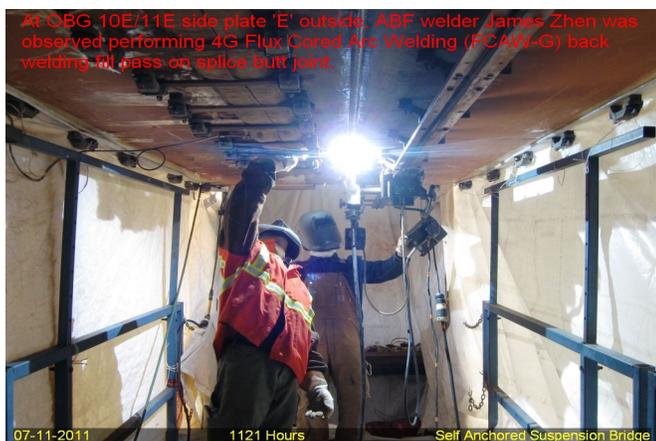
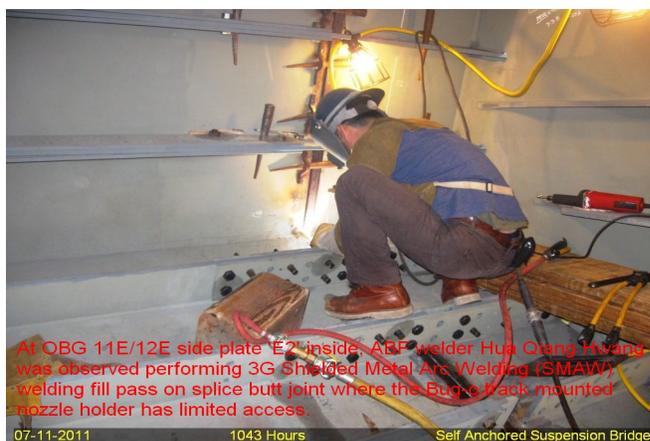
At OBG 11E/12E edge plate 'B' outside, QA randomly observed ABF/JV qualified welder Han Wen Yu perform root pass welding on the Complete Joint Penetration (CJP) splice butt joint. The welder was observed manually welding in the 3G (vertical) position utilizing a Shielded Metal Arc Welding (SMAW) with 1/8" diameter E7018H4R electrode and implementing Caltrans approved Welding Procedure Specification (WPS) ABF-WPS-D15-1040B. The joint being welded has a single V-groove butt joint with steel backing bar. ABF Quality Control (QC) Fred Vonn Hoff was noted monitoring the welding parameters of the welder. QA randomly monitored the welding parameter with reading of 135 amperes on a 1/8" diameter E7018H4R electrode which appears in conformance to the contract requirements. At the end of the shift, SMAW root pass welding was still continuing and should remain tomorrow.

At OBG 11E/12E side plate 'C2' (4278mm to 5278mm) inside, QA randomly observed ABF/JV qualified welder Wai Kitlai continuing to perform CJP groove (splice) welding fill pass on the splice butt joint. The welder was observed perform automatic welding in the 3G (vertical) position utilizing a dual shield Flux Cored Arc Welding (FCAW-G) with E71T-1M, 1/16" diameter wire electrode and implementing Caltrans approved Welding Procedure Specification (WPS) ABF-WPS-D15-3042B-1. The joint being welded has a single V-groove butt joint with backing bar. The splice joint was preheated and maintained to greater than 150 degrees Fahrenheit using propylene gas torch prior welding. During welding, ABF Quality Control (QC) Pat Swain was noted monitoring

At OBG 11E/12E side plate 'E1' (0mm to 300mm) inside, QA randomly observed ABF/JV qualified welder Hua Qiang Hwang continuing to perform CJP groove (splice) welding fill pass to cover pass on the splice butt joint at the corner of edge plate 'F' where the track mounted Bug-o nozzle holder has limited access . The welder was observed perform manual welding in the 3G (vertical) position utilizing a Shielded Metal Arc Welding (SMAW) with 1/8" diameter E7018H4R electrode and implementing Caltrans approved Welding Procedure Specification (WPS) ABF-WPS-D15-1040B. The joint being welded has a single V-groove butt joint with backing bar. During welding, ABF Quality Control (QC) Pat Swain was noted monitoring the welding parameters of the welder. During the shift, cover pass welding at this location was completed and the welder has moved to the bottom of side plate 'E1' (4278mm to 5278mm) corner of bottom plate 'D1' where the track mounted Bug-o nozzle holder has also limited access. At the end of the shift, fill pass welding was still continuing and should remain tomorrow.

QA randomly observed ABF/JV qualified welder James Zhen perform CJP groove back welding fill pass on OBG 10E/11E side plate 'E1' outside. The welder was observed welding in the 4G (overhead) position utilizing a dual shield Flux Cored Arc Welding (FCAW-G) with E71T-1M, 1/16" diameter wire electrode and implementing Caltrans approved Welding Procedure Specification (WPS) ABF-WPS-D15-3110-4. The welders were using a track mounted welder holder assembly that was remotely controlled. The joint being welded has the backing bar gouged using the Esab Plasma Arc machine and was ground smooth. The gouged and ground splice butt joint was also Non Destructive Testing (NDT) tested using the Magnetic Particle Testing (MT). The splice joint was preheated to greater than 150 degree Fahrenheit using Miller Proheat 35 Induction Heating System located on top of the plate prior welding and maintained by moving the heater blanket at the side of the plate being welded during welding. The vicinity was properly protected from wind. During welding, ABF Quality Control (QC) Fred Vonn Hoff was noted monitoring the welding parameters of the welder. The measured welding parameters during welding were 220 amperes, 24 volts with travel speed of 190 mm per minute and calculated heat input of 1.67Kj/mm which appears in compliance with the contract requirements. At the end of the shift, fill pass welding was still continuing and should remain tomorrow.

ABF QC John Pagliero and this QA performed a joint fit up verification on the Electro Slag Welding (ESW) T-joint S-042 at location 'L' scheduled to be welded tomorrow July 12, 2011. The measured root gap was noted 19.2mm minimum and 24mm maximum. There was no lesser than 16mm nor more than 25mm root gap noted from the bottom to the top of the T-joint. With the measurements that were recorded during the fit up verification, the fit up of the weld T- joint was deemed in compliance to the contract requirements.
