Contract #: 04-0120F4Cty: SF/ALA Rte: 80 PM: 13.2/13.9File #: 1.28**WELDING INSPECTION REPORT****Resident Engineer:** Siegenthaler, Peter**Address:** 333 Burma Road**City:** Oakland, CA 94607**Report No:** WIR-025186**Date Inspected:** 15-Jul-2011**Project Name:** SAS Superstructure**OSM Arrival Time:** 700**Prime Contractor:** American Bridge/Fluor Enterprises, a JV**OSM Departure Time:** 1530**Contractor:** American Bridge/Fluor Enterprises, a JV**Location:** Job Site

Caltrans Office of Structural Material (OSM) Quality Assurance Inspector (QAI) Joselito Lizardo was present at the Self Anchored Suspension (SAS) job site as requested to perform observations on the welding of components for the San Francisco Oakland Bay Bridge (SFOBB) Project.

At Tower Base Elevation 13Meters Shear Plate Electro Slag Welding (ESW);

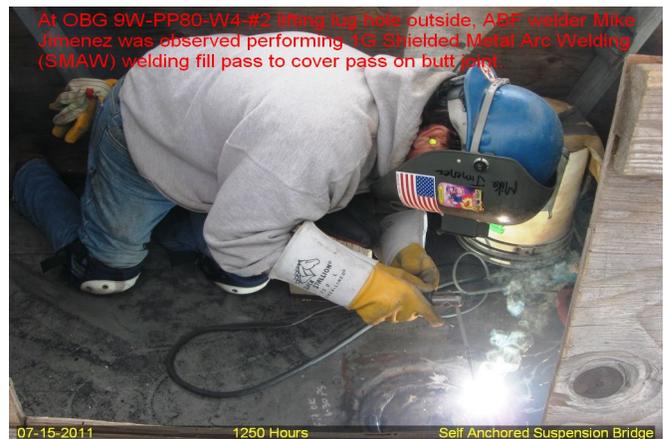
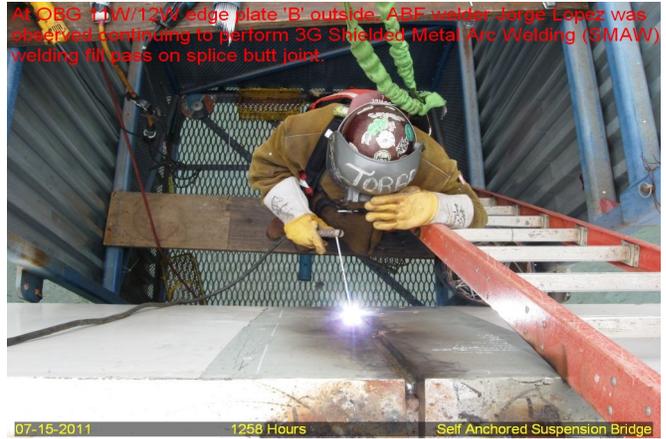
This QA together with ABF QC Jesse Cayabyab performed a joint fit up inspection/verification on the alignment of the 80-100mm transition butt joint W-043 at location 'V' in preparation for the next ESW that was scheduled to be welded July 16, 2011. The root gap and offset were measured from bottom to top. The result noted on the offset verification was less than 3.0mm on most of the part except on the following which has exceeded the maximum allowed;

Y-location	Offset	Length
8760mm to 9780mm	4-5mm	1020mm
7490mm to 7700mm	4-5mm	210mm
4350mm to 7490mm	5-6mm	3140mm
3380mm to 4350mm	4-5mm	970mm
0mm to 300mm	4mm	300mm

The root gap measured was 19mm minimum and 25mm maximum which appears in compliance to the approved WPS.

At OBG 11W/12W edge plate 'B' outside, QA randomly observed ABF/JV qualified welder Jorge Lopez continuing to perform fill pass welding on the Complete Joint Penetration (CJP) 28mm thick splice butt joint. The welder was observed manually welding in the 3G (vertical) position utilizing a Shielded Metal Arc Welding (SMAW) with 1/8" diameter E7018H4R electrode and implementing Caltrans approved Welding Procedure Specification (WPS) ABF-WPS-D15-1040B. The joint being welded has a single V-groove butt joint with steel backing bar. ABF Quality Control (QC) William Sherwood was noted monitoring the welding parameters of the welder. QA randomly monitored the welding parameter with reading of 130 amperes which appears in conformance to the contract requirements. At the end of the shift, SMAW fill pass welding was still continuing and should remain tomorrow.

At OBG 11W/12W edge plate 'F' outside, QA randomly observed ABF/JV qualified welder Fred Kaddu continuing to perform fill pass to cover pass welding on the Complete Joint Penetration (CJP) 18mm thick splice butt joint. The welder was observed manually welding in the 3G (vertical) position utilizing a Shielded Metal Arc Welding (SMAW) with 1/8" diameter E7018H4R electrode and implementing Caltrans approved Welding Procedure Specification (WPS) ABF-WPS-D15-1040B. The joint being welded has a single V-groove butt joint with steel backing bar. ABF Quality Control (QC) William Sherwood was noted monitoring the welding parameters of the welder. QA randomly monitored the welding parameter with reading of 138 amperes which appears in conformance to the contract requirements. At the end of the shift, SMAW cover pass welding was completed including the flush grinding of the weld cover as required.

At OBG 9W-PP80-W4-#2 lifting lug hole to top deck plate outside – ABF welder Mike Jimenez was observed 1G Shielded Metal Arc Welding (SMAW) welding fill pass to cover pass on the infill plate to top deck plate butt joint. The welder was noted using 5/32" diameter E7018H4R electrode implementing Caltrans approved Welding Procedure Specification (WPS) ABF-WPS-D15-1070. During welding, ABF QC William Sherwood was noted monitoring the welder's welding parameters. At the end of the shift, cover pass welding on the top side location of the joint was completed.
